West Fork White River Restoration at Brentwood Mountain Summary Report
Arkansas Department of Agriculture – Natural Resources Division Project 17-0900

Watershed Conservation Resource Center

July 11, 2022

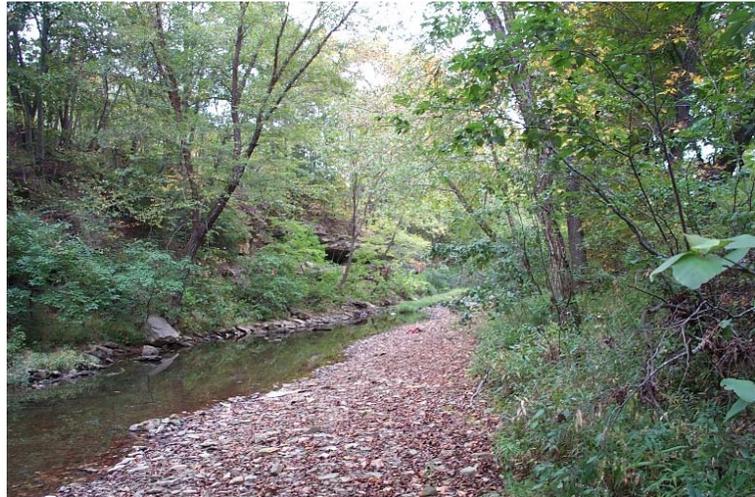
Figure 2. Site prior to destabilization with a healthy riparian and low channel width to depth

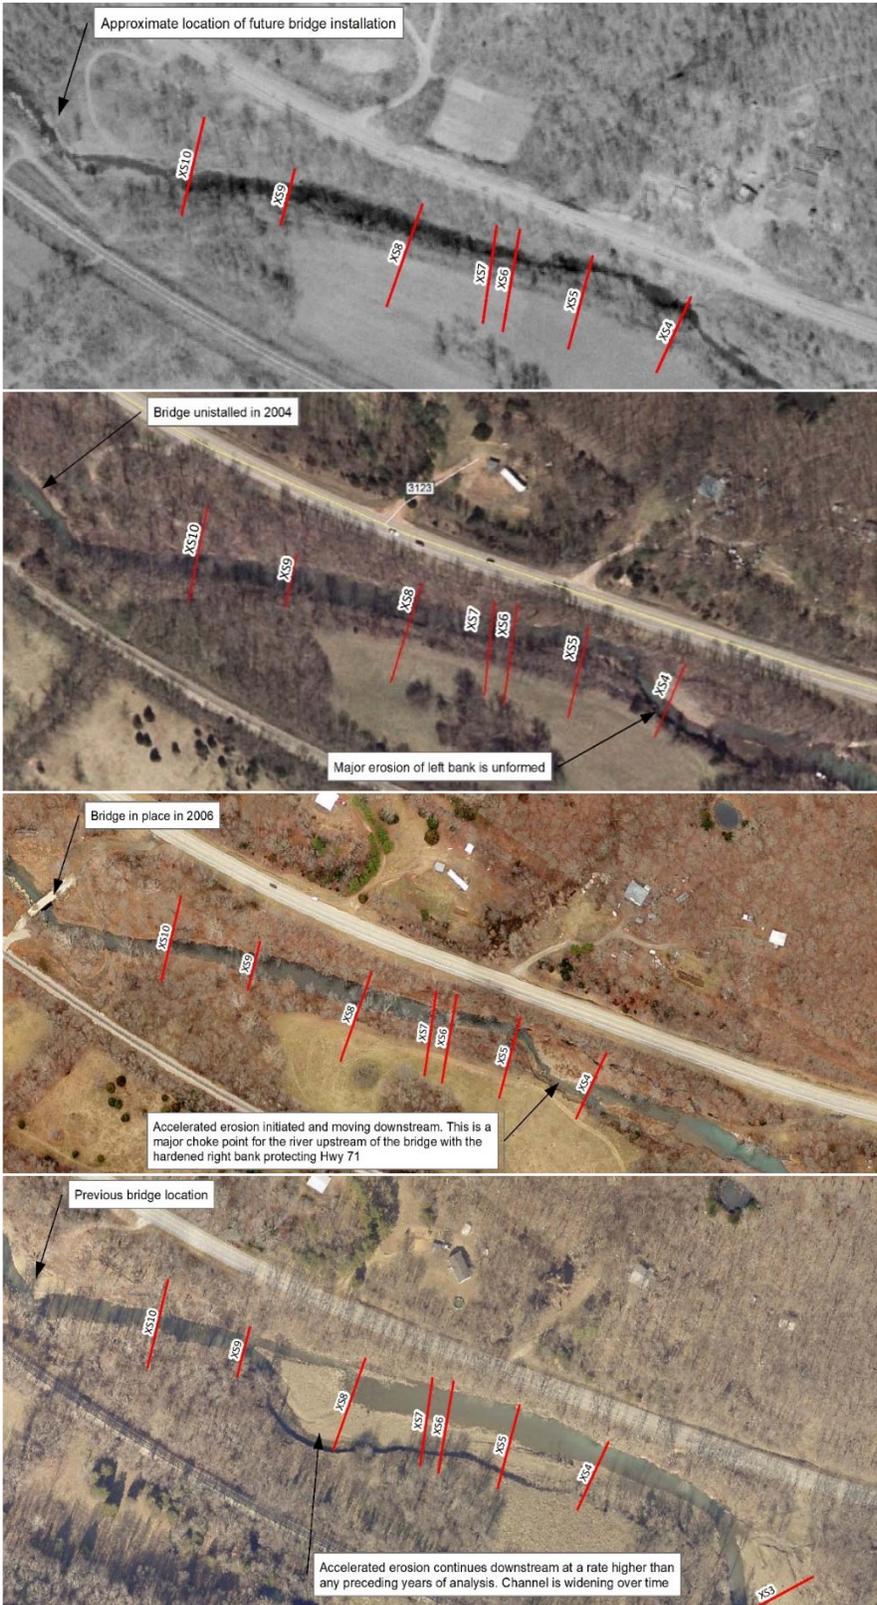
Figure 3. Procession of changes on site. The top image is of 1964, then 2004 prior to installing a low water bridge downstream, then in 2006 where site changes began to initiate coinciding with installation of a bridge, and then in 2020 following a major erosion.

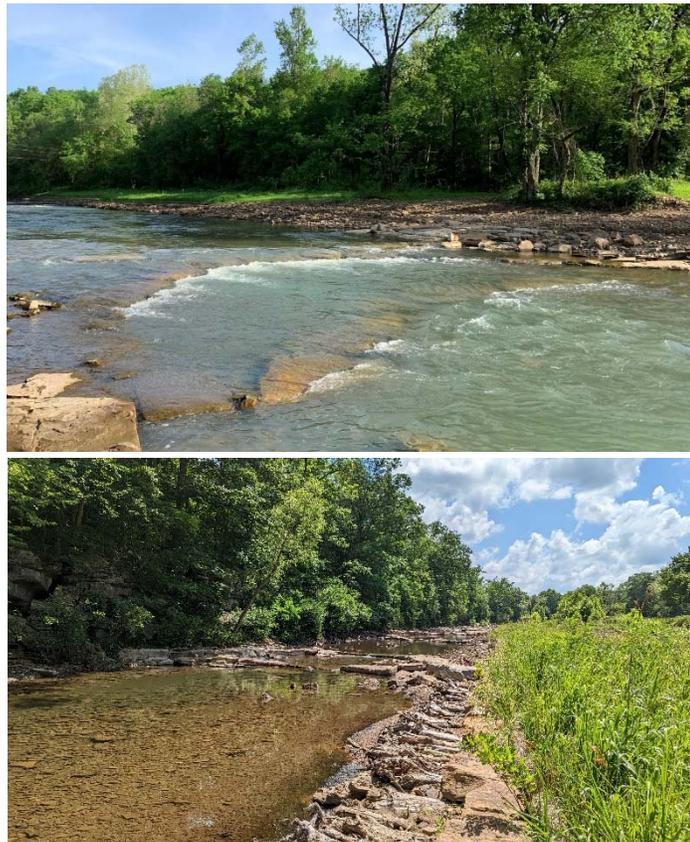
Figure 7. Top – Photo of low water crossing and J-Hook Vane taken May 2022 following construction and the 3-times bankfull event. Bottom - Photo of the Restoration Site at the Downstream End Looking Upstream during low flow conditions and taken during the as-built survey 7-1-22

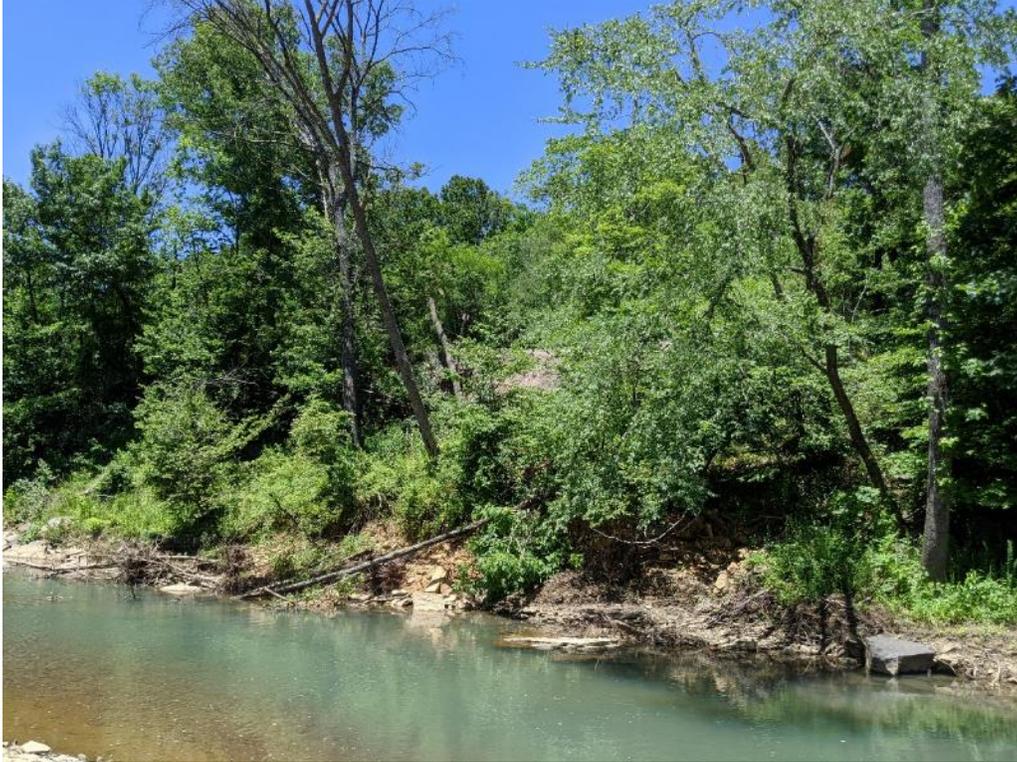
Figure 14. The right bank, that is hardened with a rock cliff and boulders along its sheer slope in most places at the site has eroded, destabilized, and created a landslide damaging parts of Highway 71 in 2020.

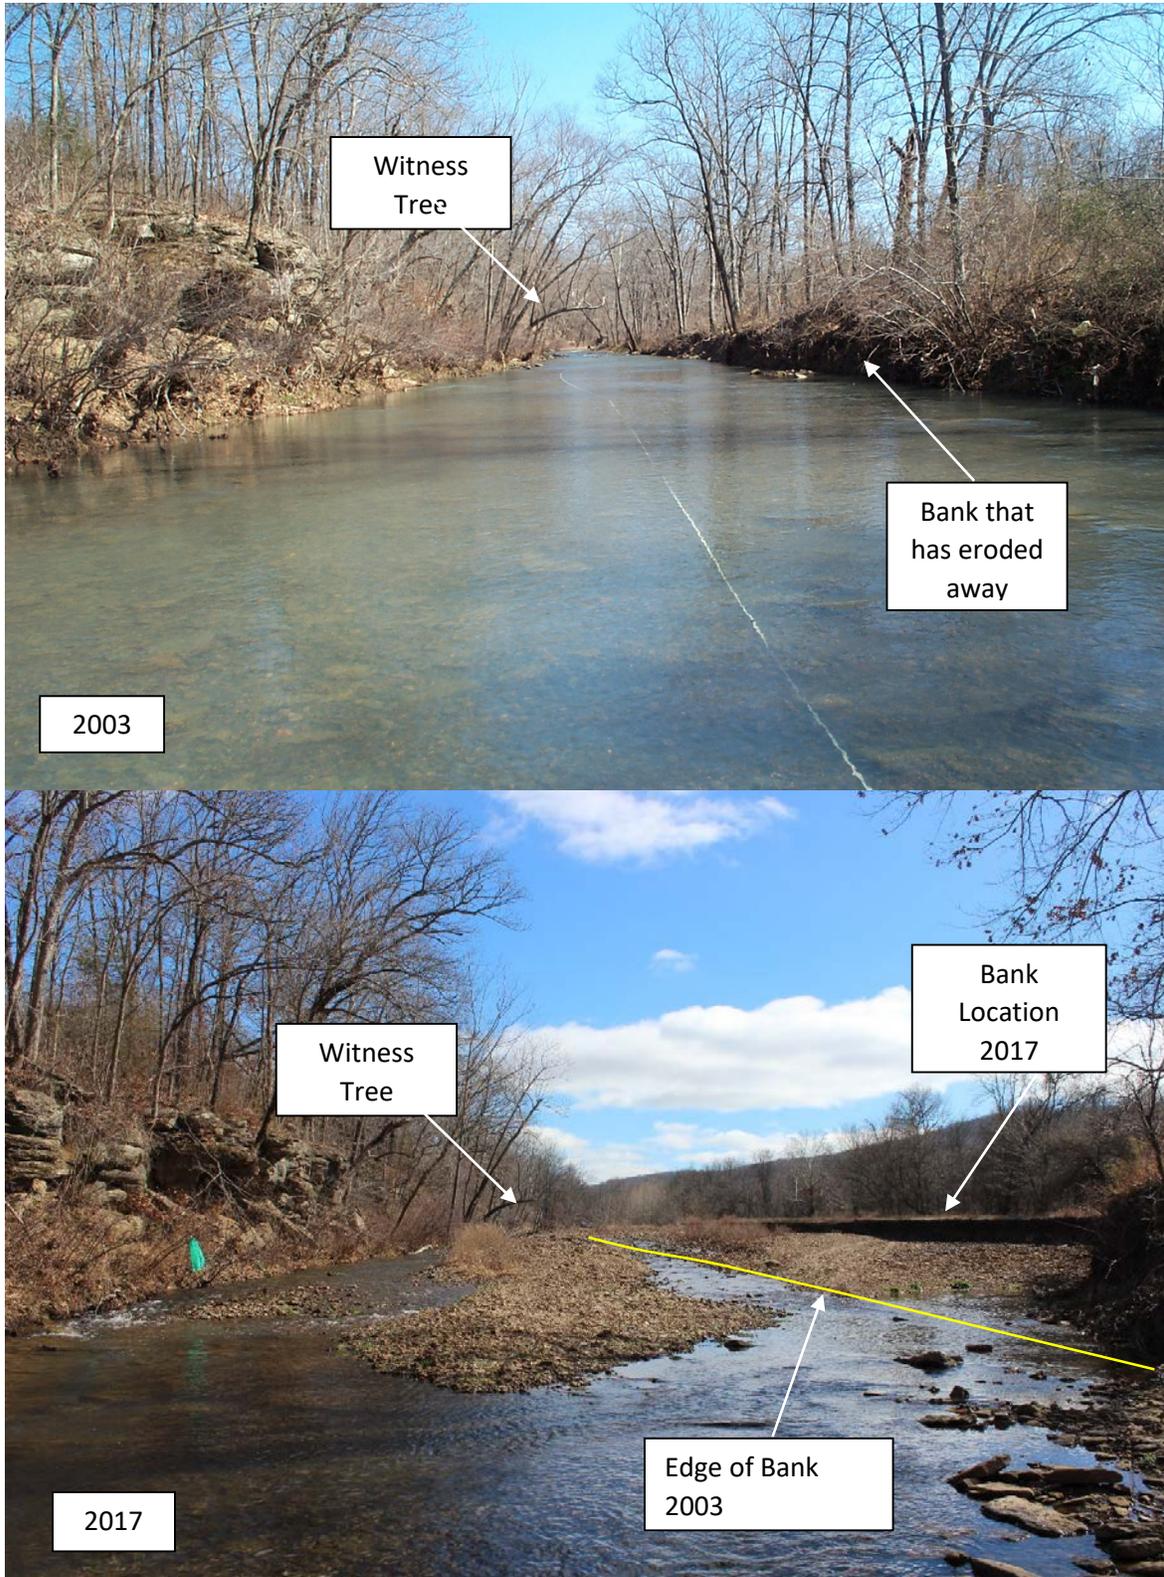
Figure 3. Stream channel instability at the streambank has resulted in severe lateral erosion and the loss of high quality riparian (right side of above images) along the WFWR.

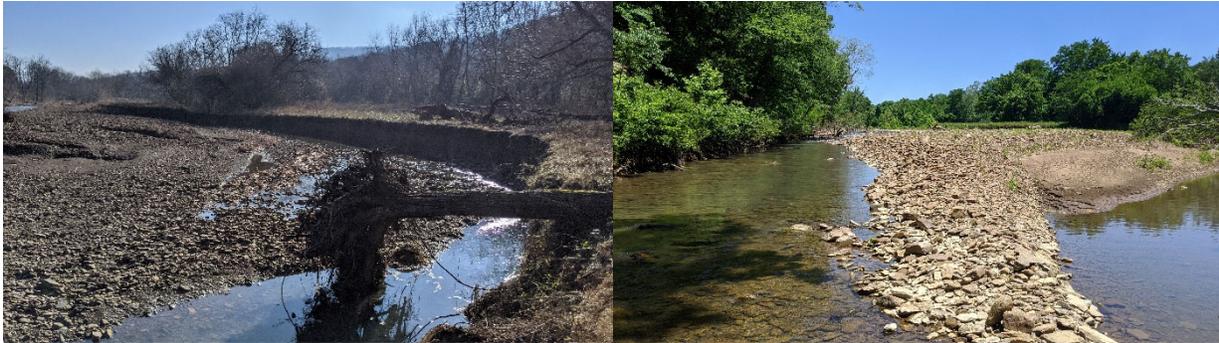
Figure 2. Site instability, the left image shows the over-widened channel downstream with a tree that was recently washed into the area and the right image shows the aggrading mid channel point bar

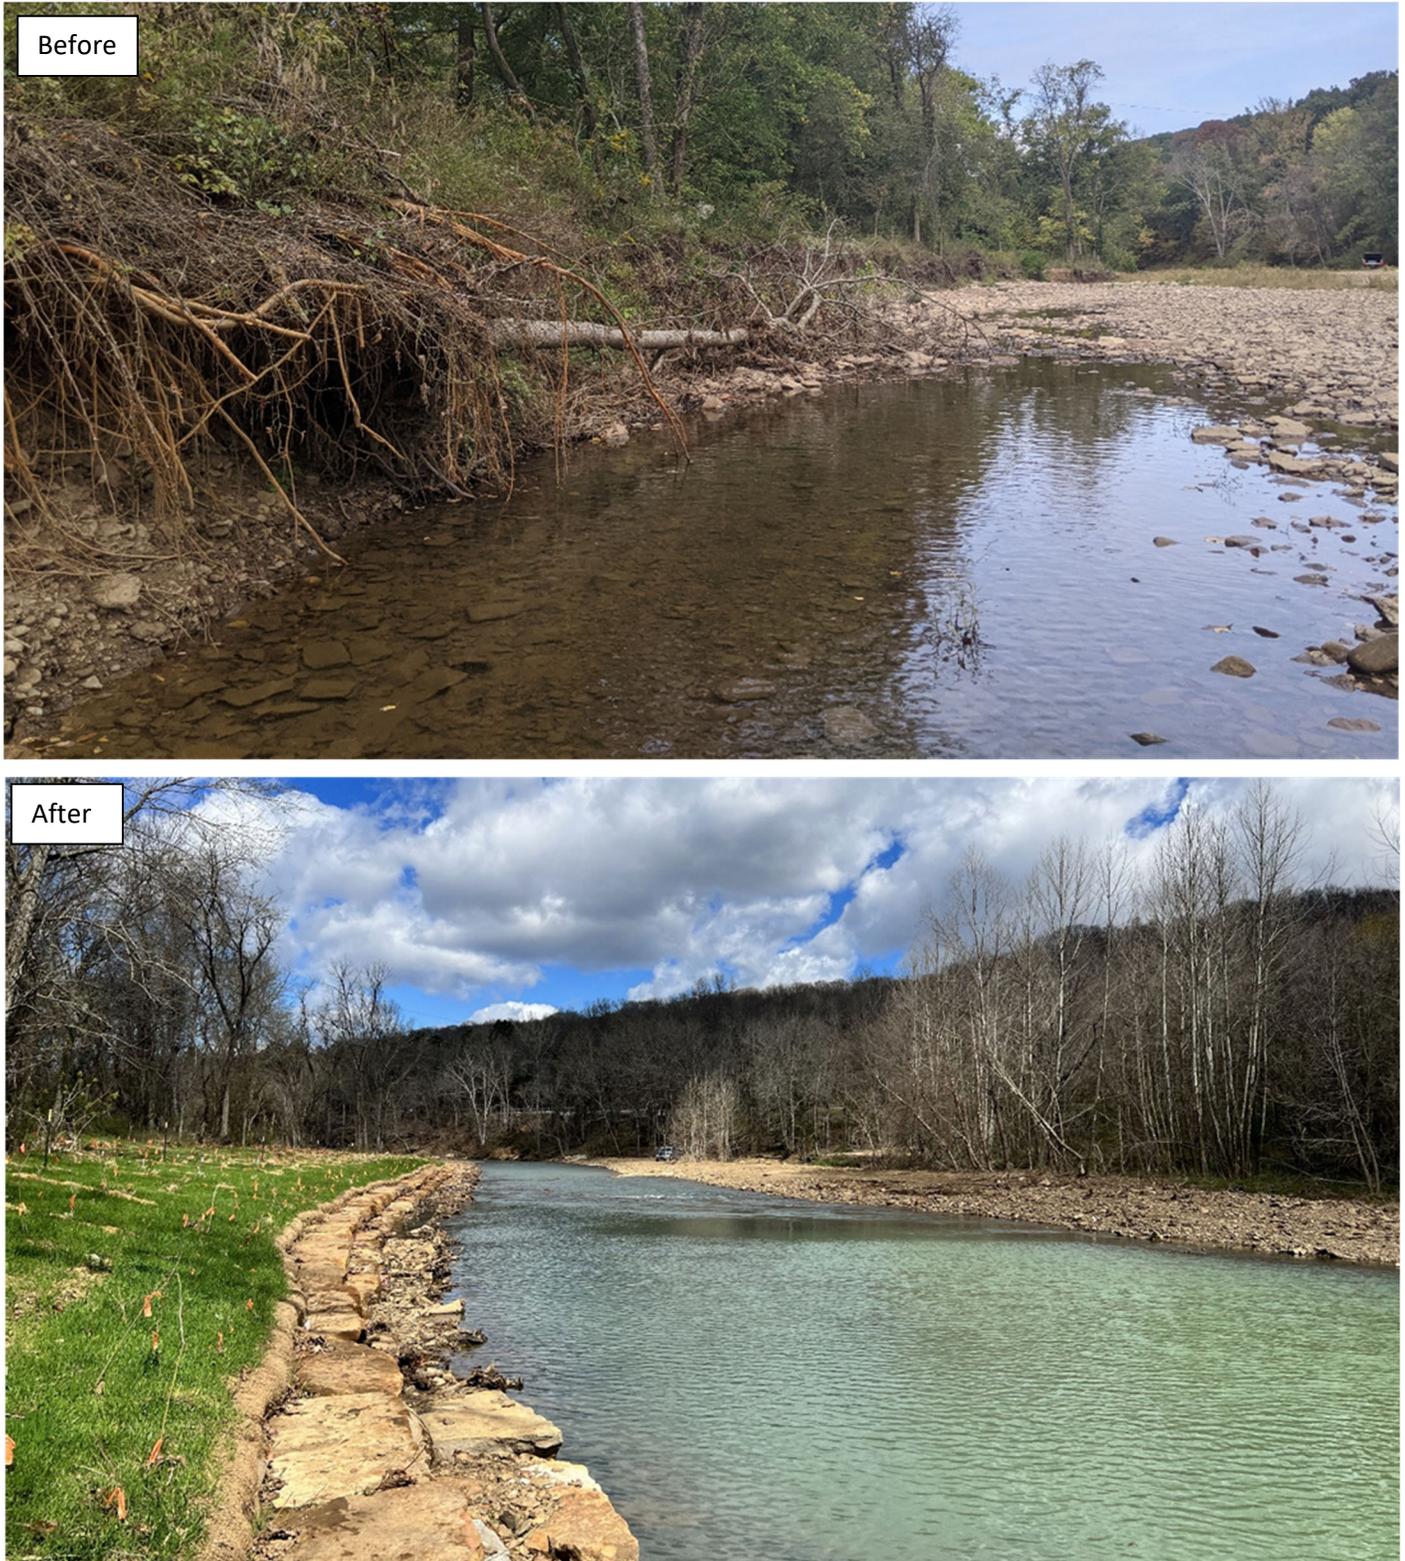
Figure 14. The upstream cut bank before and after restoration. The upper photo shows the eroding streambank prior to restoration. The lower photo shows the constructed riparian bank with a toewood bench, stack rock, and a soil mattress filled with native species of trees, shrubs, grass, and forbs. The bright green aspect of the bank at this point is due to winter wheat sprouting as a cover crop.

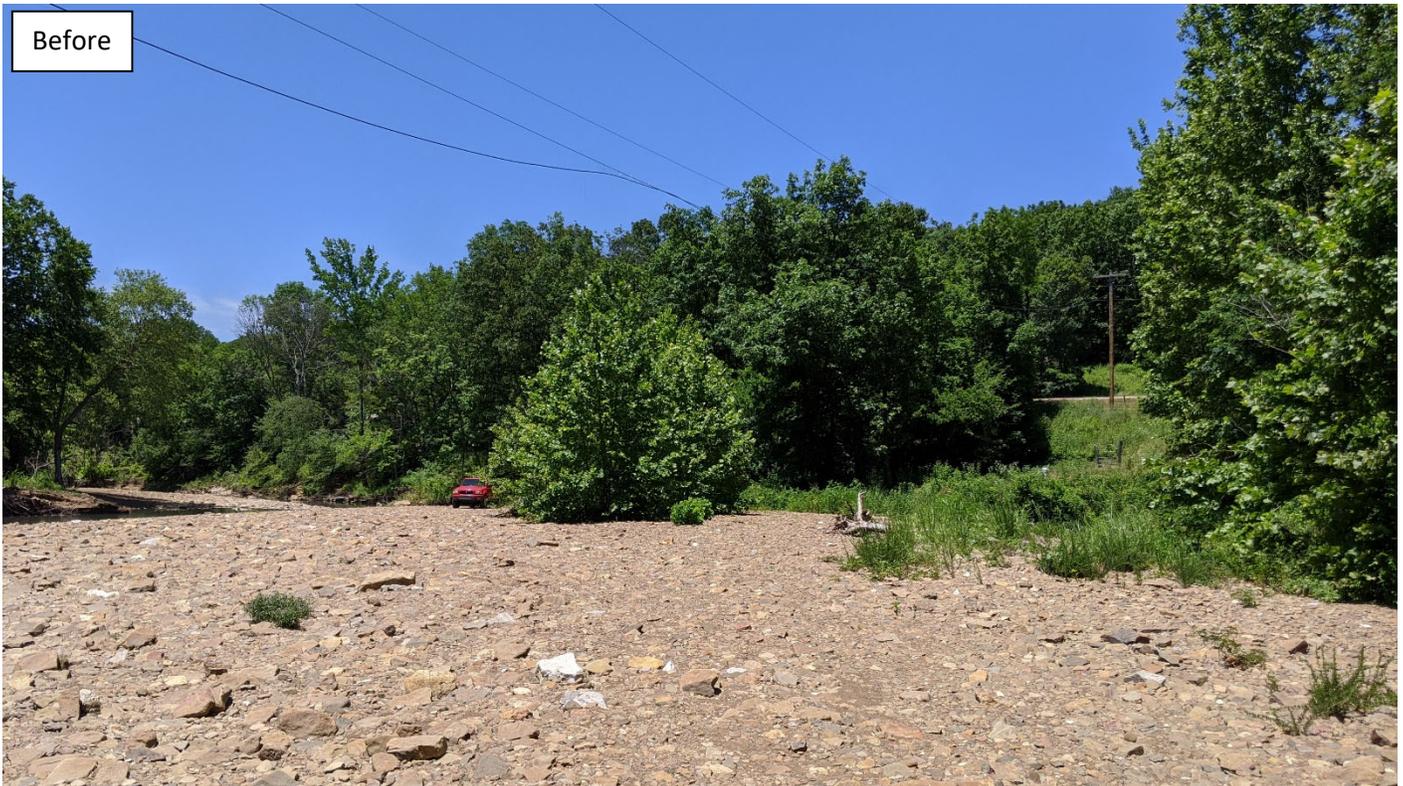
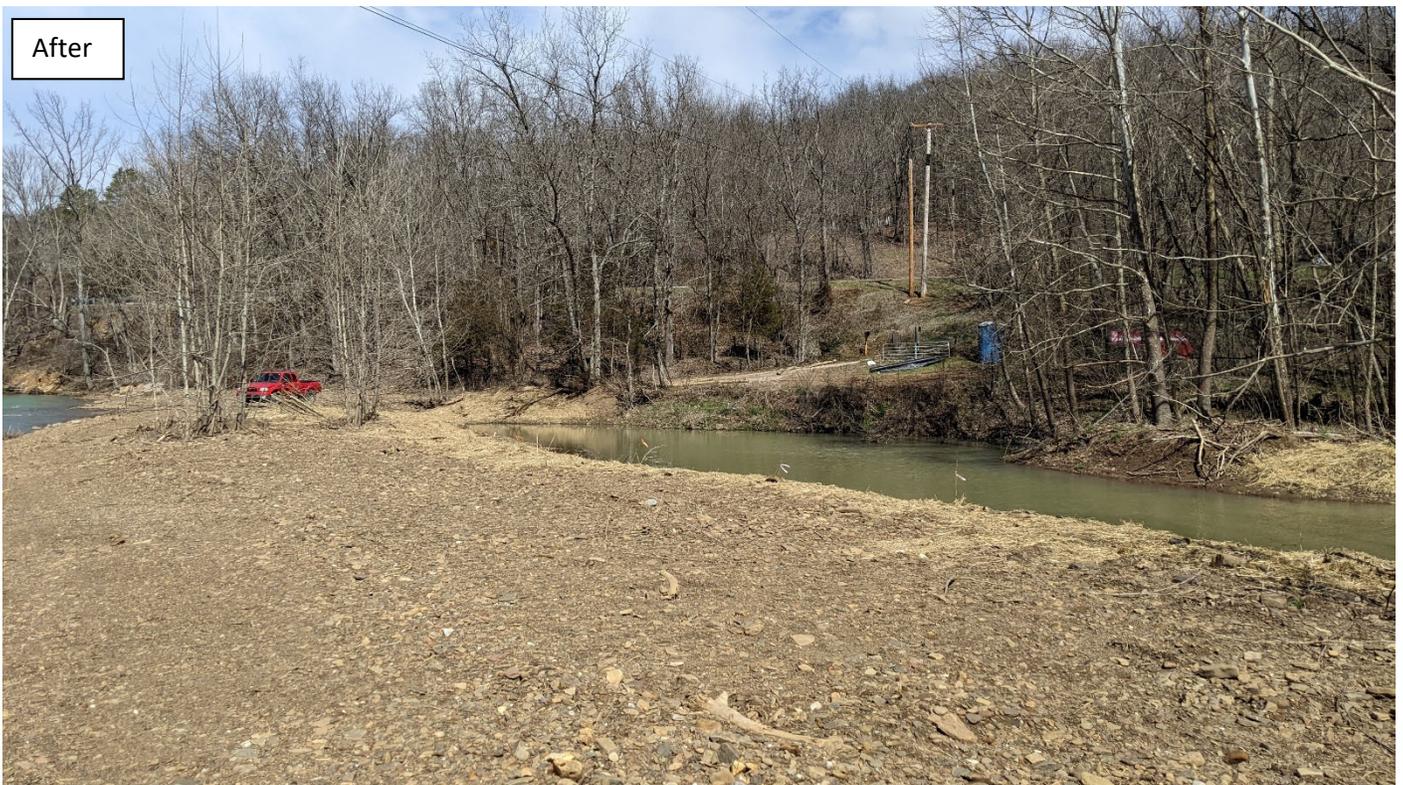
Figure 15. The upstream floodplain depression before and after restoration. The upper photo shows the low lying area full of gravels, cobbles and sandy soils. The bottom photo shows the area that was excavated for fill that would help recreate the left riparian streambank, filled with water and revegetated along its banks recreating wetland conditions

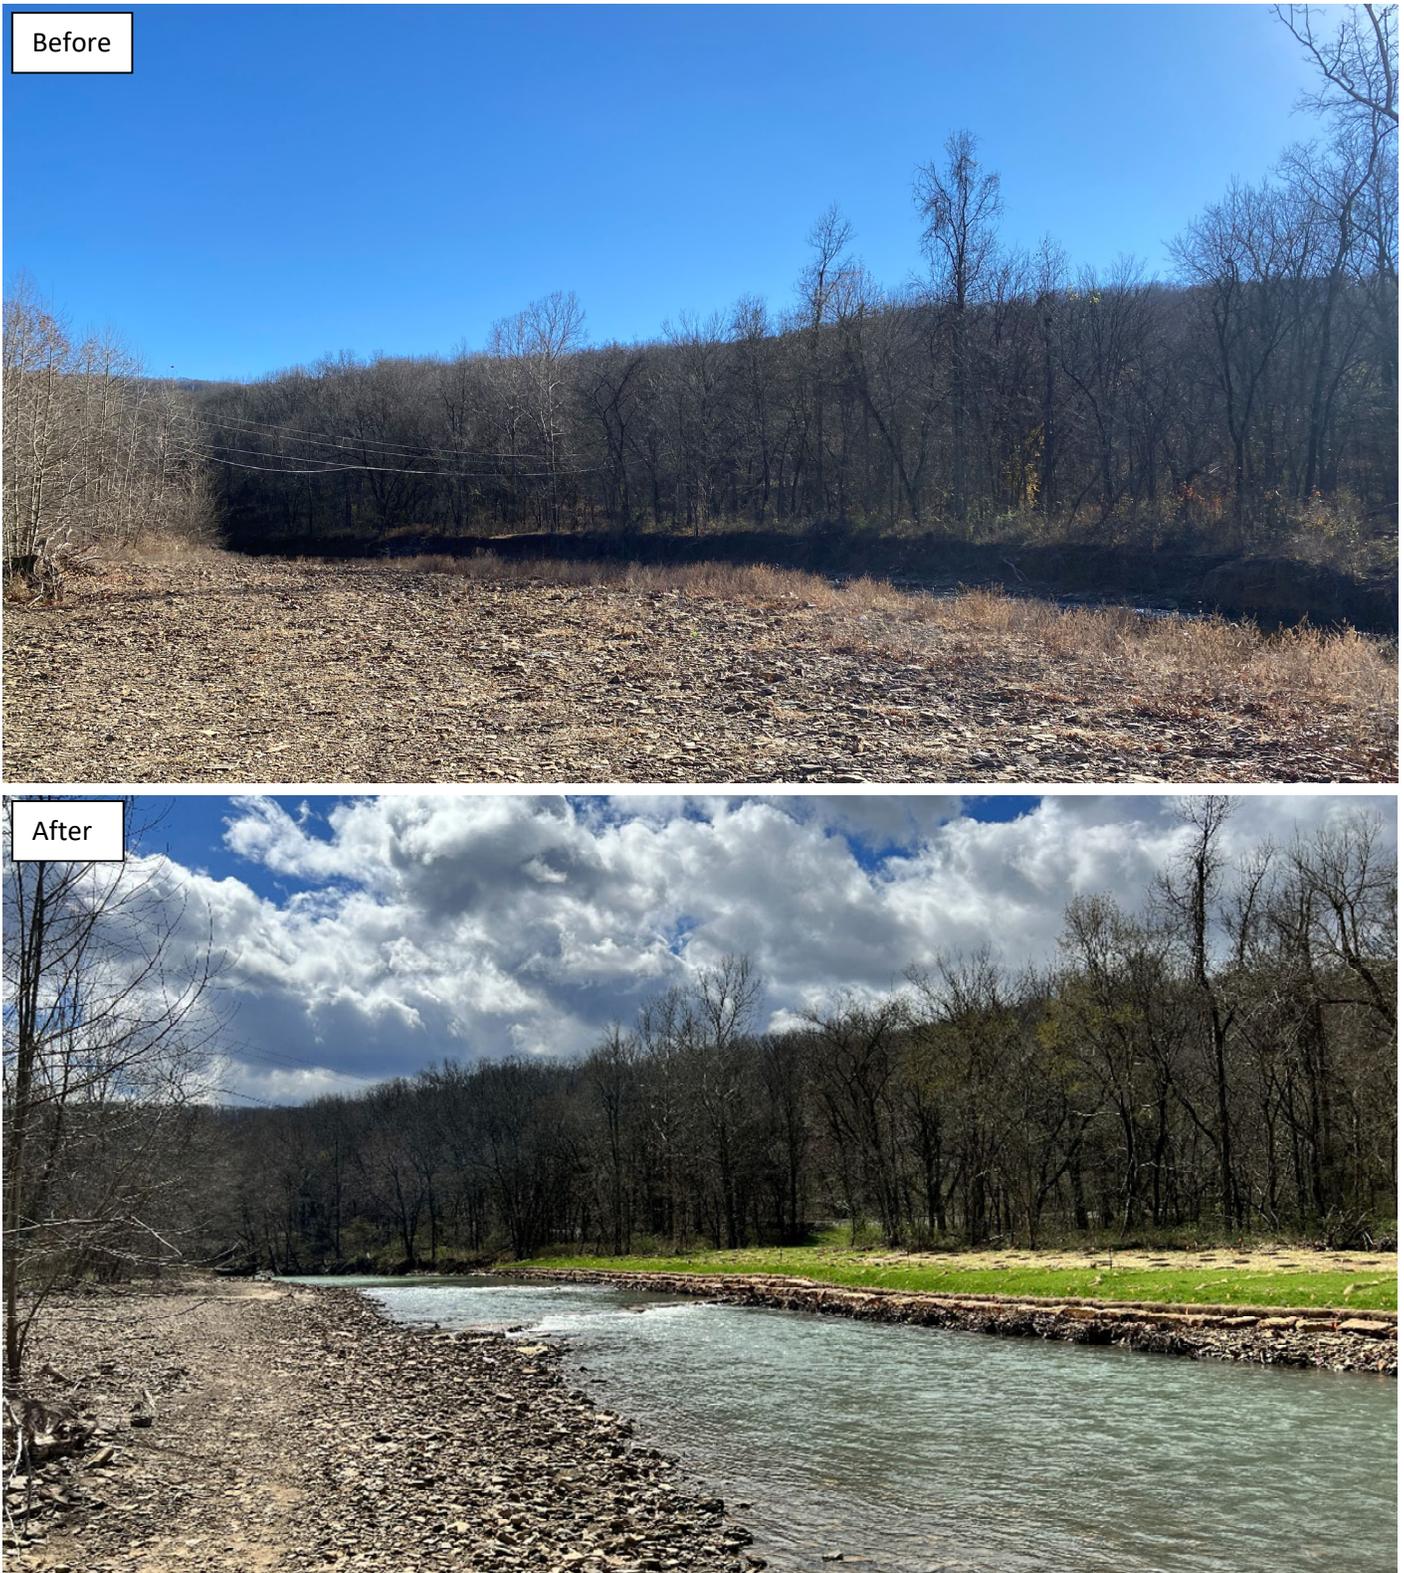
Figure 12. A before and after view of the riparian upstream bank looking upstream. The upper photo shows the eroding cut bank and shallow overwidened channel conditions. The bottom photo shows the constructed riparian bank with native plant species now conducive for sediment transport. Two riffle grade control structures are visible in the channel, maintaining flow in the channel centerline, maintaining the riffle shape, dissipating energy, and oxygenating water.

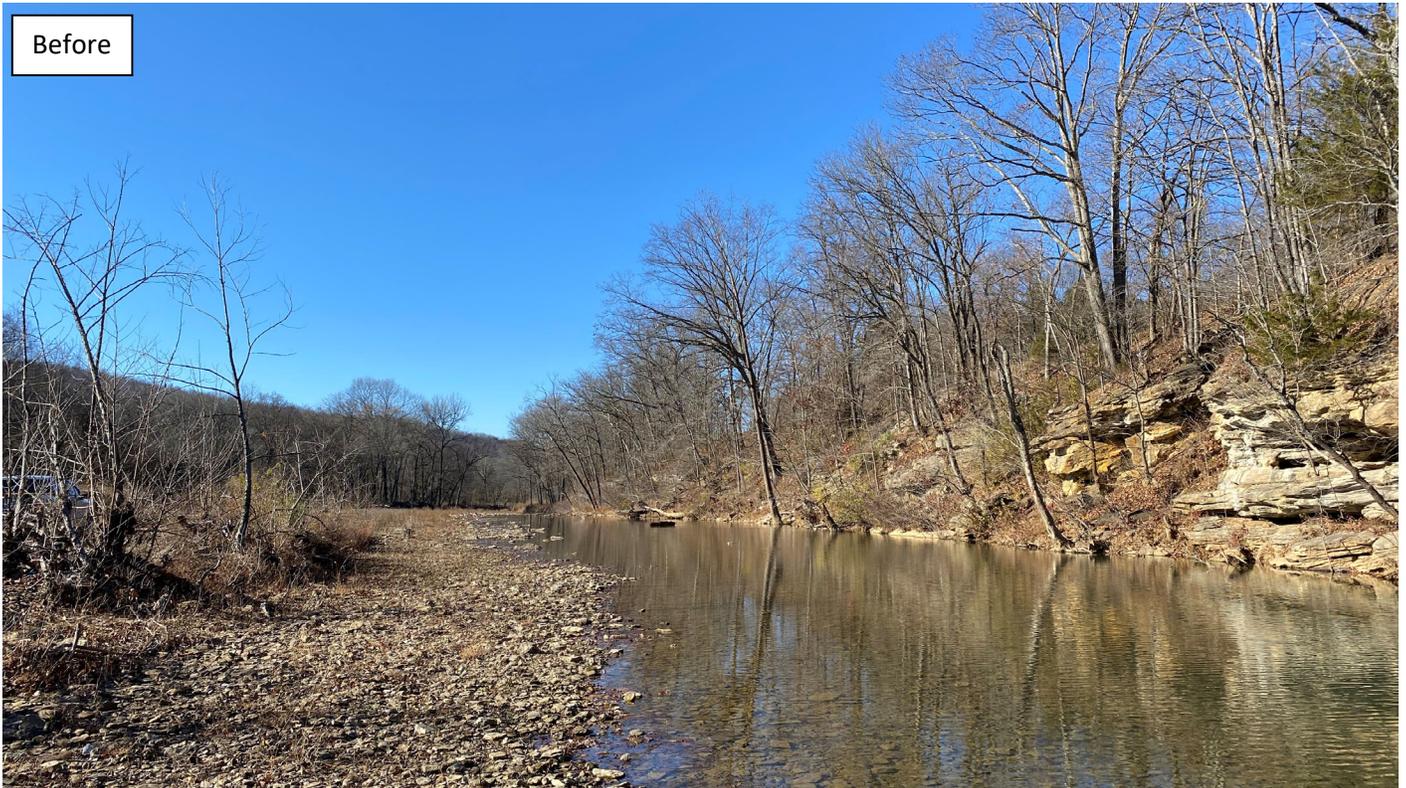
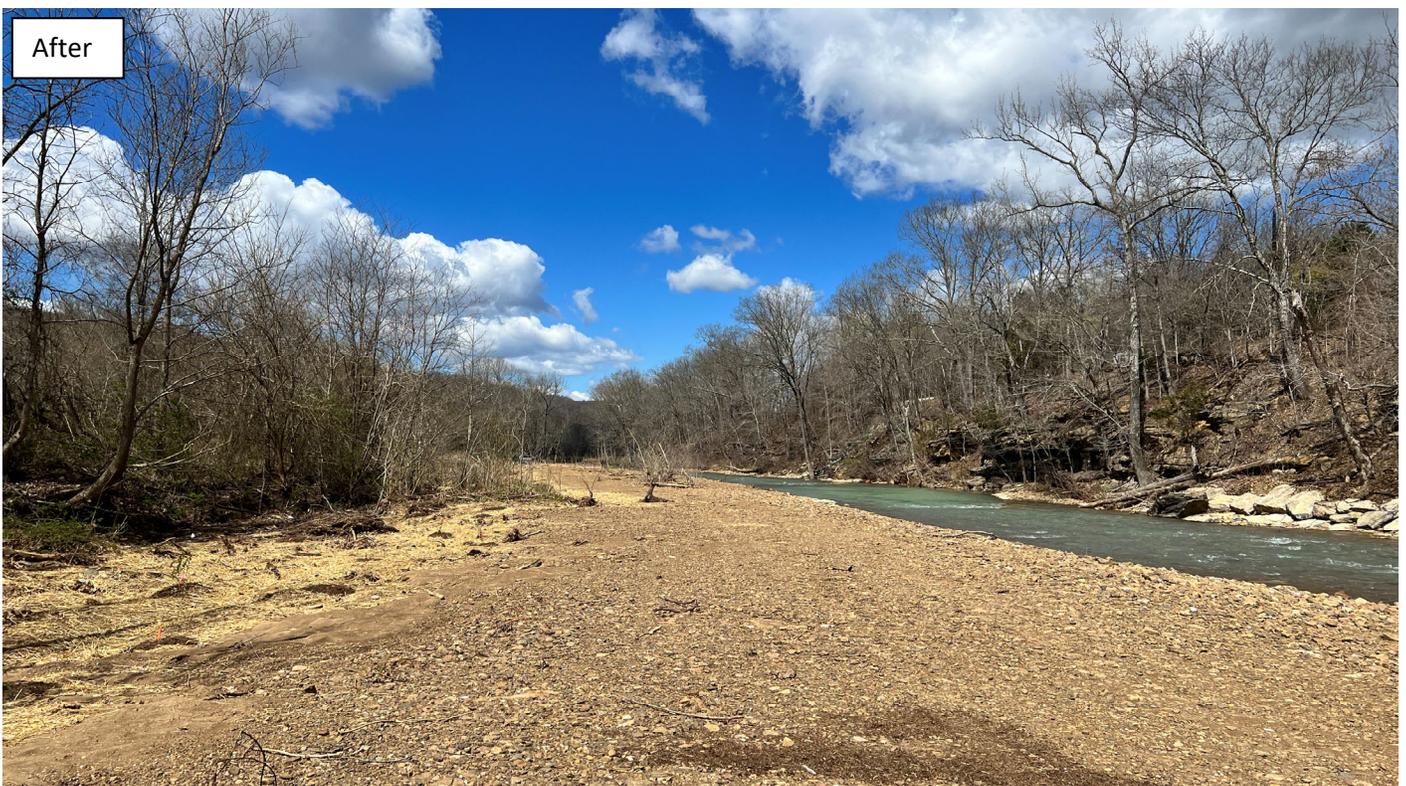
Figure 13. This photo shows the downstream gravel bar shaped to decrease the high width to depth ratio of the evolving channel prior to restoration. The upper photo shows this area prior to restoration, the bottom photo shows the low width to depth ratio stream with limestone rock protection added to tie in to river right, gravel fill placed to create the floodplain, and native vegetation.

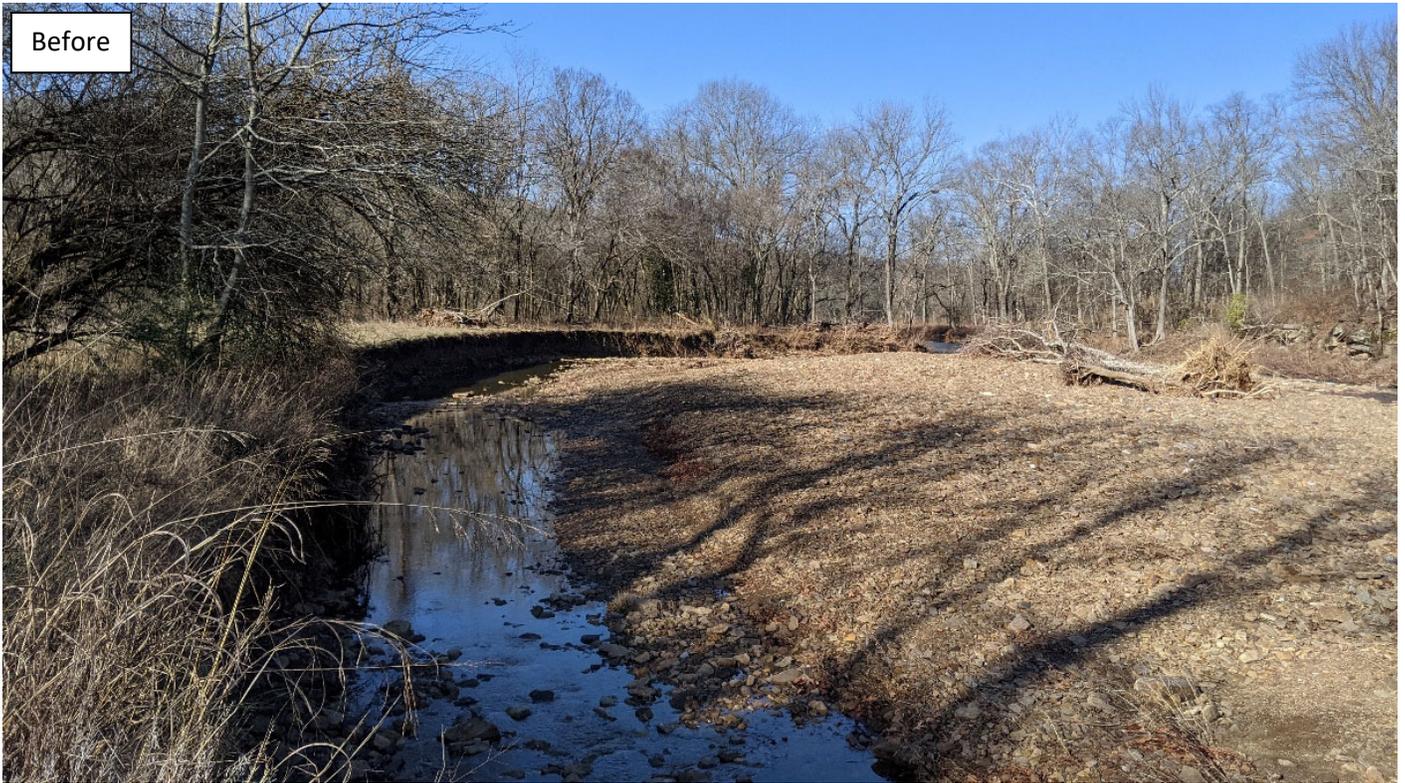
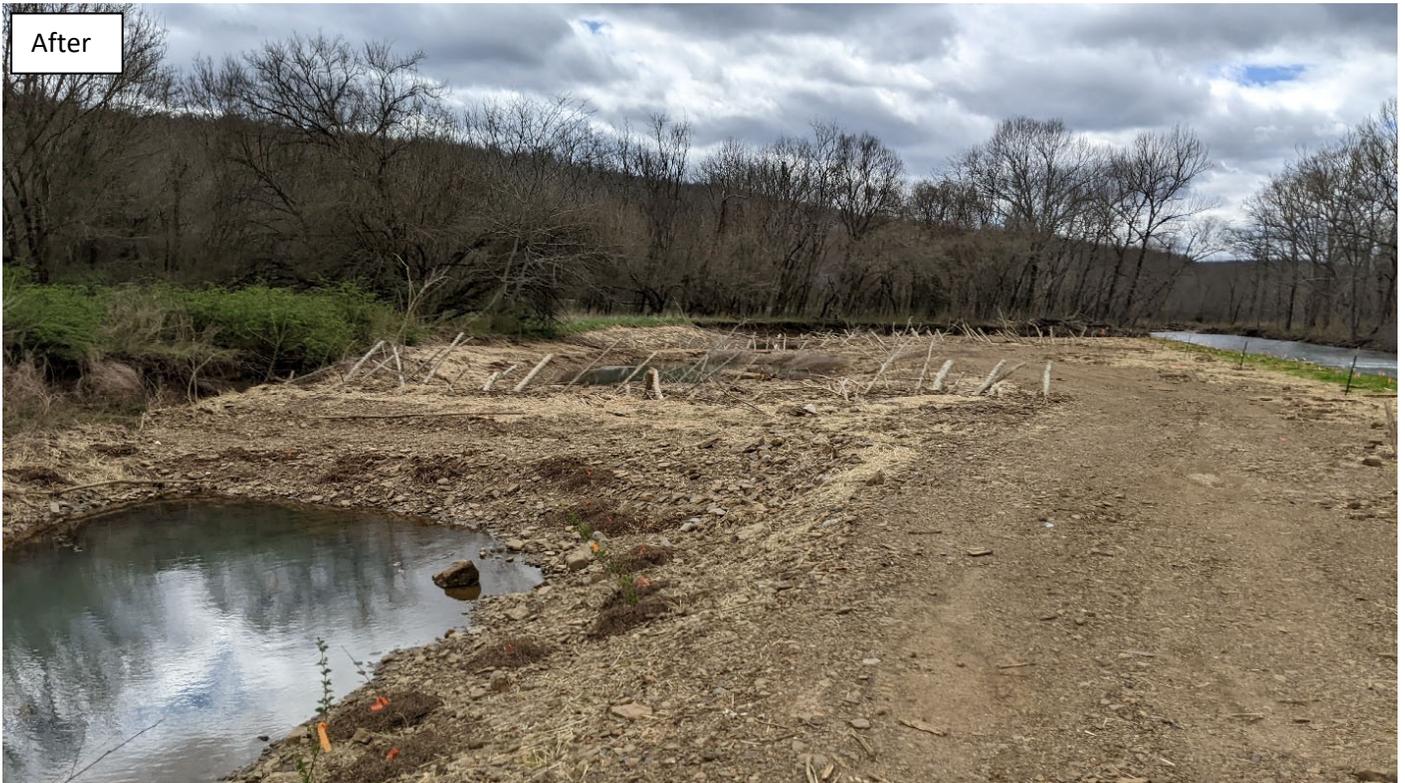
Figure 19. This photo shows the downstream cut bank. The upper photo shows the secondary, high flow channel path that was eroding the left streambank. Fallen trees are visible with a large, unvegetated gravel floodplain feature between the primary and secondary channel. The bottom photo shows the restored area, with a series of floodplain depression to create wetland conditions, sycamore sills to induce deposition and reduce the potential for the channel to cut through this area.

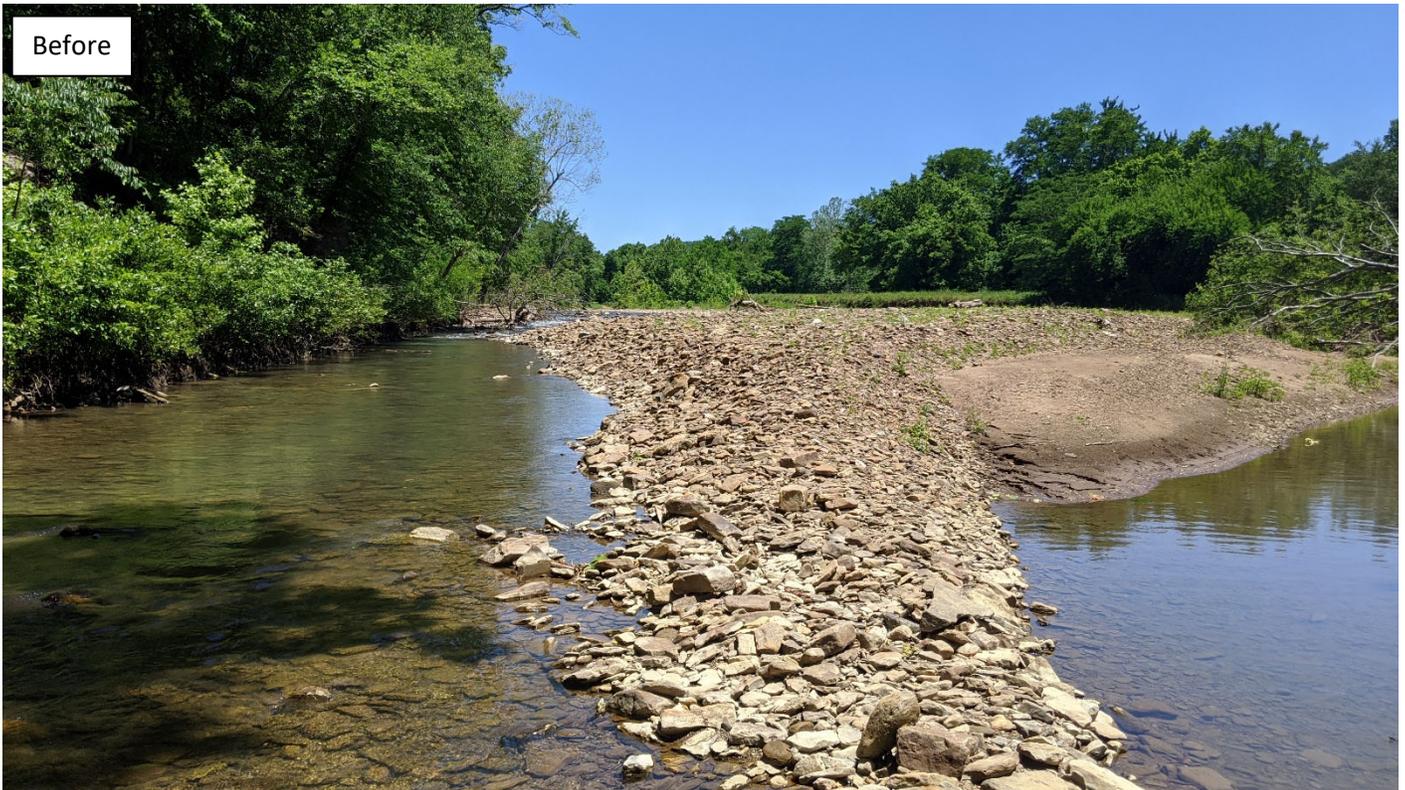
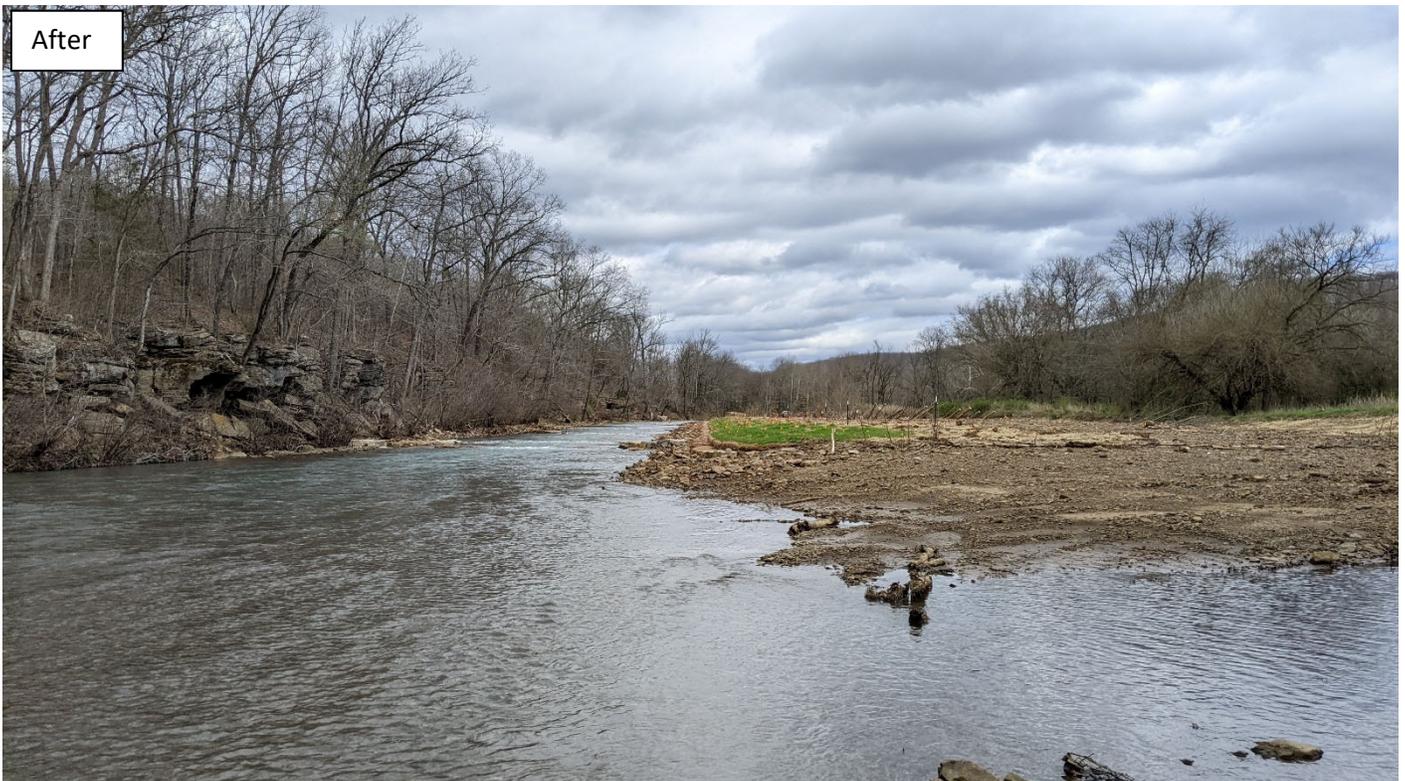
Figure 20. The Brentwood Mountain site looking upstream at the downstream project extent. The upper photo shows the site prior to restoration. A large midpoint channel bar is formed with cobbles and gravels due to the overwidened channel not able to transport materials. This feature is redirecting high flows around this aggradation leading to erosion of the left bank while having poor soil conditions for native, long lasting riparian vegetation. The bottom photo shows the restored channel ending with a cross vane structure and with a riparian streambank.
