# **Voluntary Implementation of Forestry Best Management Practices for Water Quality Protection in Arkansas**

**Arkansas Department of Agriculture**

## ***Results of the 2023-2025 BMP Implementation Survey***

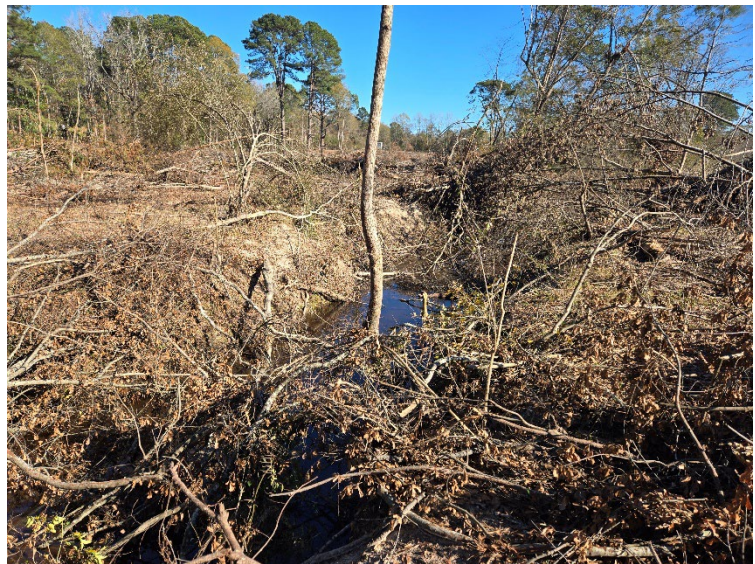
*Figure 4: An example of a stream with logging debris where guidelines for an SMZ were not followed.*

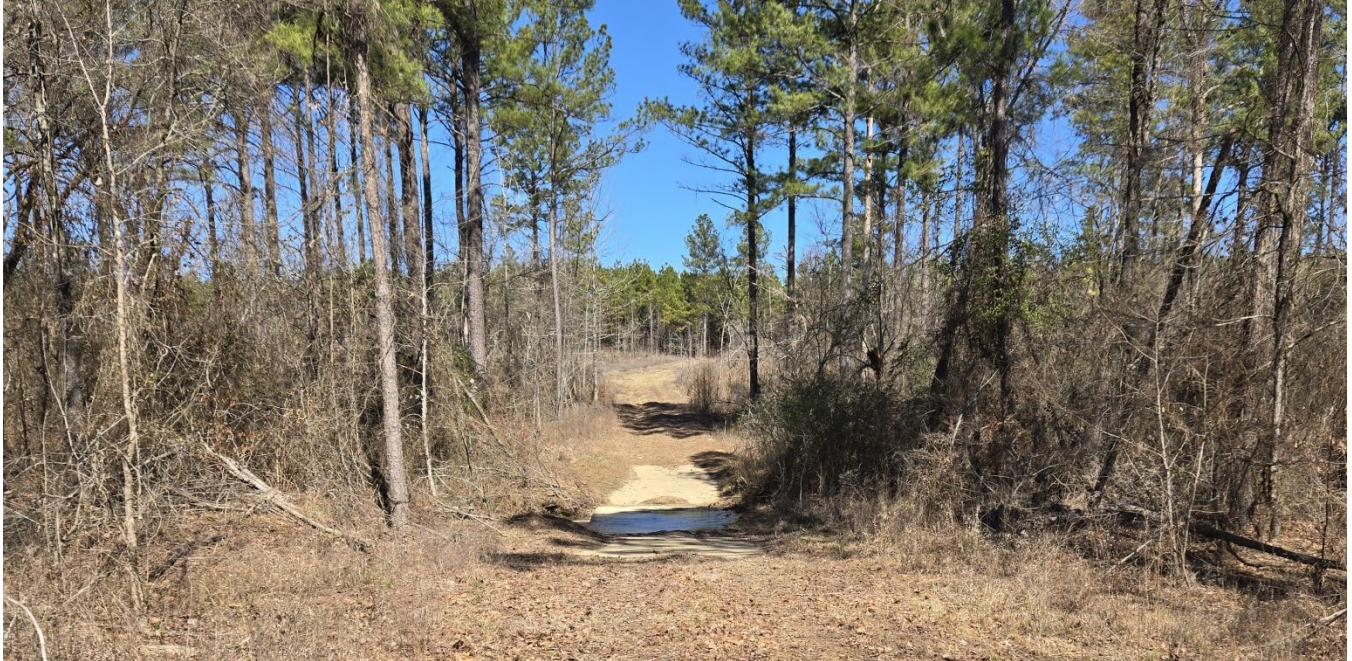
Figure 5: Low water crossing with a well-maintained streamside management zone. This SMZ is located within a clearcut harvest tract, demonstrating a meaningful effort to maintain the stream's water quality.

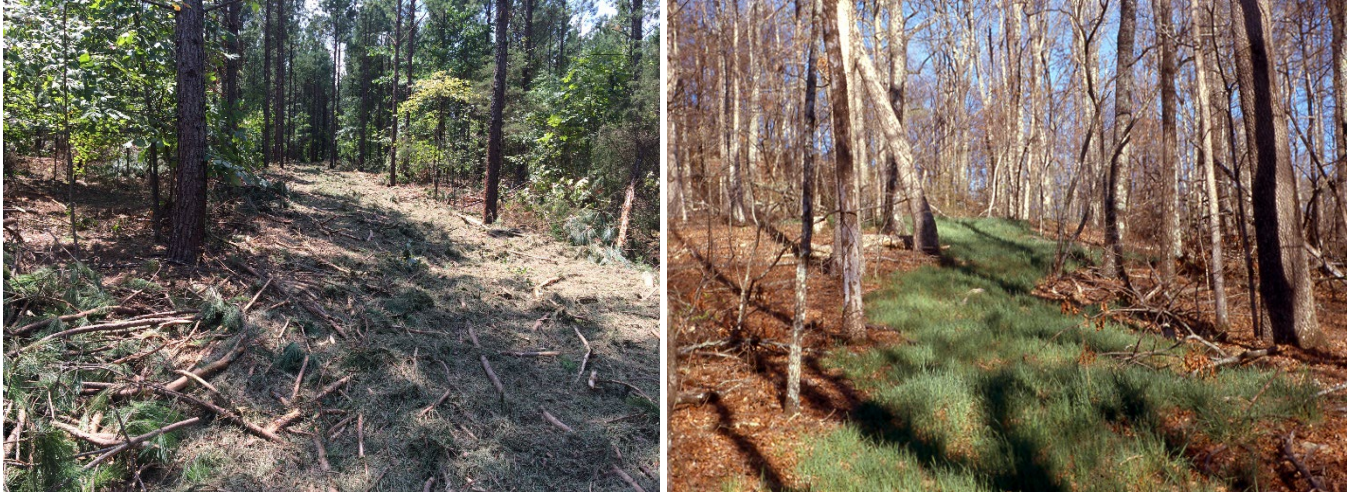
Figures 8 (left) and 9 (right): Two skid trails with BMPs. Logging slash was used to minimize equipment rutting and erosion concerns (left). During closeout, the skid trail was seeded and revegetated to stop soil erosion (right).
