Structure Number: 01689

Facility Carried: SH 7 Newton

Bridge Inspection Report

Maintenance Needs

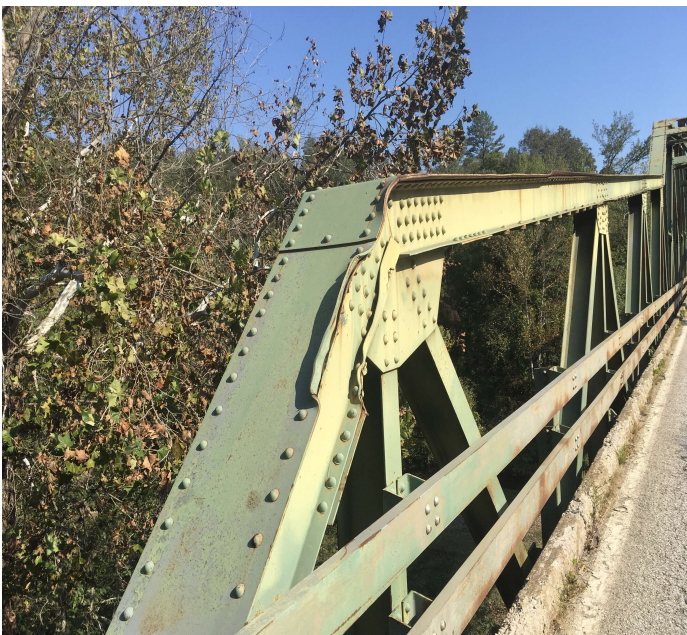
PHOTO 1 Description

Left truss top chord at PP U1 vehicle damage

Right truss top chord at PP U29 vehicle damage

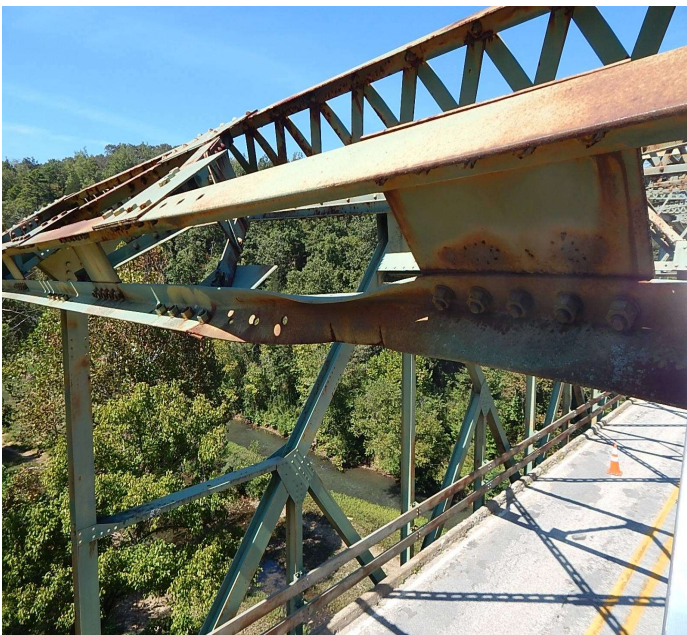
PHOTO 1 Description

Lateral sway bracing at U8 and U 10 have vehicle damage with distortion.

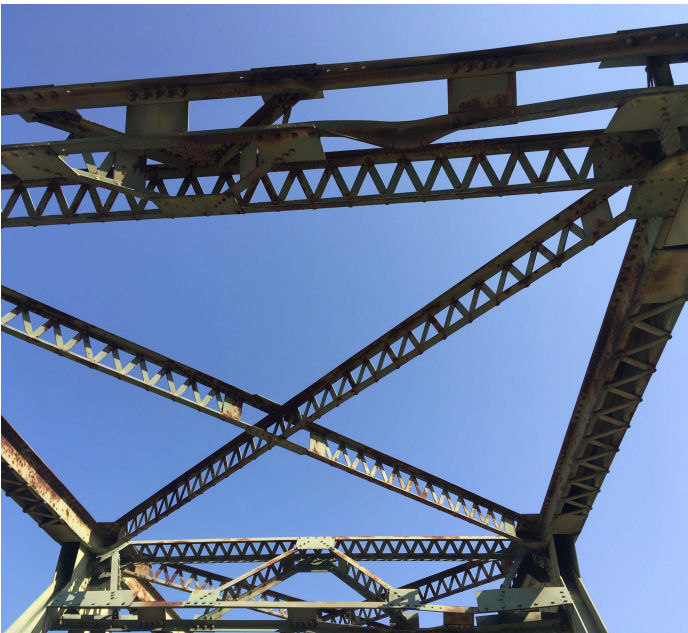
PHOTO 3	Description	Portal brace damage at beginning of the truss. U8
---------	-------------	---

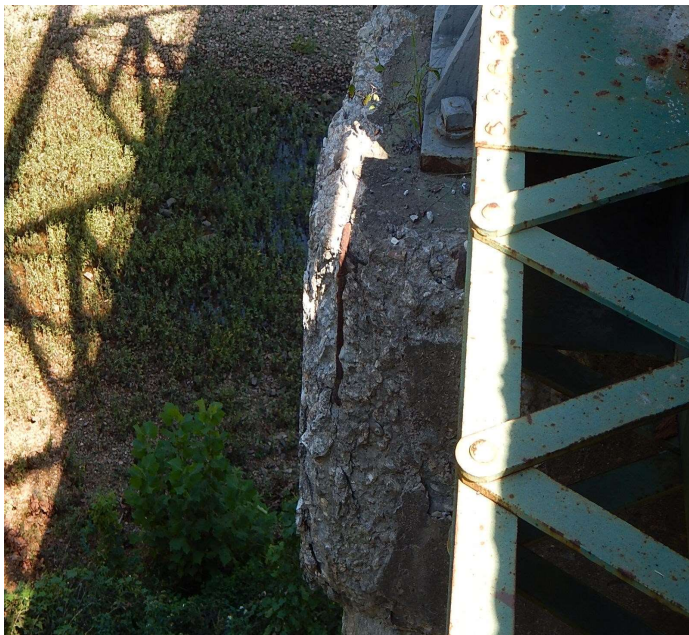
PHOTO 1 Description

Caps at bents #2 and #3 have severe deterioration with exposed rebar.

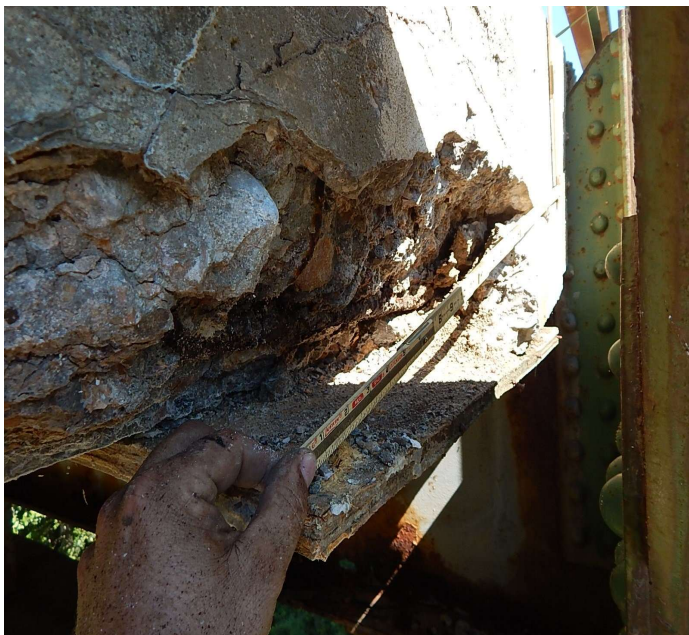
PHOTO 1 Description

Cracking with heavy efflorescence exists along the underside edge of the deck in span #4 and through out the width and length of all other spans, also the ends of the spans have areas of deep spalling with rebar exposed.

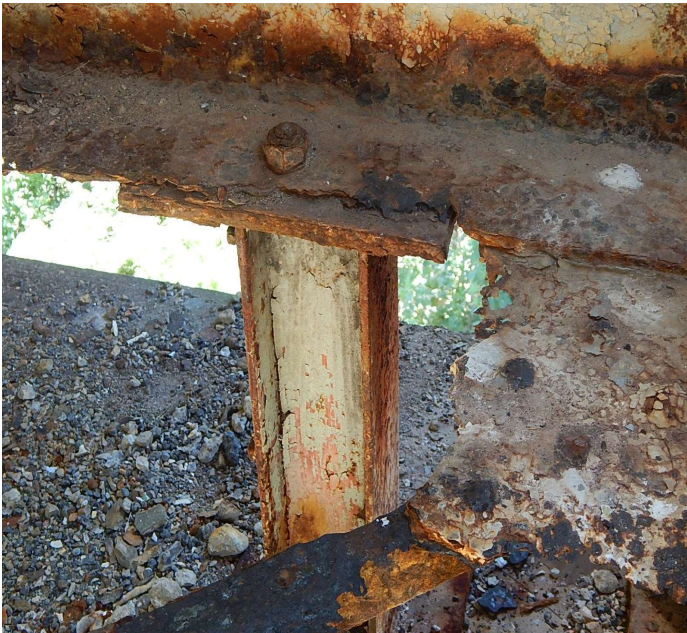
PHOTO 1 Description

Rust holes and severe corrosion with knife edge on the bottom flange at floor beams #9 and #25.

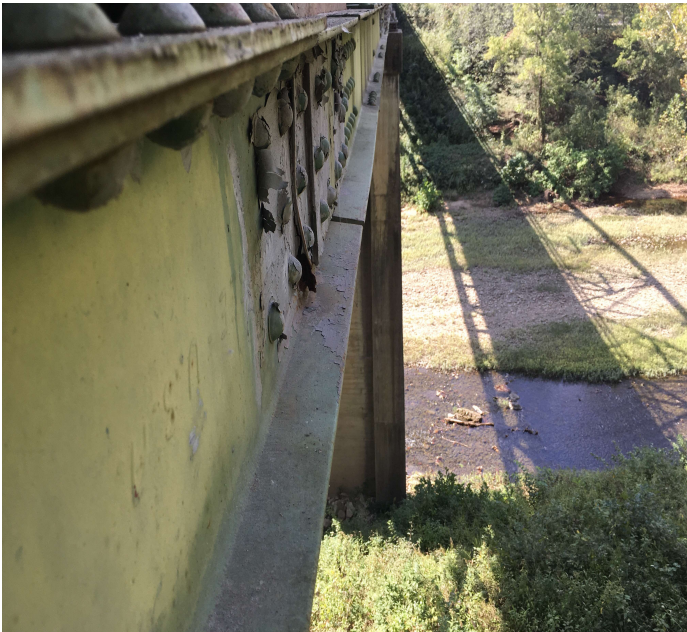
PHOTO 1 Description

The left truss bottom chord splice plates have pack rust with distortion at the interior and exterior connections at L29 and L30.

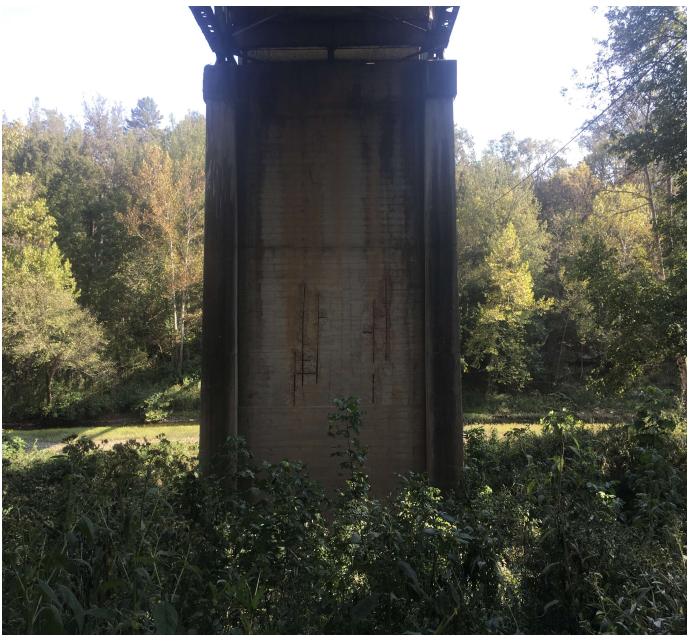
PHOTO 1 Description

The pier wall of pier #1 has a small area of spalling with rebar exposed. Piers # 2,3 have large areas of spalling with rebar exposed.

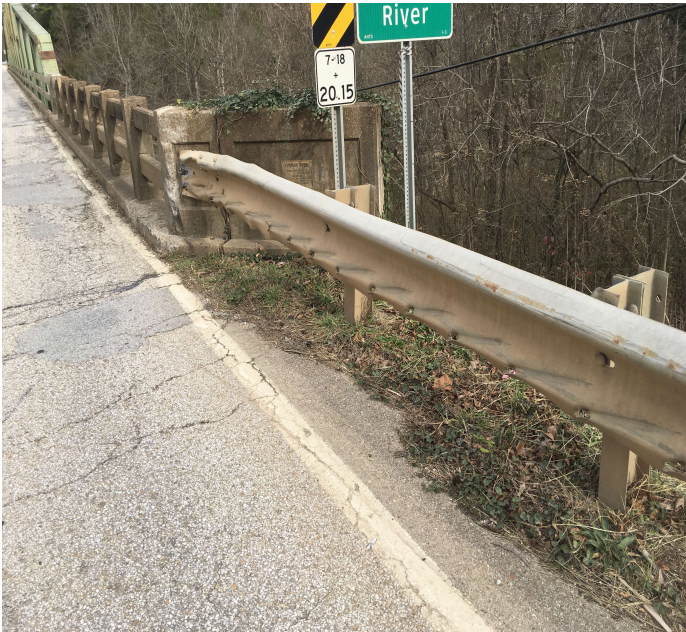
PHOTO 1 Description

The right beginning guard rail has vehicle damage that has created a pocket in the railing that could re direct traffic into the end post of the structure.

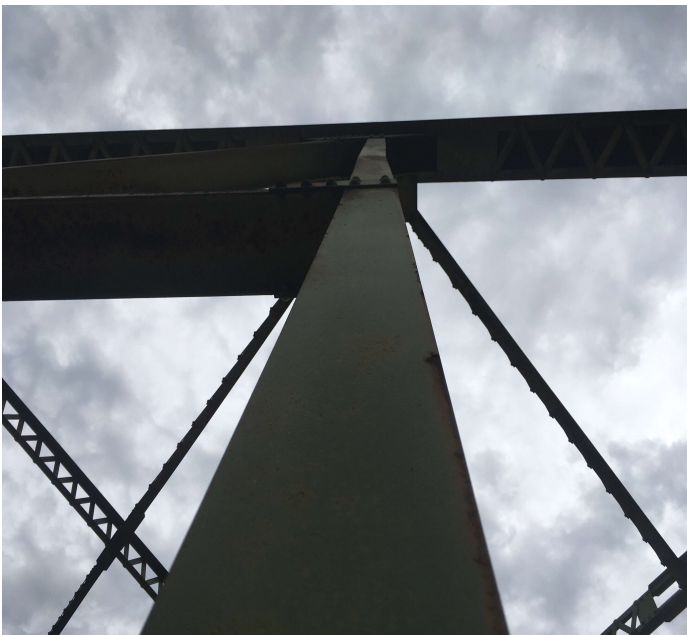
The vertical member at U 12 left truss has out of plane bending due to the lateral bracing having vehicle impact damage.

PHOTO 1 Description Out of plane bending at the U12 vertical due to the lateral bracing having vehicle impact damage.

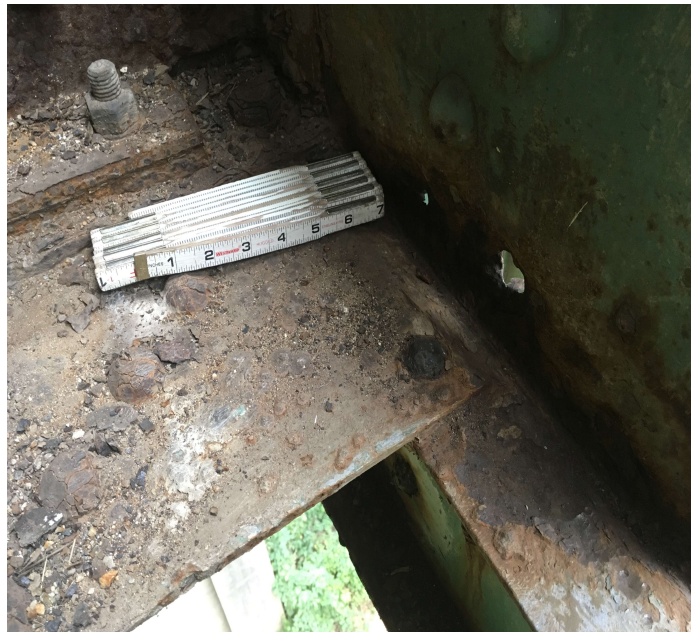
The interior vertical gusset plate connections have section loss and/or rust holes at the following locations-
Right truss- L4, L6, L8, L10, L13, L14, L17, L20, L24, L26, L28.

PHOTO 1 Description 1" and 1/4" rust holes in the vertical gusset plate at the back side of L6 right truss at the bottom chord. The gusset plate has 1/4" section loss for 13" on the interior side. The original gusset plate thickness is 3/8" thick.

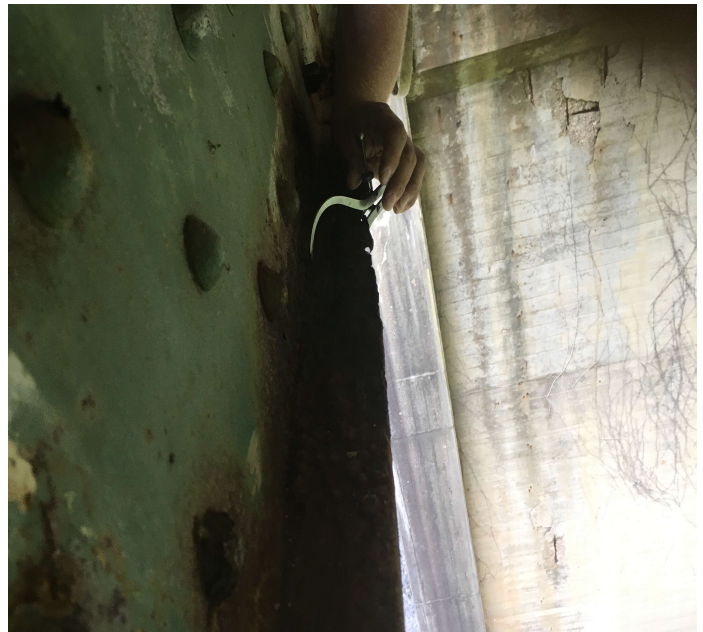
The bottom chord c-channel has section loss and/or rust holes on the bottom flange or web at the following locations-
Right-L4, L17, L26

PHOTO 2 Description Section loss on the interior bottom chord flange at L 26. The remaining section is 5/8" next to the web down to knife edge at the edge of the c-channel flange for a length of 8";
