Bridge Inspection Report

03416

SH35 S5 Lm 12.28

BIG CREEK RELIEF

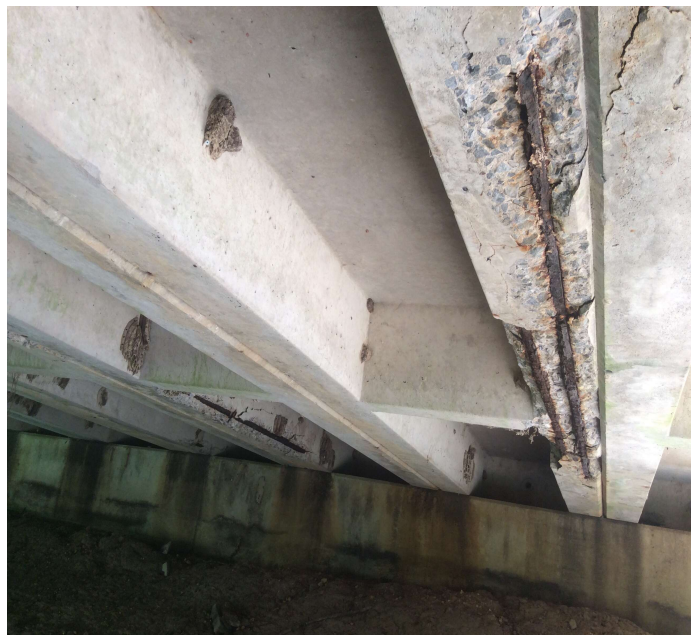
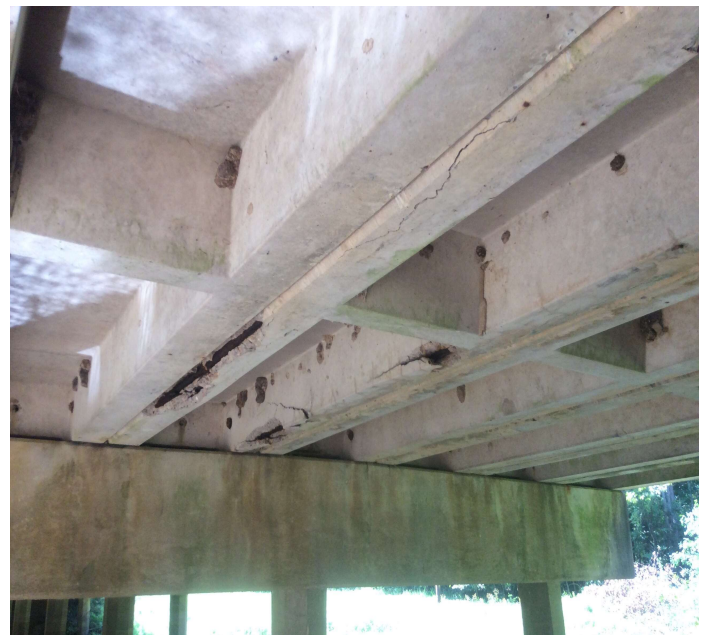
PC units cracked and spalled with packrust.

Span 1 units 2,3,4,5,& 7

Span 2 units 3,6, & 7

Span 3 unit 5

Span 4 unit 1,2, & 5

Span 5 units 3,4, & 6

Span 6 units 3,5, & 6

Span 7 units 2 & 3

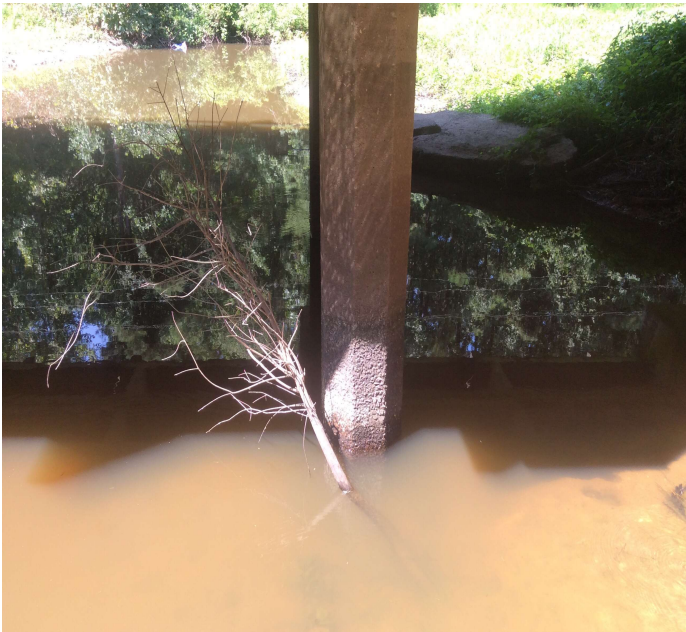
PHOTO 1 Description

All columns bents 3-6 are "pebbled" from the high water line down with aggregates showing but still imbedded in the concrete.
