# Bridge Inspection Report

**05715**  
**SH 35-03 LM 2.74**  
**over**  
**Camp Creek**

Structure Number: 05715

Facility Carried: SH 35-03 LM 2.74

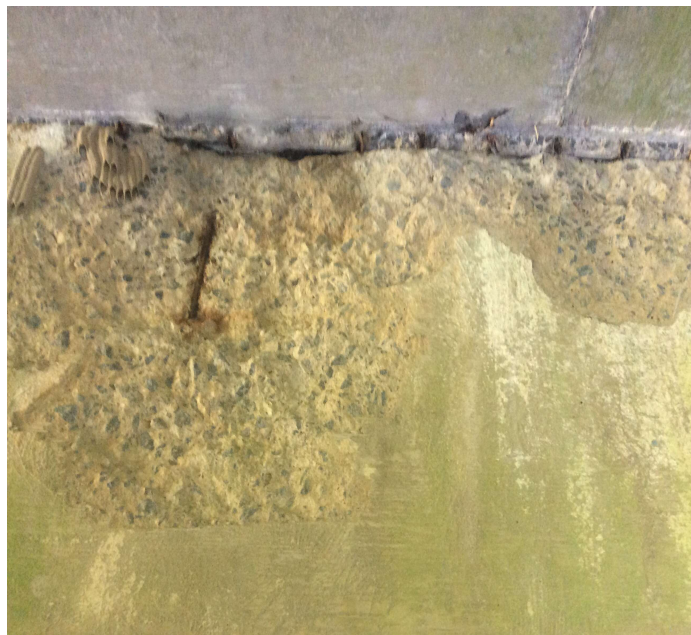
1080 - Delamination/Spall/Patched Area		1			1		
234 - Reinforced Concrete Pier Cap	1- Ben.	74	ft.	55	19	0	0
	Caps: 37' each / Bents 2 & 3. Cap - Bent 3 back side: Spalling near ends with little steel exposed (very little section loss). 10' on left end / 6' on right end (2' total with steel exposed) Bent 2 bottom of cap has small spalls with exposed rebar.						
1080 - Delamination/Spall/Patched Area		14			14		
1090 - Exposed Rebar		5			5		
301 - Pourable Joint Seal	1- Ben.	136	ft.	0	0	136	0
	Joints: 34" each / Bents 1-4. Bents 1-4: Poured joint material is mostly intact, but has lost adhesion in most places - allowing stormwater to leak through joint and onto cap.						
2320 - Seal Adhesion		136				136	
321 - Reinforced Concrete Approach Slab	1- Ben.	2450	sq. ft.	2274	0	176	0
	Approach slabs: 1 each end / Bents 1 & 4. Bent 1: A couple minor- to moderate-sized transverse and longitudinal cracks. Bent 4: One moderate-sized transverse crack.

Cap – Bent 3 back side:

Spalling near ends with little steel exposed (very little section loss) - 10' on left end / 6' on right end.

PHOTO 1      Description      Bent 3 spalls and spall with exposed rebar.

Stage: Monitor

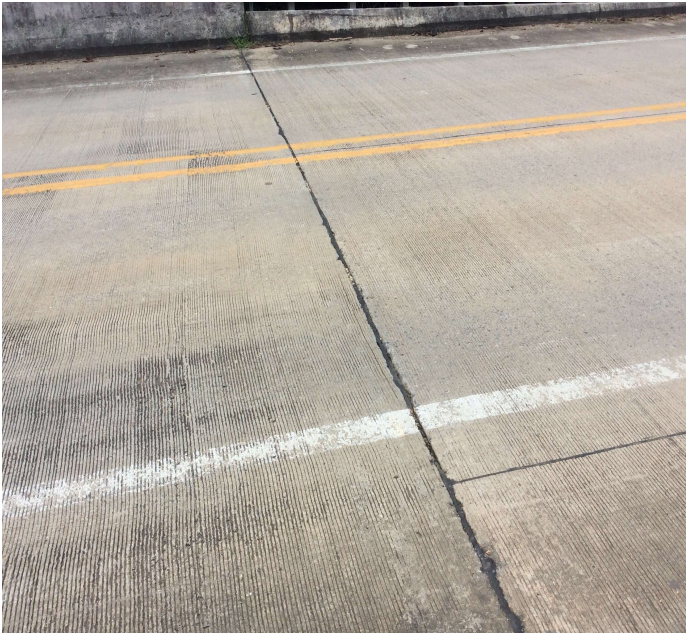
Joints – Bents 1-4:

Poured joint material is mostly intact, but has lost adhesion in most places – allowing stormwater to leak through joint and onto cap.

PHOTO 1      Description      Joint - Bent 1: Loss of adhesion

Stage: Monitor
