Bridge Inspection Report

05716
SH 35-03 LM 1.79
over
Hurricane Creek

Structure Number: 05716

Facility Carried: SH 35-03 LM 1.79

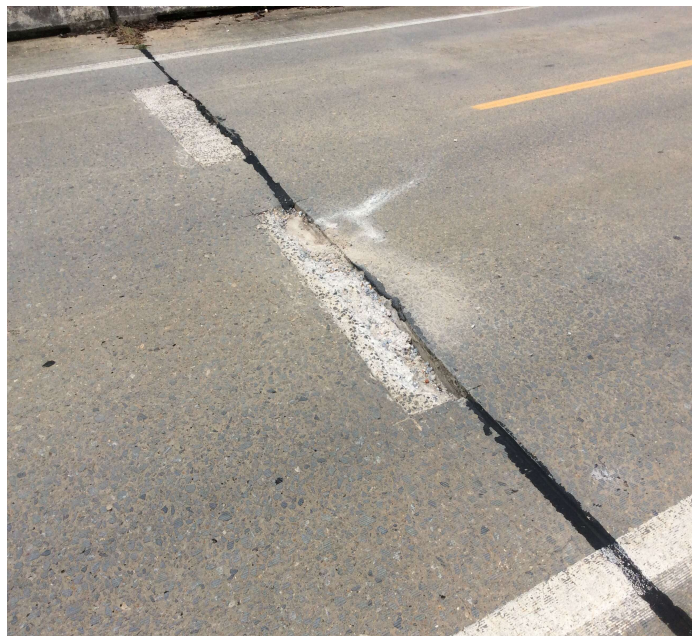
Deck - various locations: Several concrete patches are deteriorating with pieces of concrete coming loose - these loose pieces could pose a hazard to traffic. Several areas have a 2-3" bump- up or drop-off in the wheel ruts at edges of the patches.

PHOTO 1 Description Deck - Bent 7: Patch deterioration

David: Lets jackhammer out below the reinforcing and pour these back, advise when complete

Repairs will be done when warm weather returns so that concrete repairs set up properly. 01/30/18.

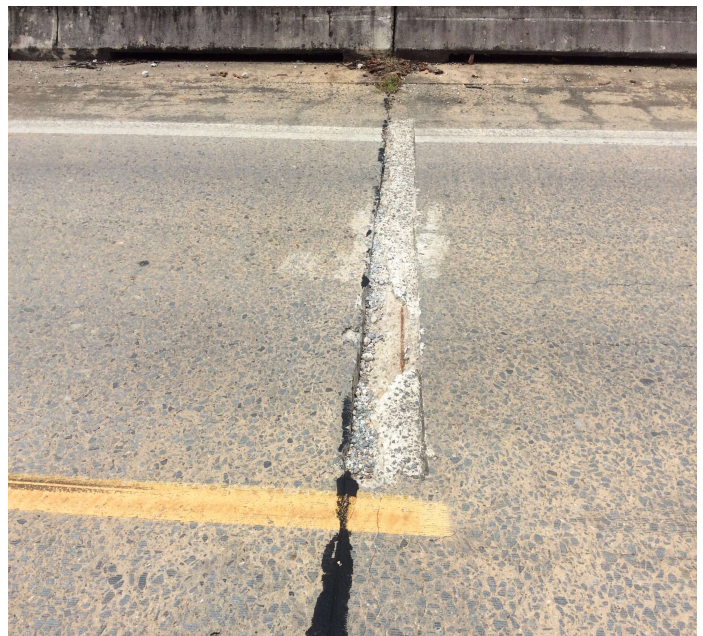
PHOTO 2 Description Deck - Bent 21 right: Patch deterioration

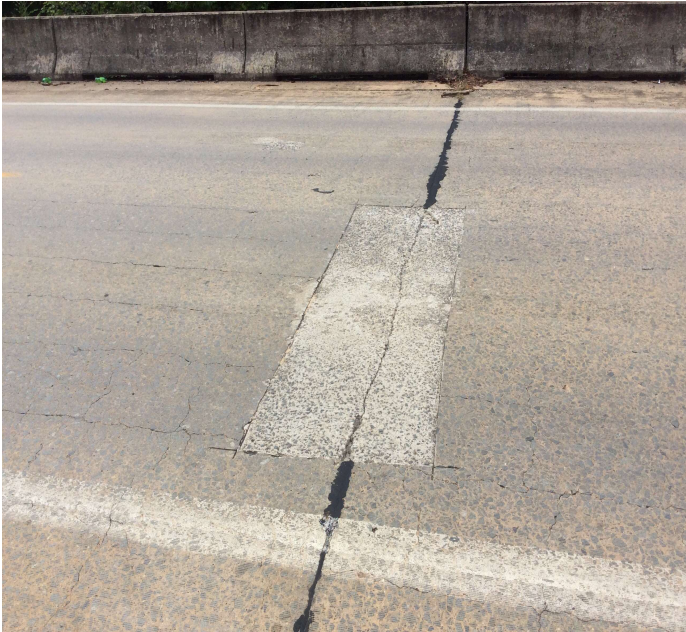
PHOTO 3 Description Deck - Bent 24 left: Patch deterioration

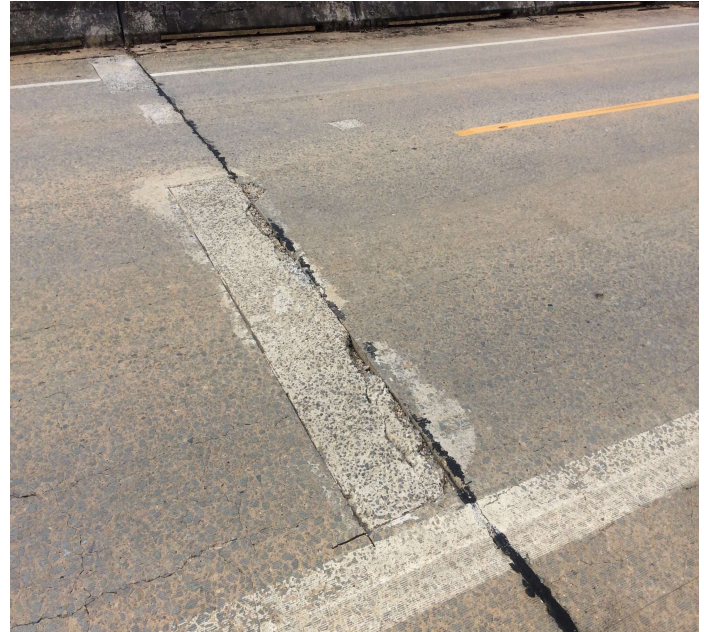
PHOTO 5 Description Deck - Bent 35 left: Patch deterioration

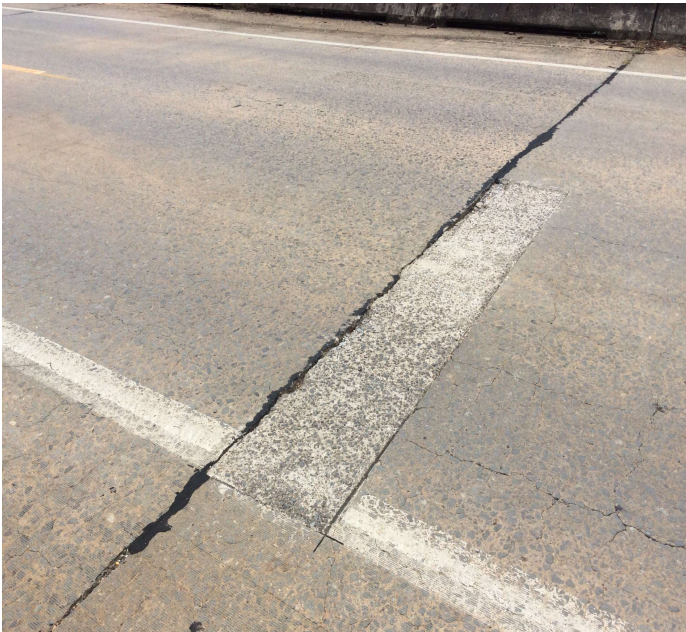
PHOTO 4 Description Deck - Bent 25 left: Patch deterioration

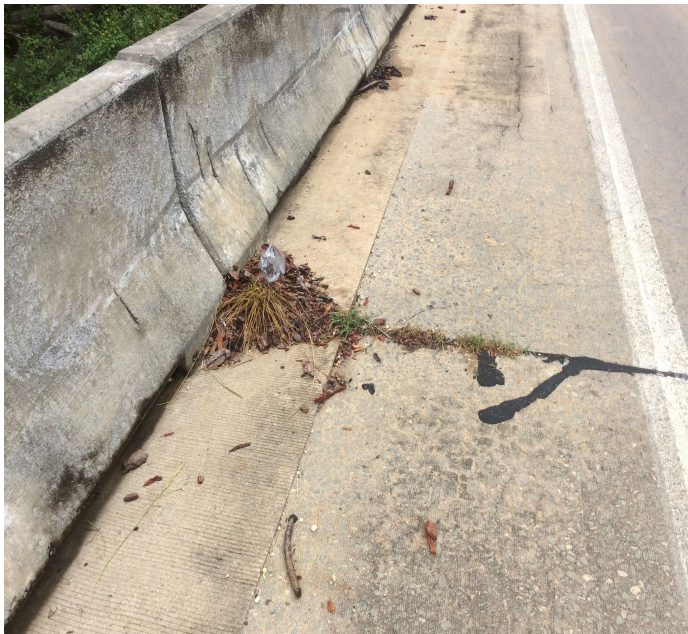
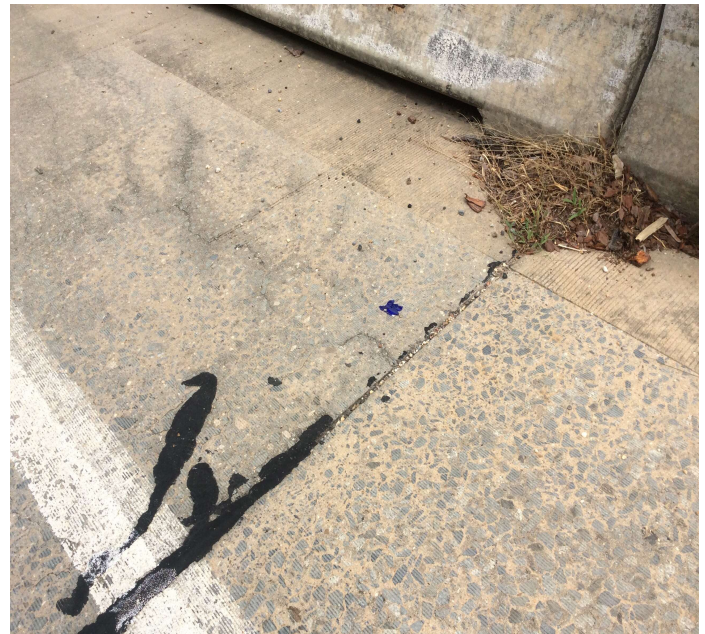
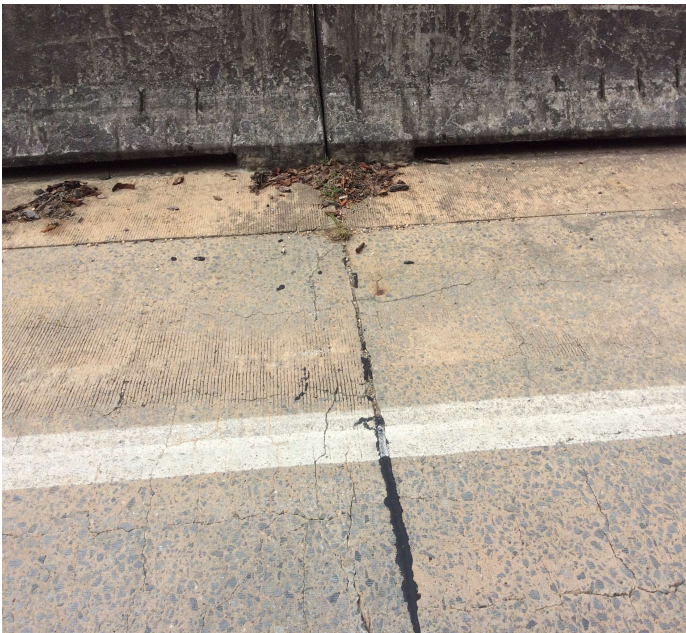
Joints - all bents: Outer 4' filled with gravel, dirt, and other debris - grass is growing up in most of these areas just inside railing.

NOTE State forces have sealed interior of joints with an asphalt sealant.

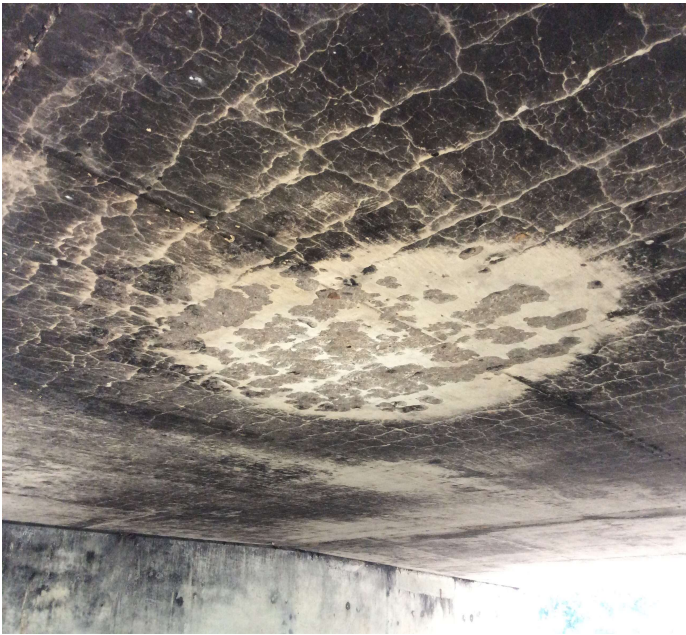
Span 31 soffit:

Fire damage on left side near midspan with some minor delaminations and shallow spalls. (6' x 6' area)

PHOTO 1 Description Soffit - Span 31 left: Fire damage

No action at this time, but continue to monitor.

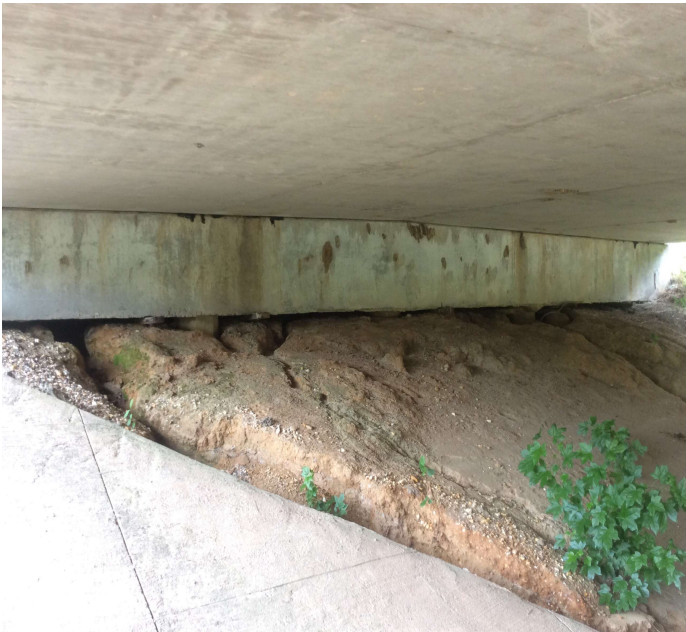
End slope – Bent 38:

Minor settlement/erosion along bottom of cap. (4" tall x 1-1.5' deep – piling slightly exposed.)

PHOTO 1 Description Endslope - Bent 38: Erosion

No action at this time. Continue to monitor and advise if condition worsens.

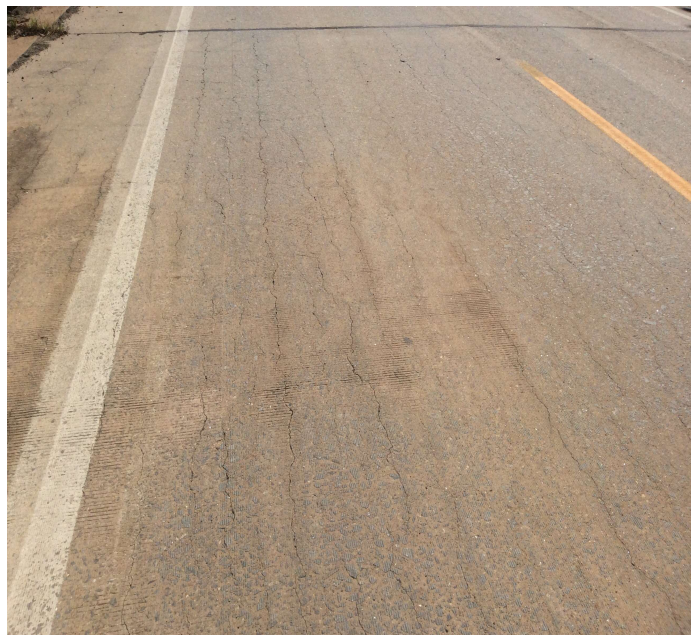
Deck – Spans 16- 37 : Numerous moderate- to large-sized unsealed cracks with small areas of spalling at joints.

PHOTO 1 Description Span 16 large unsealed longitudinal crack.

This joint needs to be re-done. Cleanout old material, clean joint, repair spalls, and re-apply joint material. Seal cracks as necessary.

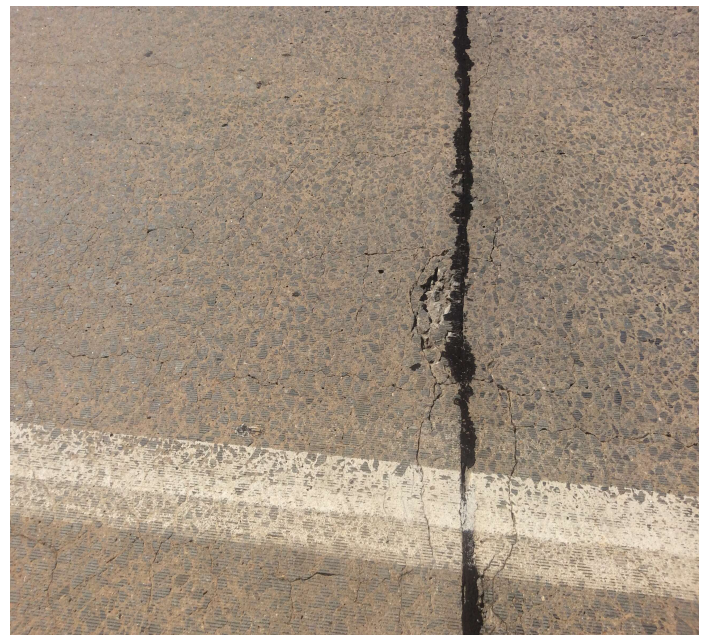
PHOTO 2 Description Span 29 at bent 29 left lane small spall forming at joint.

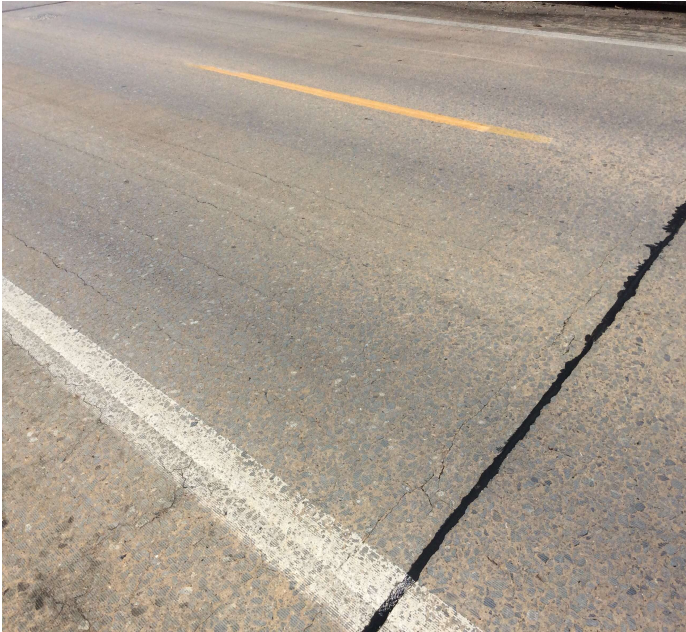
PHOTO 3 Description Deck - Span 22 left @ Bent 22:
Cracking

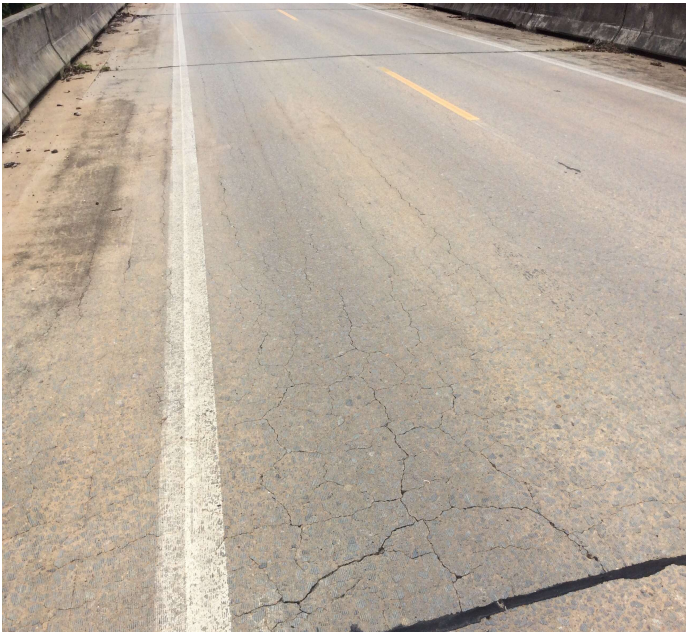
PHOTO 4 Description Deck - Span 16: Cracking

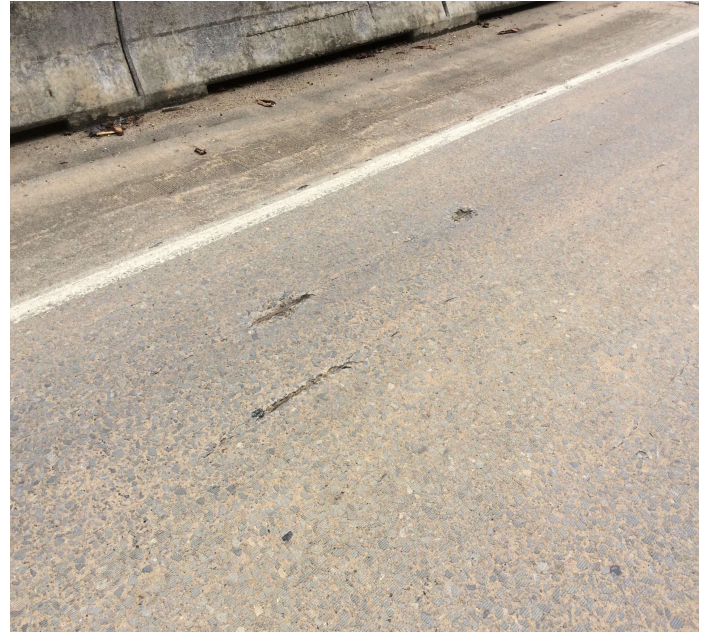
PHOTO 5 Description Deck - Span 12 left: Rebar exposed

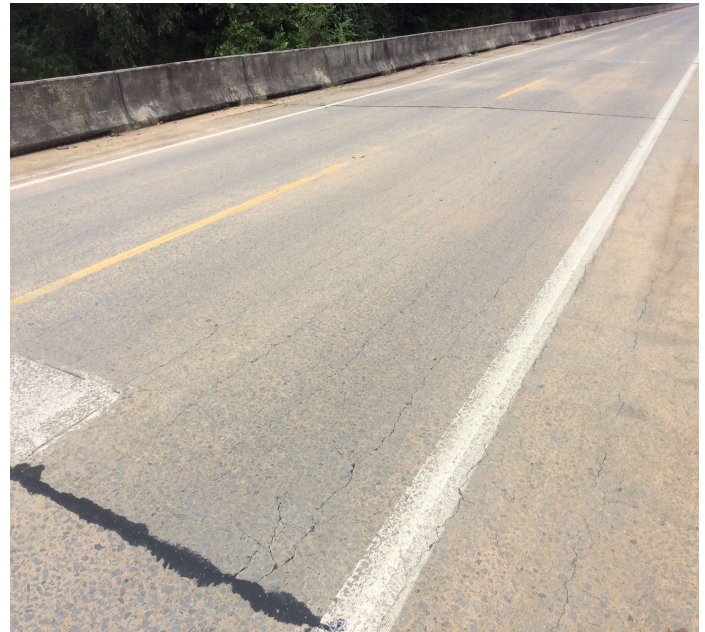
PHOTO 6 Description Deck - Span 26 left: Cracking

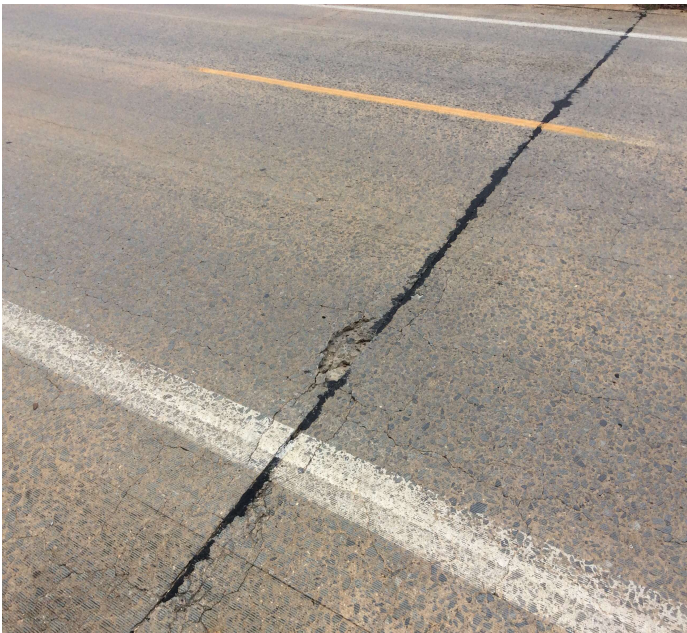
PHOTO 7 Description Deck - Span 29 left @ Bent 29: Spalling

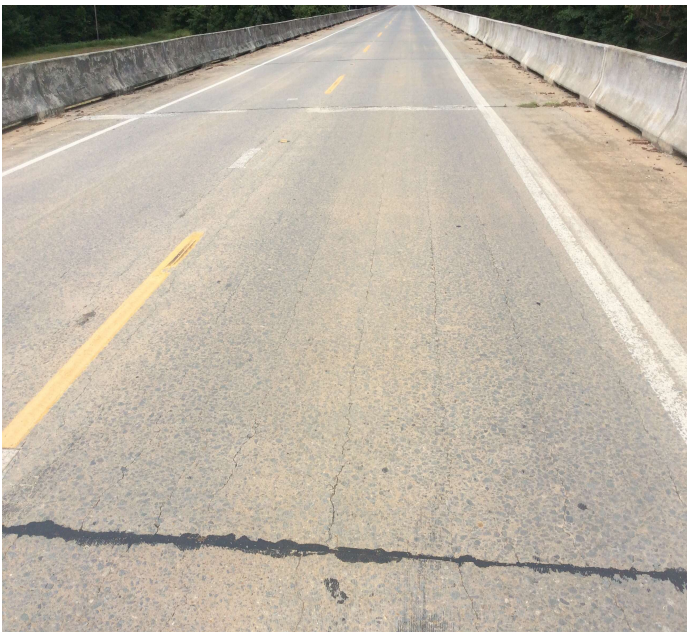
PHOTO 8 Description Deck - Span 35 left: Cracking

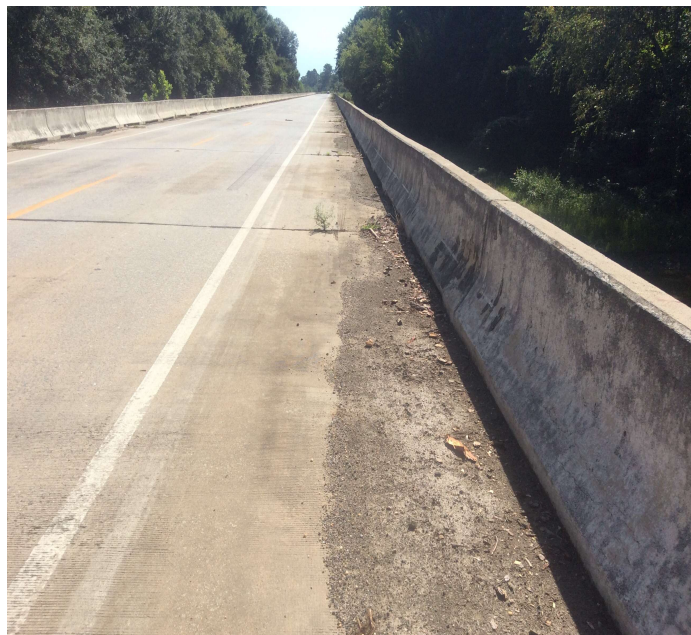
Gutterlines – both sides: Minor build-up of dirt and other debris (tree bark), somewhat restricting stormwater from flowing off bridge – grass is growing up in most of these areas just inside railing.

PHOTO 1 Description Right gutter line debris.

Grant: clean gutters, advise when complete

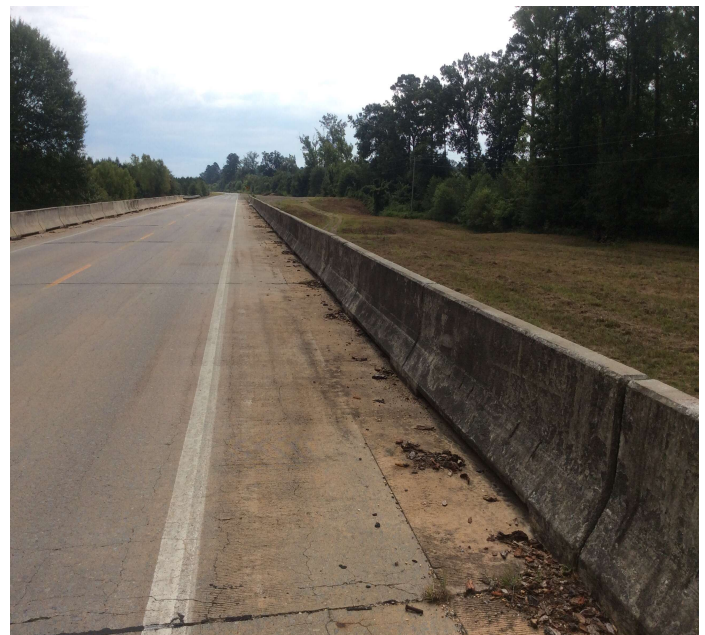
PHOTO 2 Description Gutterline - Spans 28-38 right: Minor debris build-up

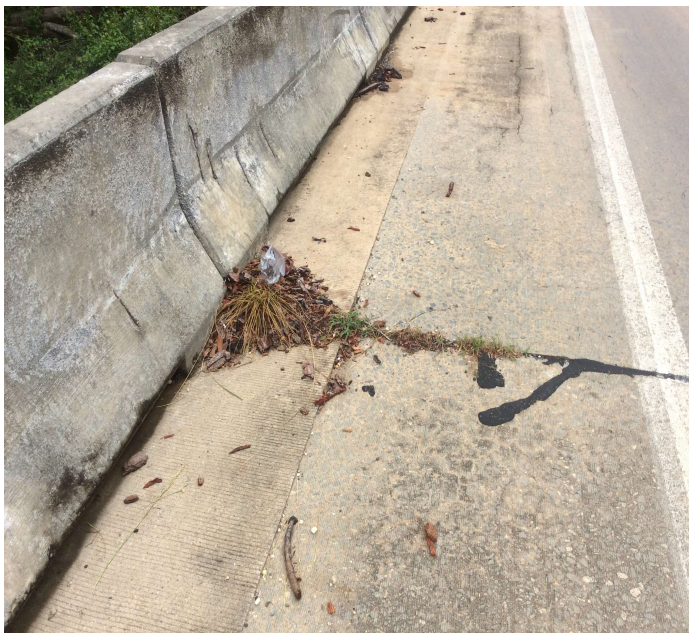
PHOTO 3 Description Gutterline/joint - Bent 16 left:
Vegetation/debris build-up

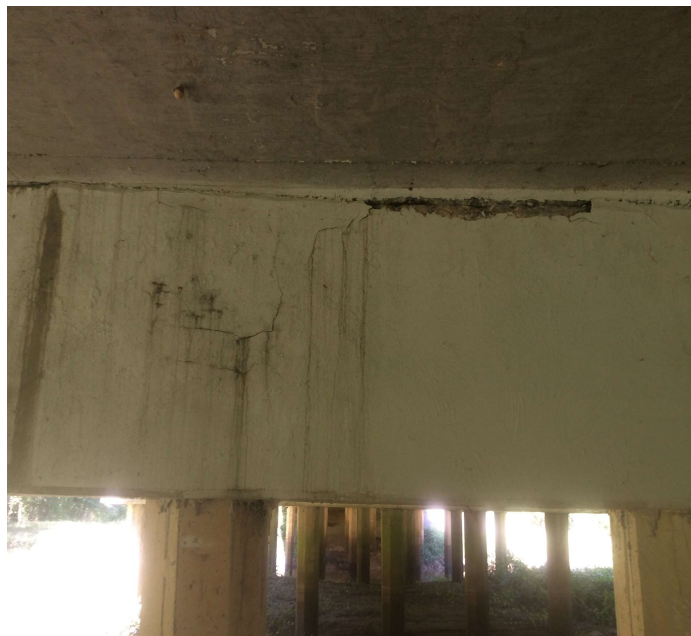
Caps - Bents 4, 6, 7, 8, 11, 12, 14, 17, 18, 19, 20, 34, 35, & 37: Various spalls, delaminations, and/or cracks on faces of caps.

PHOTO 1 Description Bent 6 ahead cap over pile 5 cracked and Delams.

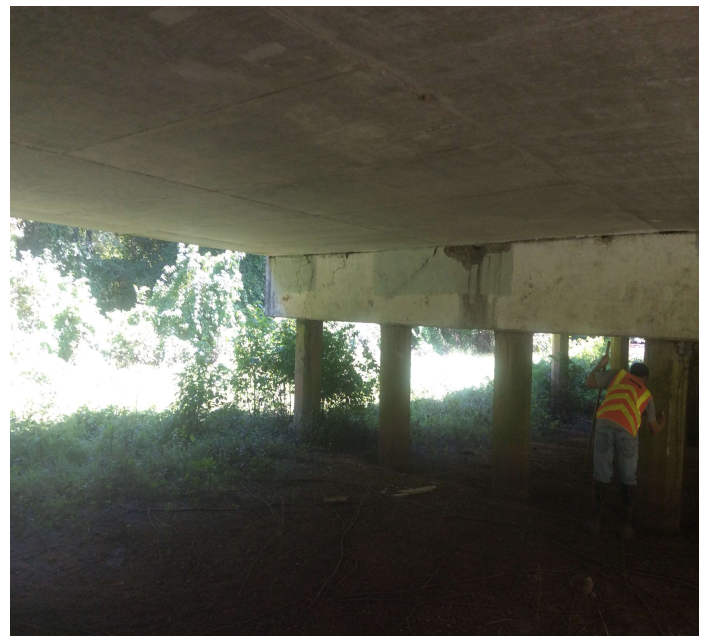
PHOTO 2 Description Bent 11 cap back spalls and Delams.

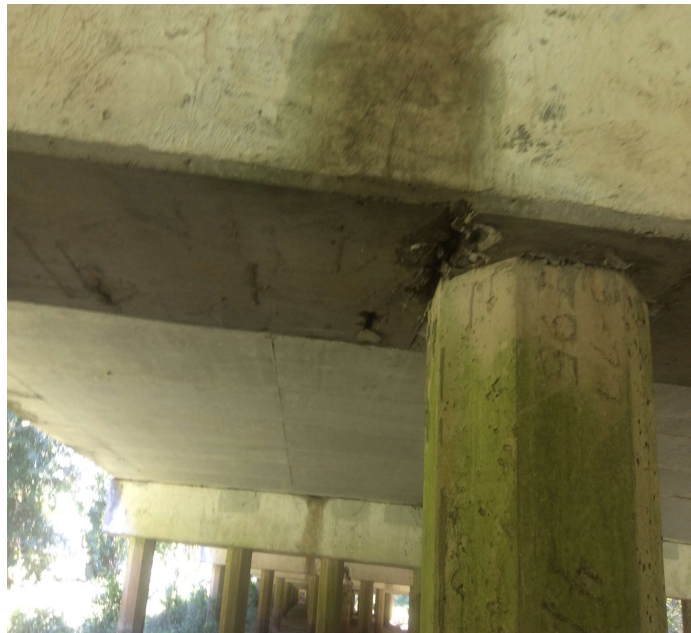
Bent 5, 7, & 13 have very small spalls with exposed rebar on bottom of caps.

PHOTO 3 Description Bent 13 bottom of cap at pile 3 spalls with exposed rebar.

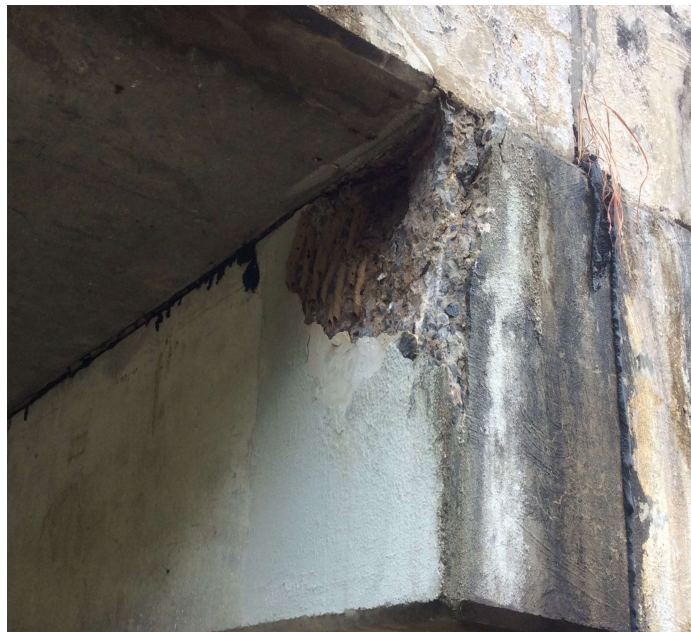
PHOTO 4 Description Cap - Bent 37 right: Spalling

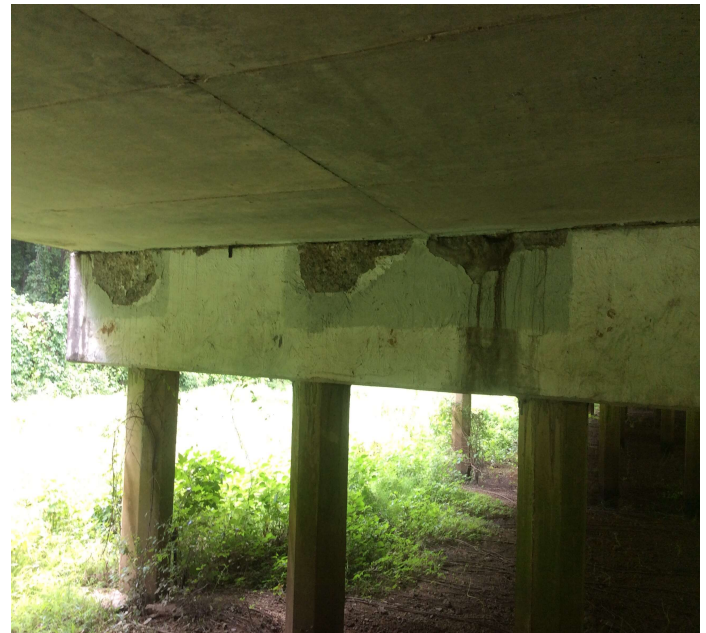
PHOTO 5 Description Cap - Bent 11 left back: Spalling

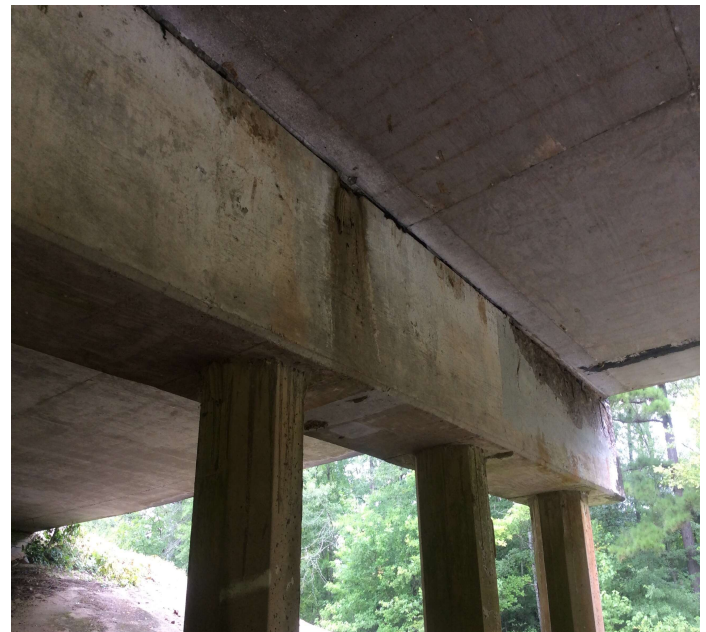
PHOTO 6 Description Cap - Bent 2 left ahead: Rebar exposed
