Bridge Inspection Report

M0796
SH35 S4 Lm6.35
over
DERISAUX RELIEF

Structure Number: M0796

Facility Carried: SH35 S4 Lm6.35

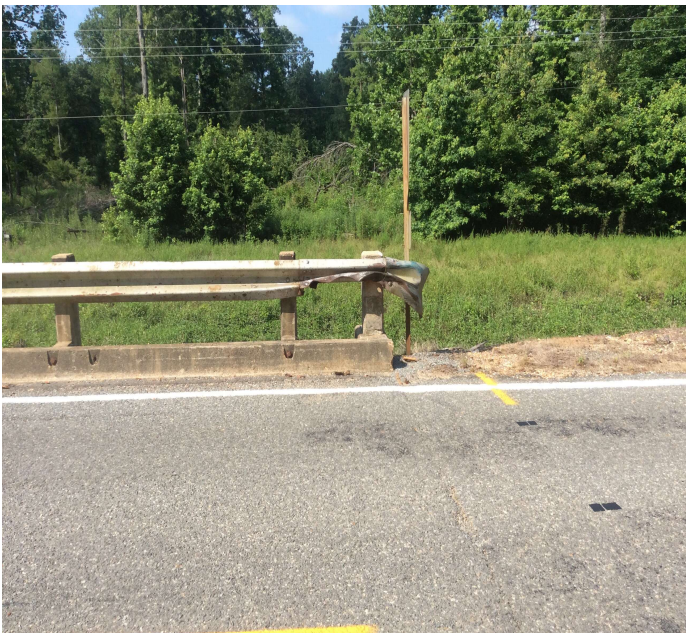
PHOTO 1 Description

Guard rail damage
