Bridge Inspection Report

M0797
SH35 S4 Lm 6.55
over
DERISAUX RELIEF

Structure Number: M0797

Facility Carried: SH35 S4 Lm 6.55

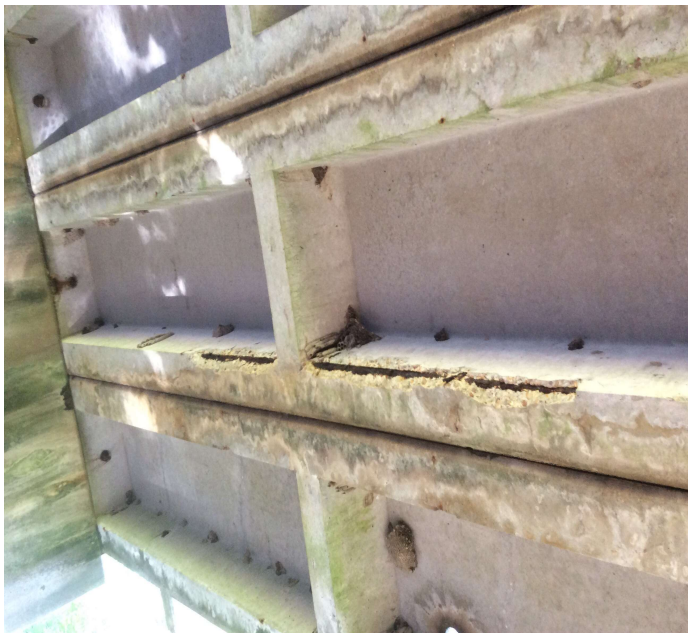
PHOTO 1 Description

Lower stem sections of numerous PC units have cracks and spalls with measurable section loss.
