Bridge Inspection Report

M0801
SH35 Sec4 Lm 9.18
over
HARRISON CREEK

Structure Number: M0801

IDENTIFICATION		INSPECTIONS	
(1) STATE CODE	056 - Arkansas	(90) INSPECTION DATE	07/26/2016
(8) STRUCTURE NUMBER	M0801	(91) DESIGNATED INSPECTION FREQUENCY	24

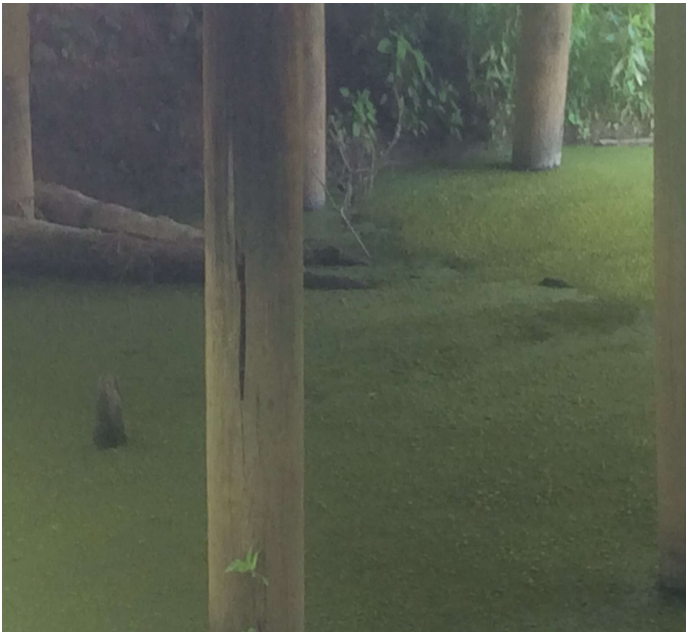
PHOTO 1 Description

Piles 1,4,5 bent 3 rotten areas. Piles 1 & 5 have holes and # 1 has vegetation growing out of it.
PC Unit 6 span 4 has very degraded stems, cracks, spalls, exposed steel with heavy pack rust etc.
