Bridge Inspection Report

M4029
SH 35-03 LM 8.80
over
White Oak Creek

Structure Number: M4029

IDENTIFICATION		INSPECTIONS	
(1) STATE CODE	056 - Arkansas	(90) INSPECTION DATE	08/15/2017
(8) STRUCTURE NUMBER	M4029	(91) DESIGNATED INSPECTION FREQUENCY	24

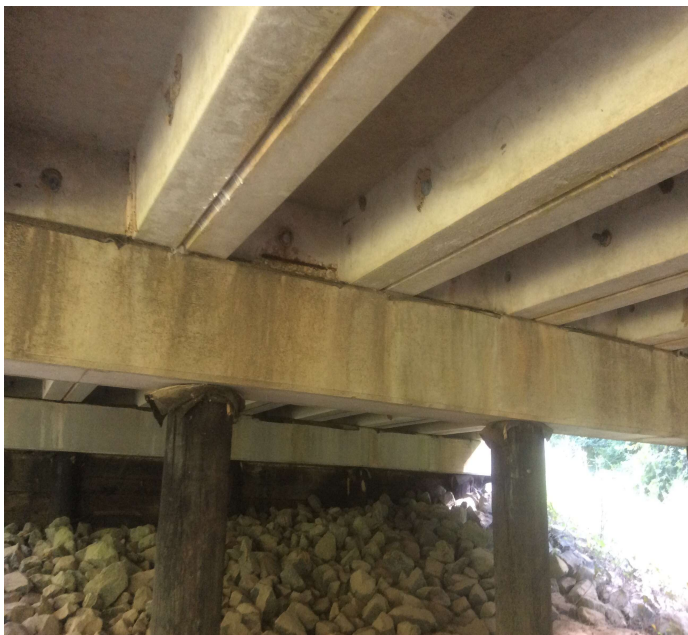
Spans 2 and 3: Some small spalls with exposed rebar on diaphragms of channel units.

PHOTO 1 Description Span 2 at bent 2 unit 6 small spall in diaphragm .
Common bent 3 span 3 unit 3

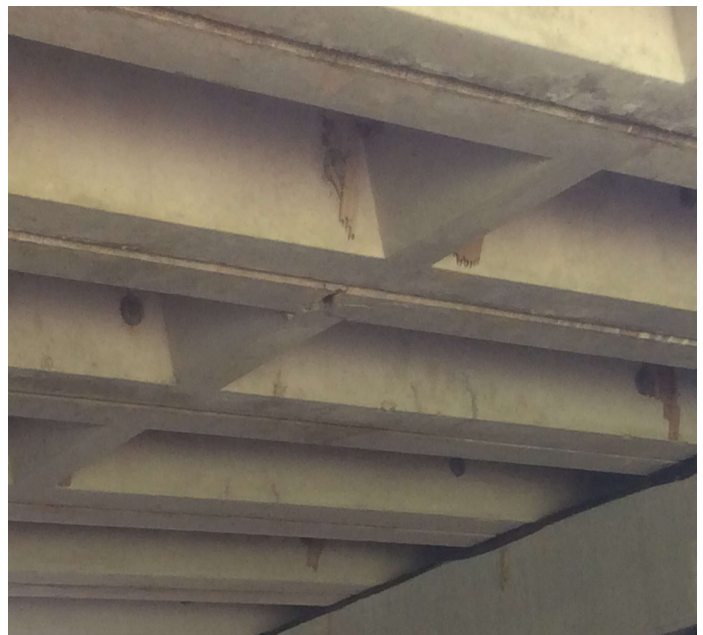
Girders - Span 4 Unit 5: Spalling on bottom of right leg with some rebar exposed (1').

PHOTO 2 Description Span 4 unit 5 small spall on bottom of channel leg.

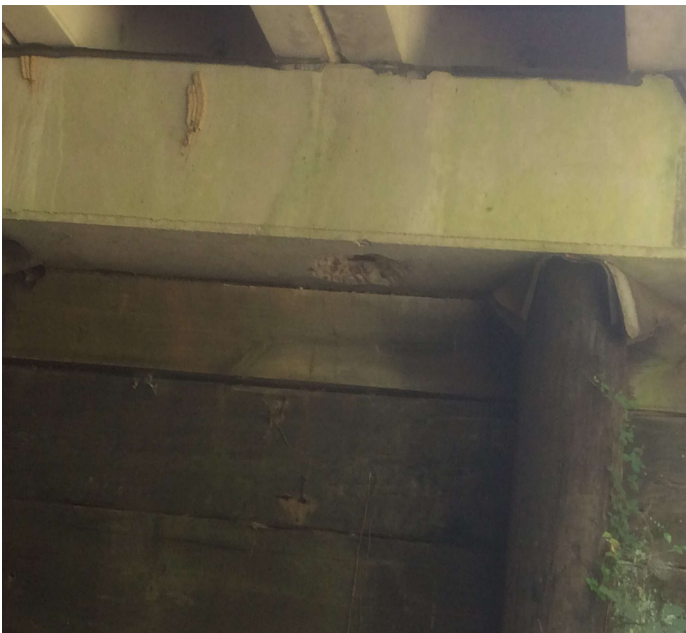
Cap - Bent 5: Small spall on bottom face between Piles 4 & 5 with exposed rebar (1').

PHOTO 1 Description Bent 5 bottom of cap between pile 4 & 5 small spall with exposed rebar.
