Bridge Inspection Report

M4030
SH 35-03 LM 8.97
over
Creek

Structure Number: M4030

Facility Carried: SH 35-03 LM 8.97

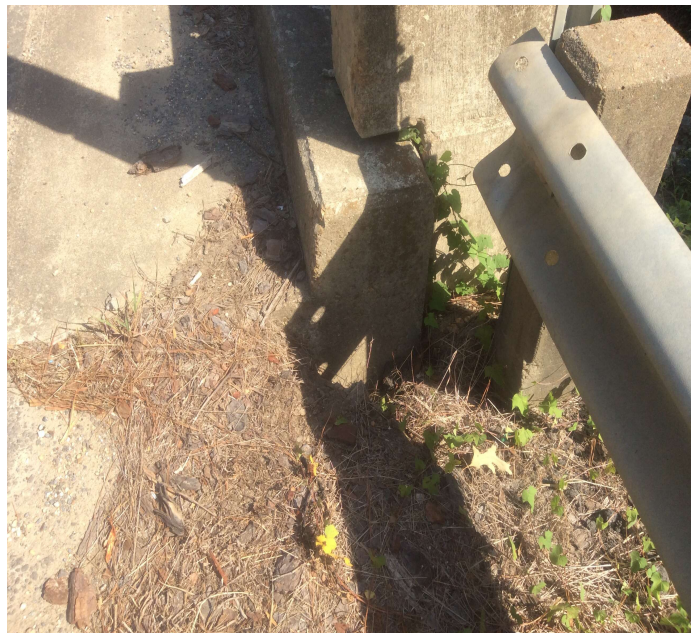
Approach roadway - Bent 3 left (southeast corner): Small area of erosion at end of bridge.

PHOTO 1 Description Bent 3 south east bridge end small area of erosion at end post.

Grant: repair., advise when complete

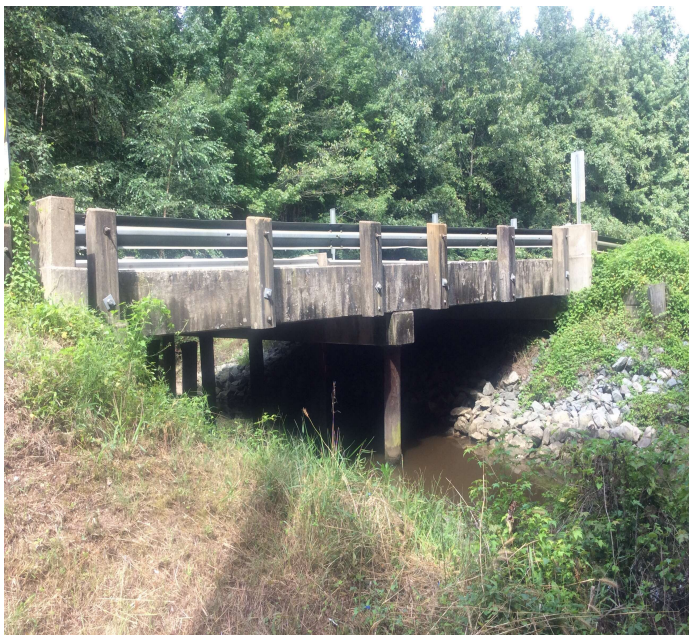
PHOTO 3 Description Left side view
