Bridge Inspection Report

M4030
SH 35-03 LM 8.97
over
Creek

Structure Number: M4030

Facility Carried: SH 35-03 LM 8.97

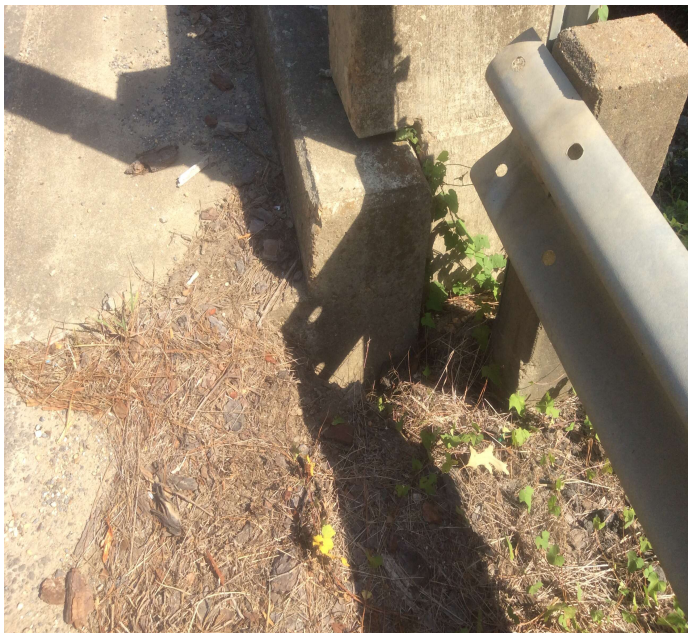
Approach roadway - Bent 3 left (southeast corner): Small area of erosion at end of bridge.

PHOTO 1 Description Bent 3 south east bridge end small area of erosion at end post.

Grant: repair., advise when complete
