# Bridge Inspection Report

**M4031**  
**SH 35-03 LM 10.88**  
**over**  
**Little Creek**

Structure Number: M4031

Facility Carried: SH 35-03 LM 10.88

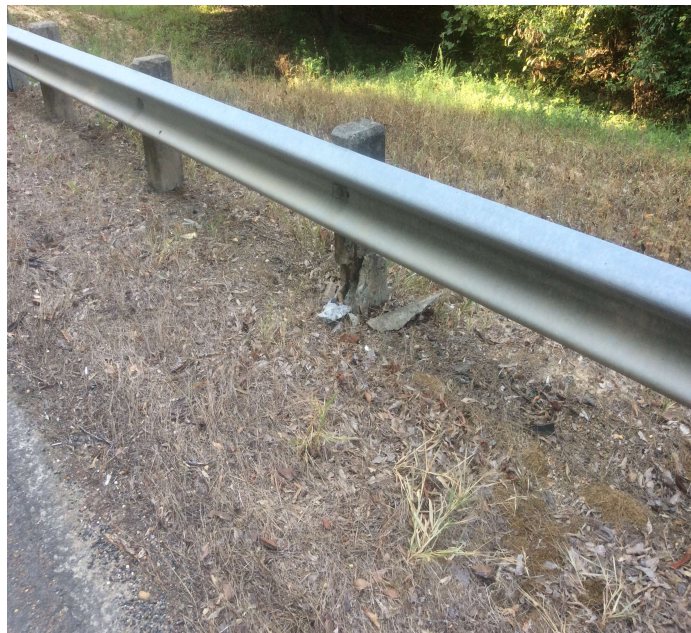
Approach railing - Bent 1 right (northwest corner): One post has been damaged - cracked and broken.

PHOTO 1      Description      Guardrail post damage.

repair as soon as you can get on your schedule

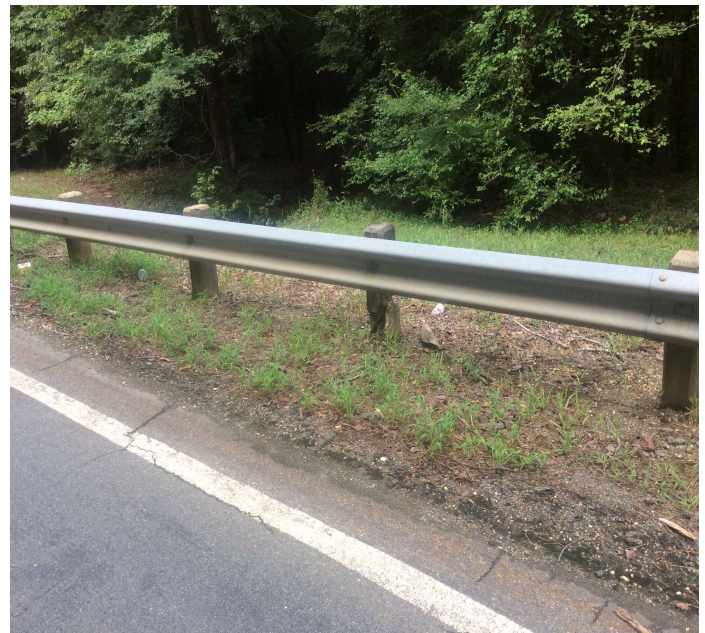
PHOTO 2      Description      Approach railing - Bent 1 right: Damage
