# Bridge Inspection Report

**M4033**  
**SH 35-03 LM 12.72**  
**over**  
**Steep Creek**

## Bridge Inspection Report

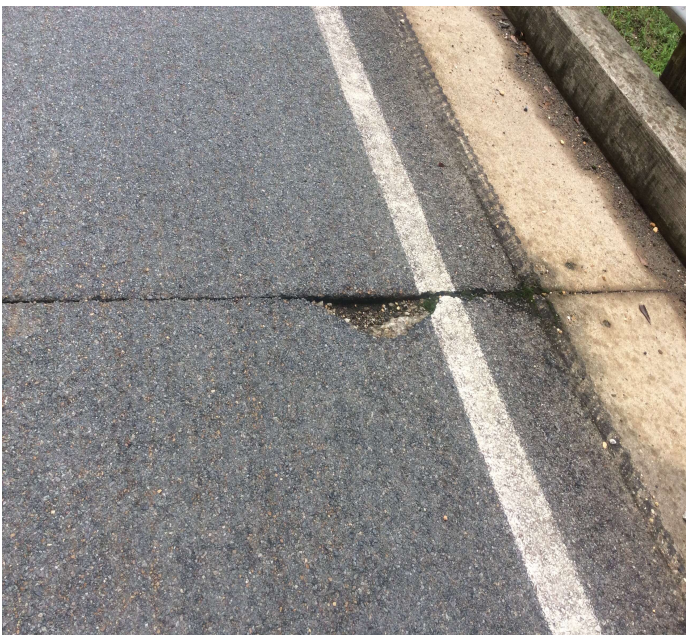
Deck – Bent 4 right: Very small (4" x 8"), shallow pothole in asphalt wearing surface just inside edge line, with some scaling of concrete deck.

PHOTO 1    Description    Deck - Bent 4 right. Pothole
