Bridge Inspection Report

05898

US 82-District 2

OUACHITA RIVER

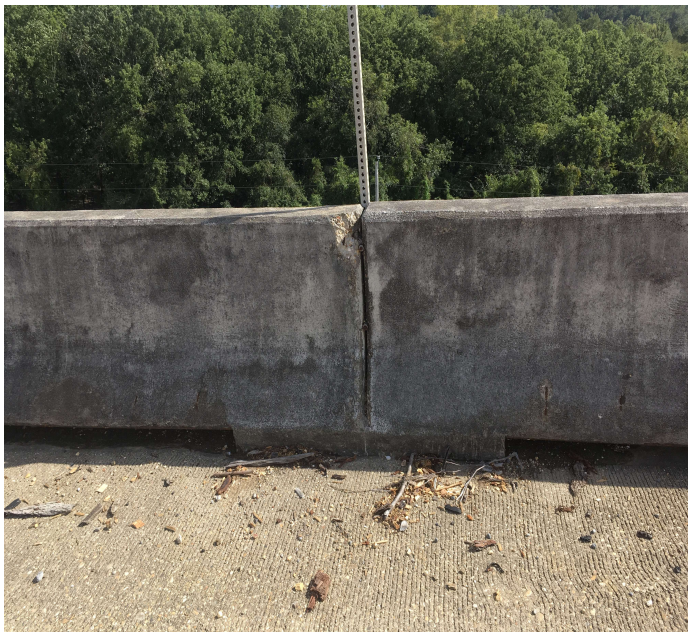
CONCRETE BRIDGE RAILING:

Vertical cracks and minor spalls in all spans. Rebar exposed in many locations.

PHOTO 1 Description Span 24, Right, Bridge Rail: Spalling.

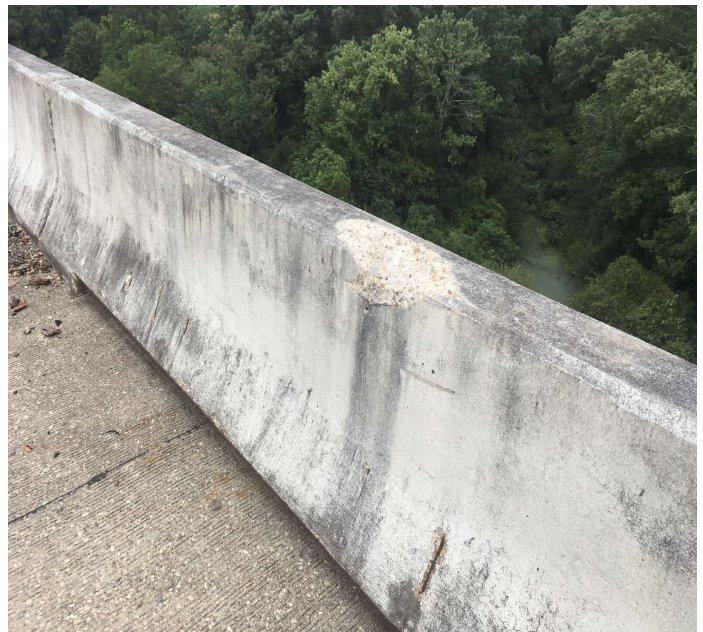
Span 16, Lt: Spall on top of bridge rail.

PHOTO 2 Description Span 16, Left, Bridge Rail: Spalling.

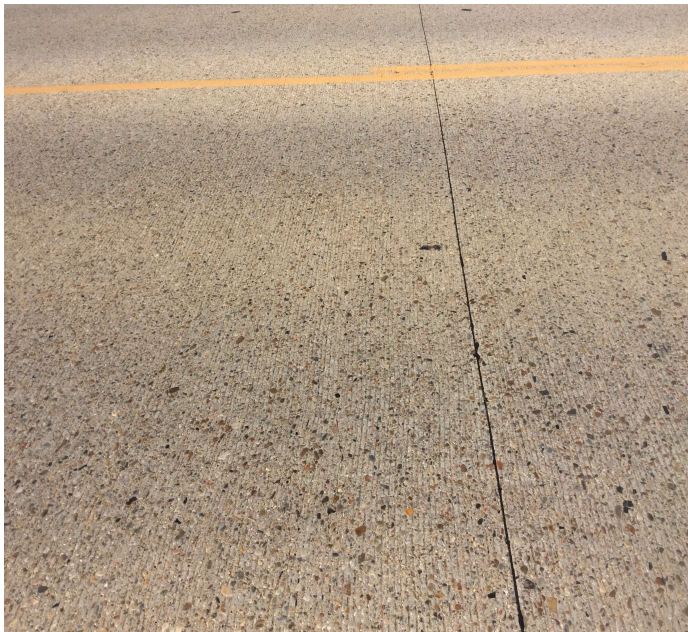
Numerous transverse deck cracks in all spans. Majority of the cracks have been sealed with epoxy in the past. Minor spall at expansion joint, Bt. 7.

PHOTO 1 Description Sealable deck cracking at random spacing. Typical

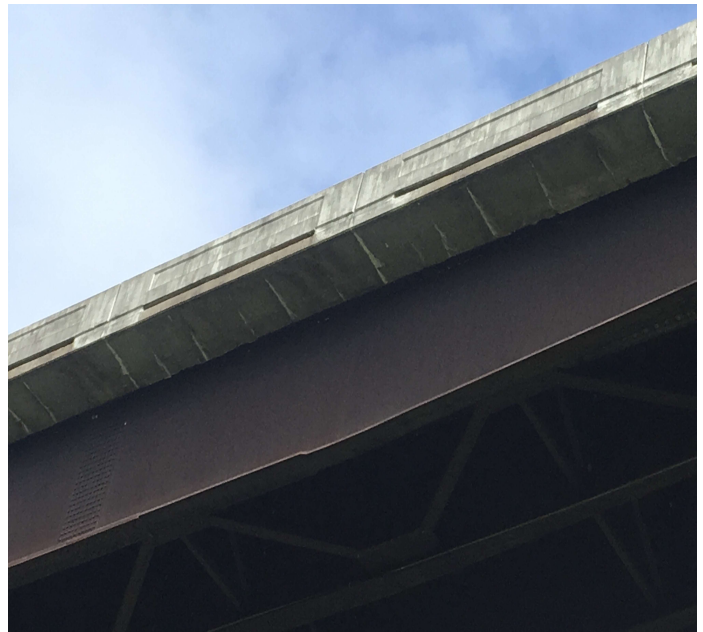
Numerous transverse efflorescence cracks in the Lt and Rt. overhang.

PHOTO 2 Description Typical cracking in the overhangs.

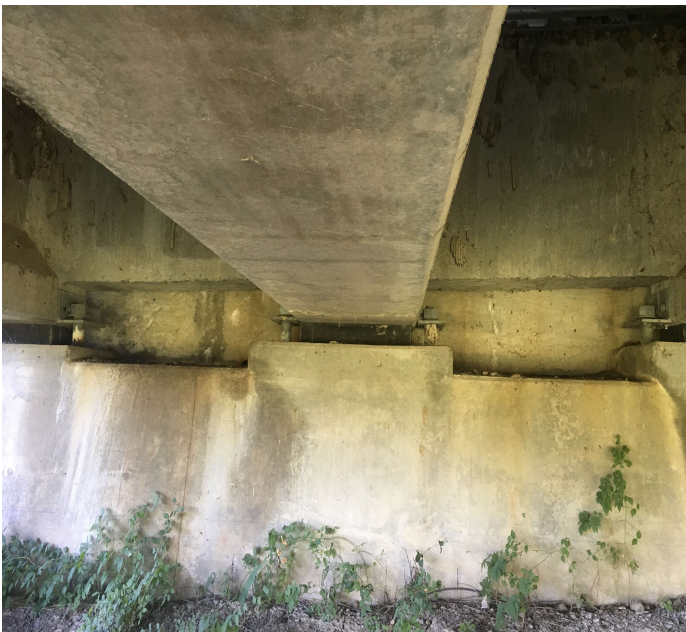
End Bent 26: East abutment has 4 vertical cracks, 3 are efflorescence.

End Bent 26: Head wall has small open cracks and has a small spall in gutterline.

PHOTO 1 Description Bent 26: Isolated diagonal and vertical cracking with light efflorescence.

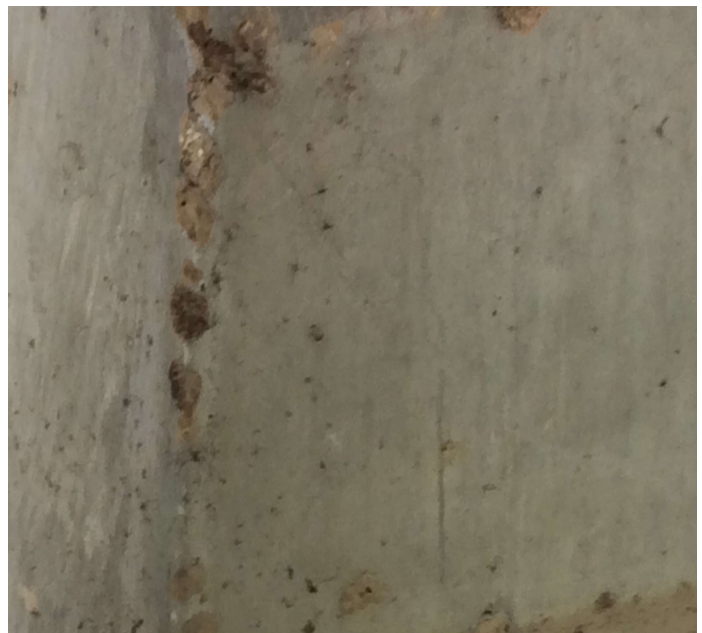
All girders that have been made continuous have 45-degree hairline cracks in the web starting at the top flange and extending back and down to a point approx. 24" from the end of the girder. None of the cracks extended into the bottom flange. Cracks ranged in width from 0.002 to 0.010 inches in width. See drawing and photos.

PHOTO 2 Description Bent 11 girder 4 diagonal crack in web of girder in bearing area.

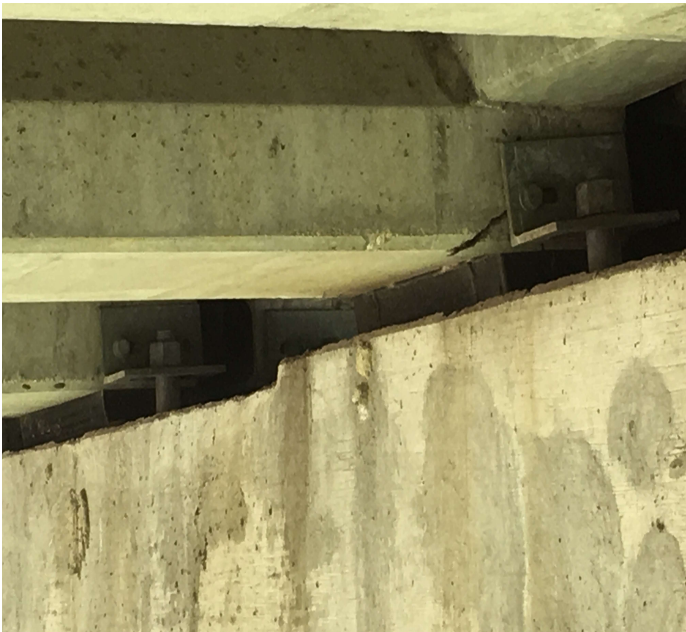
Bt. 7, Girder 3, back: Spall on side of girder at bearing area.

PHOTO 4 Description Bent 7, Girder 3: Spalling in the bearing area.

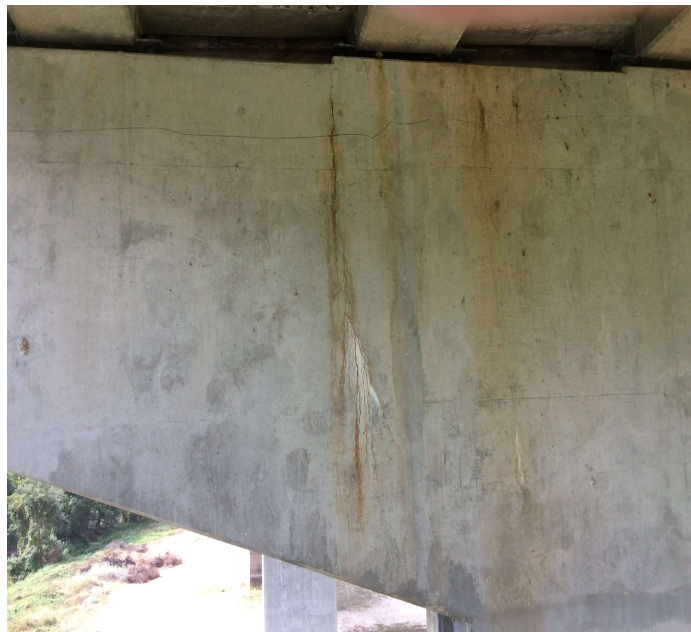
All R/C caps have vertical efflorescence cracks.

PHOTO 1 Description Bent 7 vertical hairline shrinkage crack in face of cap typical with all bent caps.

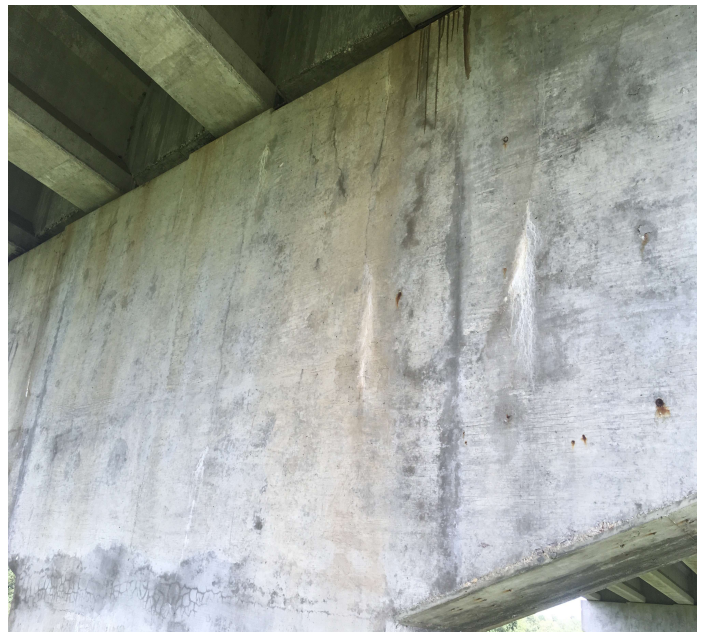
PHOTO 2 Description Bent 20, Cap: Cracking with efflorescence.

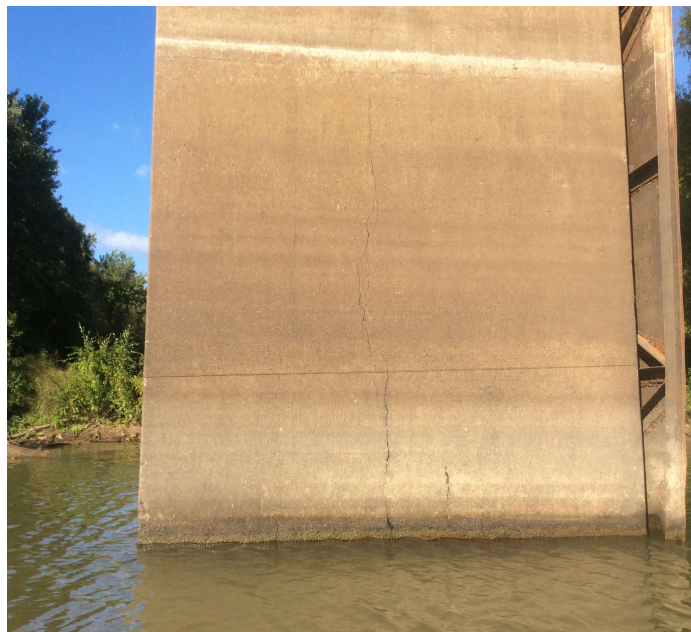
Bt. 13: Ahead: Vertical crack rising from the waterline.

PHOTO 1 Description Pier 13 vertical crack on ahead side up to 1/4" wide extending up about 15' from water line

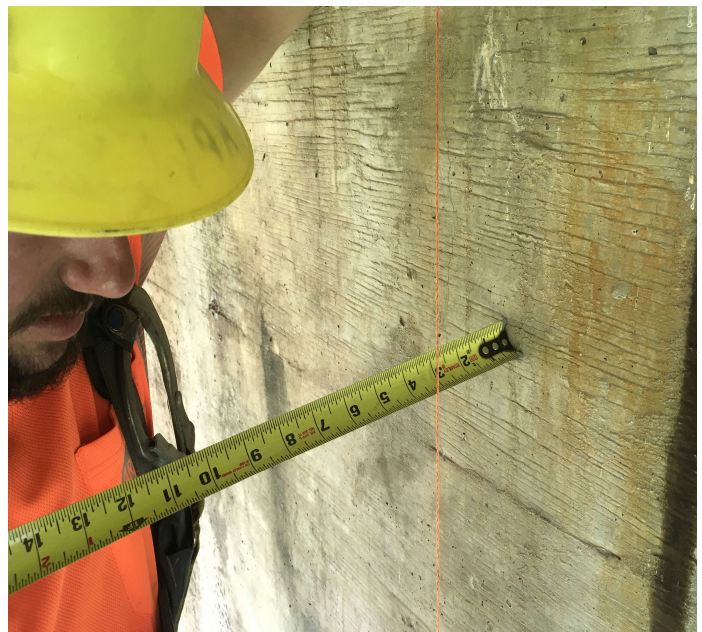
Bt. 20: Bent has rotated back 3 1/2" at the top.

PHOTO 2 Description Bent 20: Offset cap.
