Bridge Inspection Report

06449
US 82 S-7 LM 11.30
over
LaPILE DITCH

Structure Number: 06449

Facility Carried: US 82 S-7 LM 11.30

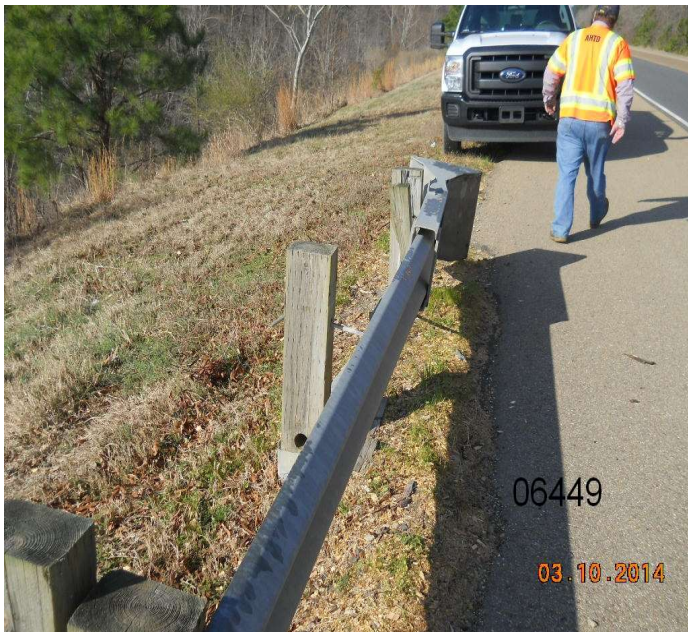
Abutment 1 end, Rt. side, Terminal anchor post.

Abutment 1 end, Rt. side, Next post from Terminal post, spacer block.
Broke.

Spacer block missing.

PHOTO 1 Description Abutment 1 Rt. side terminal end post
and spacer block broke.
