Bridge Inspection Report

**06450
US 82 S-7 LM 12.07
over
BIG SLOUGH**

Structure Number: 06450

Facility Carried: US 82 S-7 LM 12.07

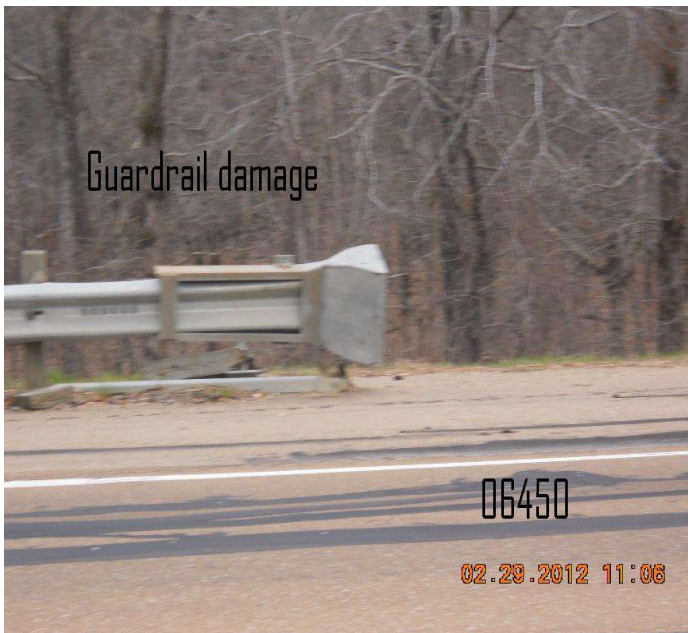
Terminal end post, Left end from abutment 2.
Collision damage to terminal end post @ terminal end section.

PHOTO 1 Description Terminal end post, collision damage.

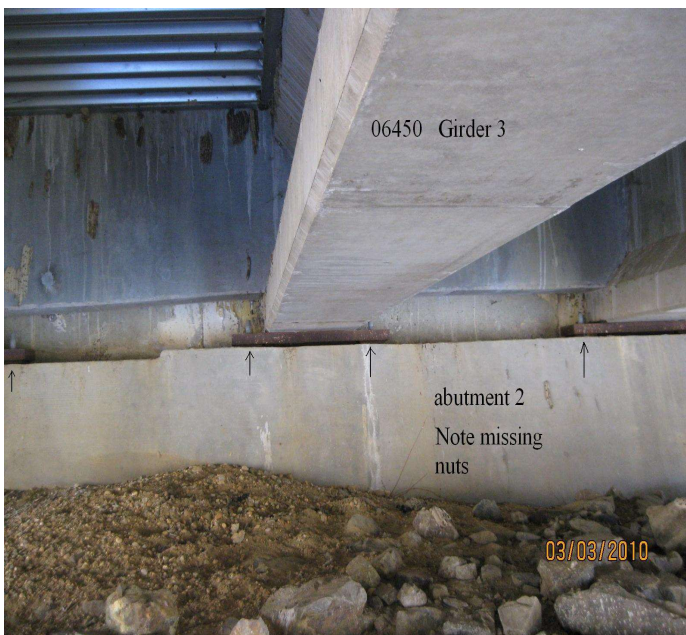
Abutment 2, girders # 2-3-4.
Anchor nuts missing.

PHOTO 1 Description Abutment 2 girders 2, 3, and 4, anchor nuts missing.

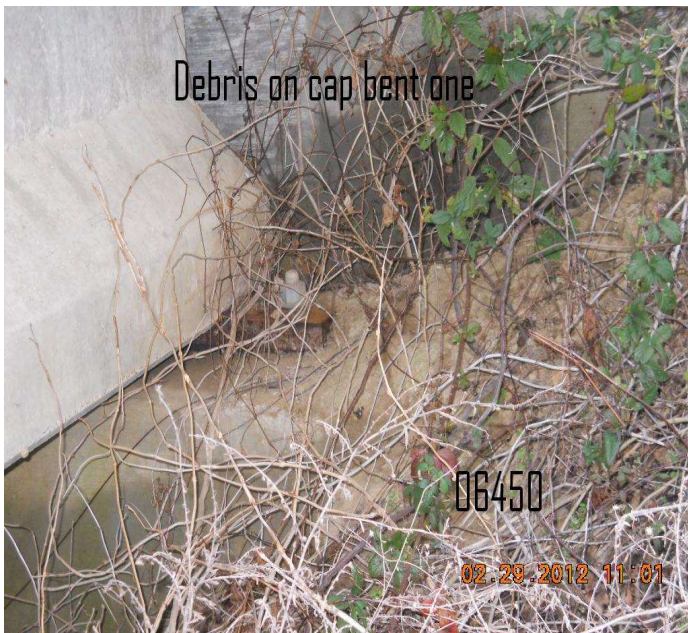
Abutment 1, cap and masonry plate, Lt side

Dirt and debris on cap and against masonry plate, thus causing premature aging and rust.

PHOTO 1	Description	Abutment 1 cap and masonry plate are prematurely rusting due to dirt and debris built up on them.
---------	-------------	---
