Bridge Inspection Report

06451
US 82 S-7 LM 13.91
over
OUACHITA REL

Structure Number: 06451

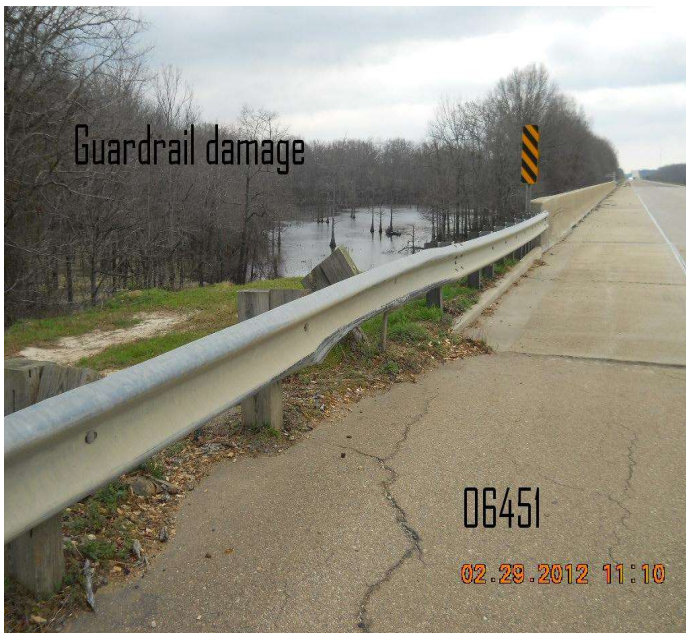
Abutment 1 end, Lt side Approach guardrail.
Collision damage.

PHOTO 1 Description Abutment 1 Lt. Guardrail has old collision damage to the rail and post.
