Bridge Inspection Report

06452
US 82-08 LM 1.12
over
Ouachita River Relief

Structure Number: 06452

Executive Summary

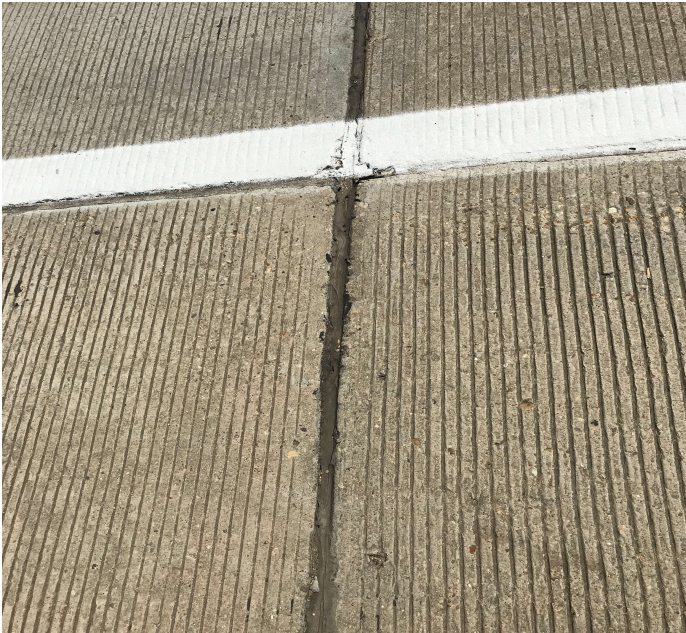
All bents: Poured joint material is mostly intact but has lost adhesion in some places and allowing storm-water to leak through onto ends of deck and girders and onto cap.

Stage construction joint on left side (between Girders 1 & 2): Poured joint material is mostly intact but has lost adhesion in some places and allowing storm-water to leak through joint.

PHOTO 1 Description Joint - Bent 1 : Loss of adhesion

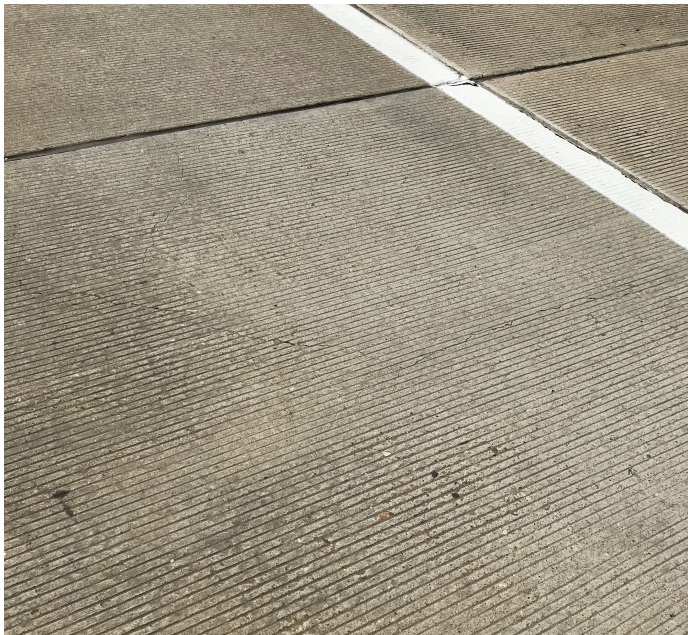
Some unsealed hairline- to moderate-sized cracks, mostly longitudinal along edges of Girders 2-4 (in main lanes) – heaviest and largest cracking on Spans 1-5 (less and smaller on Spans 6-7), with a few diagonal (corner) cracks near bents.

PHOTO 1 Description Deck - Span 1 at Bent 1 left: Diagonal cracking

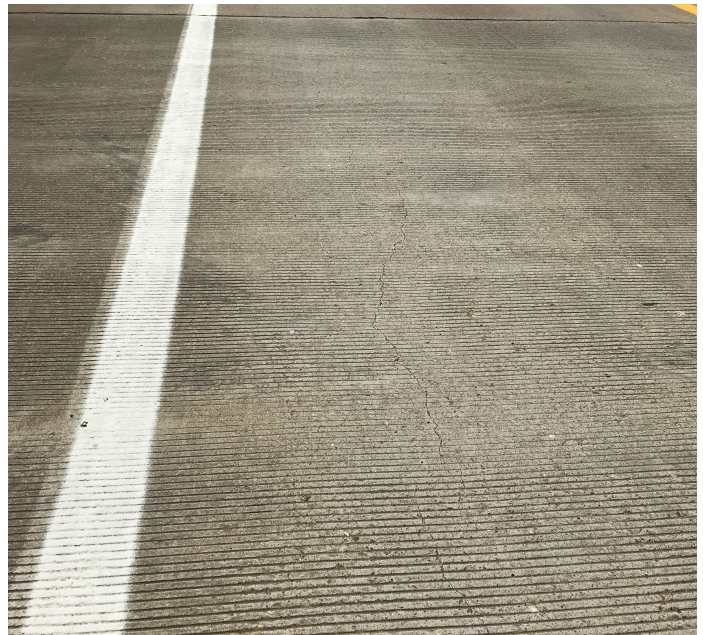
PHOTO 2 Description Deck - Span 1 right : Cracking

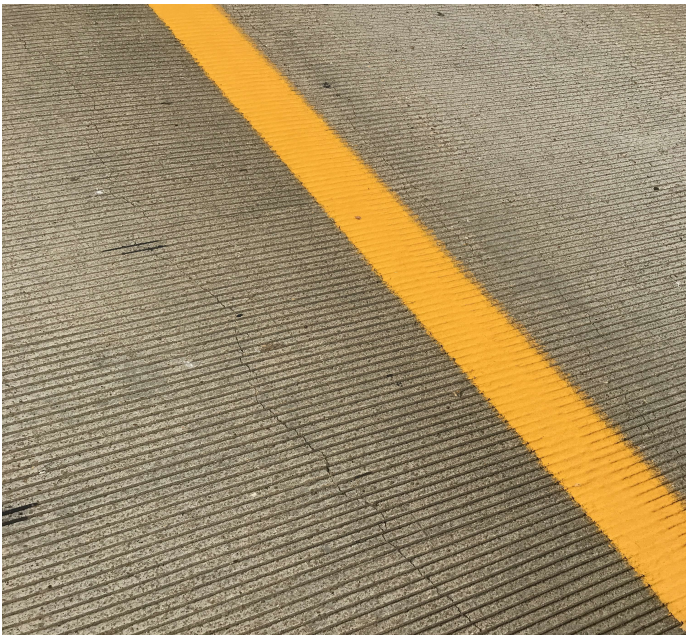
PHOTO 3 Description Deck - Span 4: Cracking

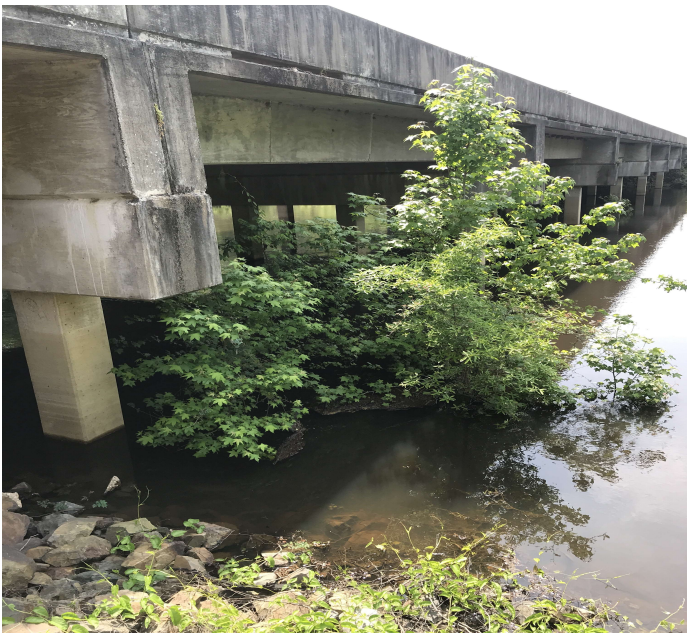
All spans have trees and vegetation growing under bridge.

PHOTO 1 Description End-slope - Span 6: Vegetation

David: remove as soon as possible, advise me when complete

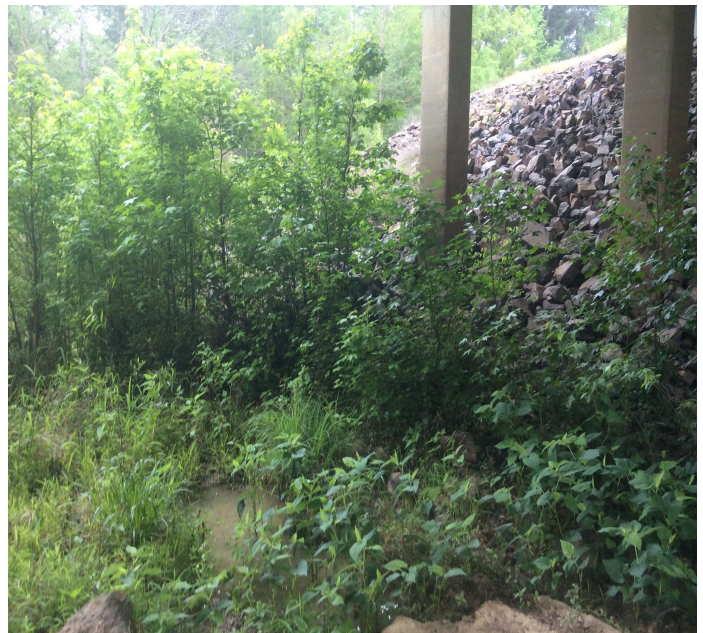
PHOTO 2 Description Span 2 trees and vegetation growing under bridge. Common all spans.
