Bridge Inspection Report

06453
US 82-08 LM 1.76
over
Ouachita River Relief

Structure Number: 06453

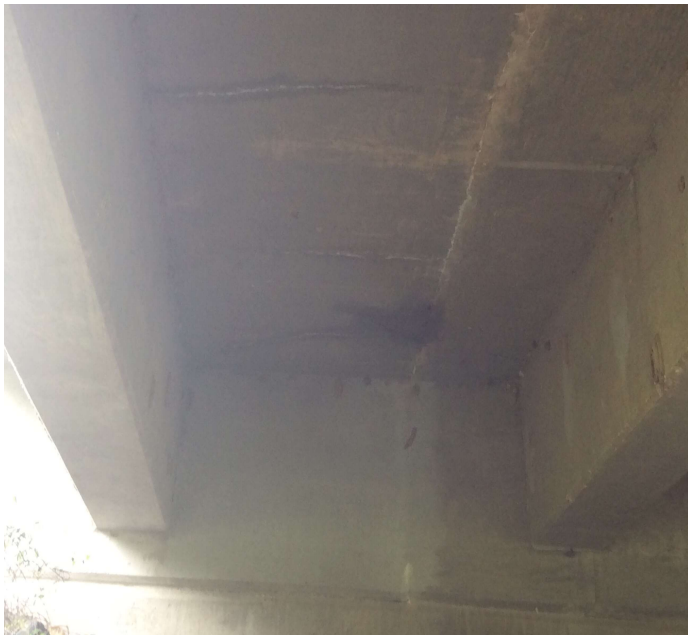
Stage construction joint on left side (between Girders 1 & 2): Poured joint material is mostly intact but has lost adhesion in some places and allowing storm-water to leak through joint, especially on Span 7 near Bent 8.

PHOTO 1 Description Soffit, Span 7 near bent 8 between girders 1 & 2 the soffit has moisture seeping from the deck at the construction joint.

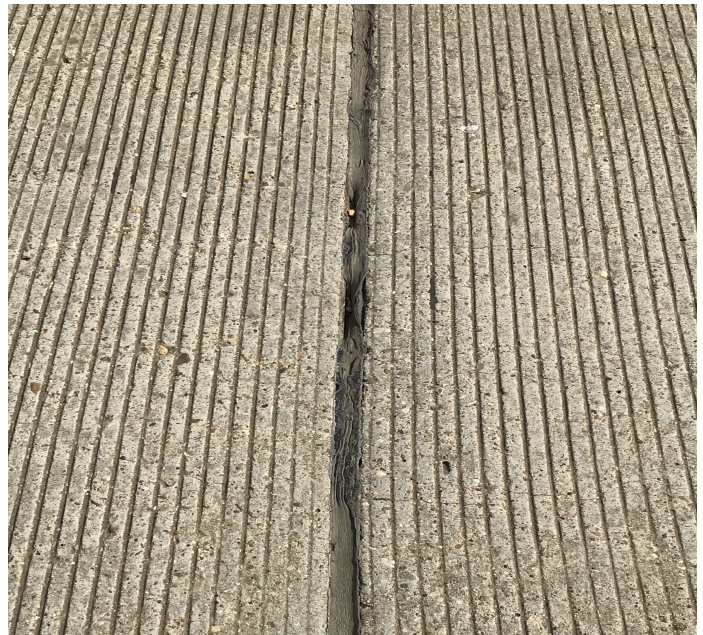
All bents: Poured joint material is mostly intact but has lost adhesion in some places and allowing storm-water to leak through onto ends of deck and girders and onto cap.

PHOTO 1 Description Joint - Bent 2 : Loss of adhesion

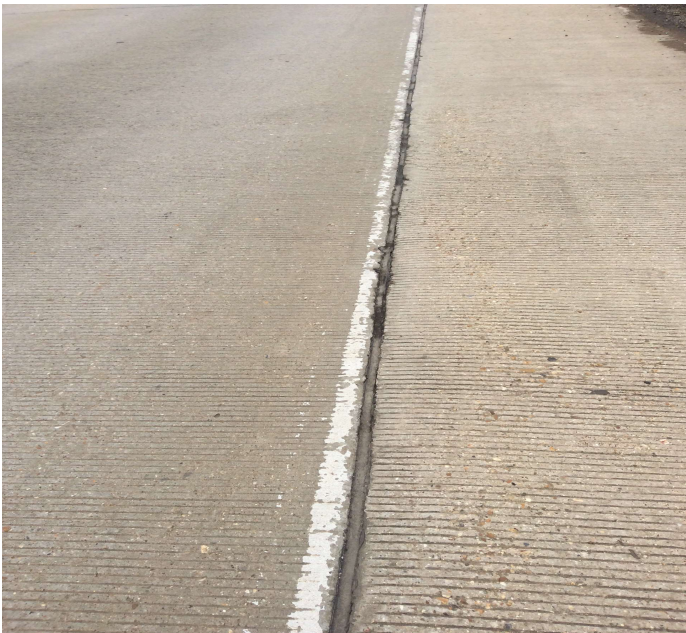
PHOTO 2 Description Deck joint at soffit crack, joint material has lost bond allowing moisture to seep through deck. (See soffit photo).

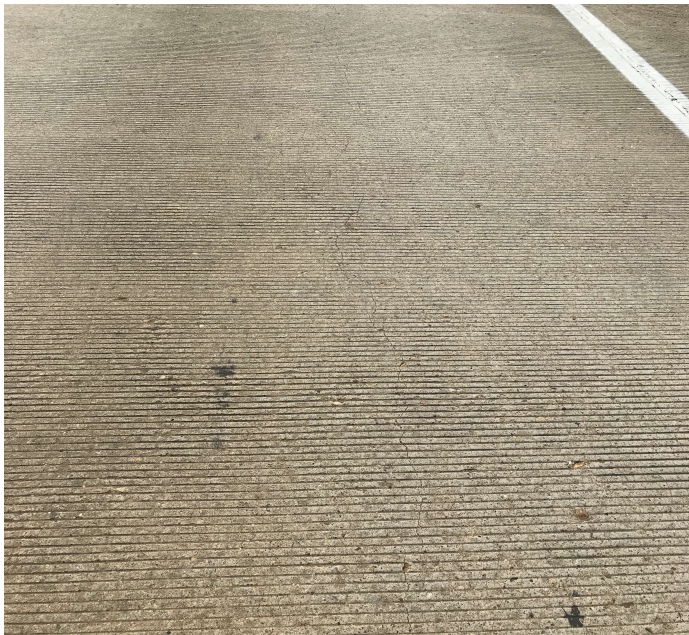
Some unsealed hairline- to moderate-sized cracks, mostly longitudinal along edges of Girders 2-4 (in main lanes) – heavier and larger cracking on Spans 1-5 and Span 7 (less and smaller cracks on Span 6), with a few diagonal (corner) cracks near bents.

PHOTO 1 Description Deck - Span 4: Cracking

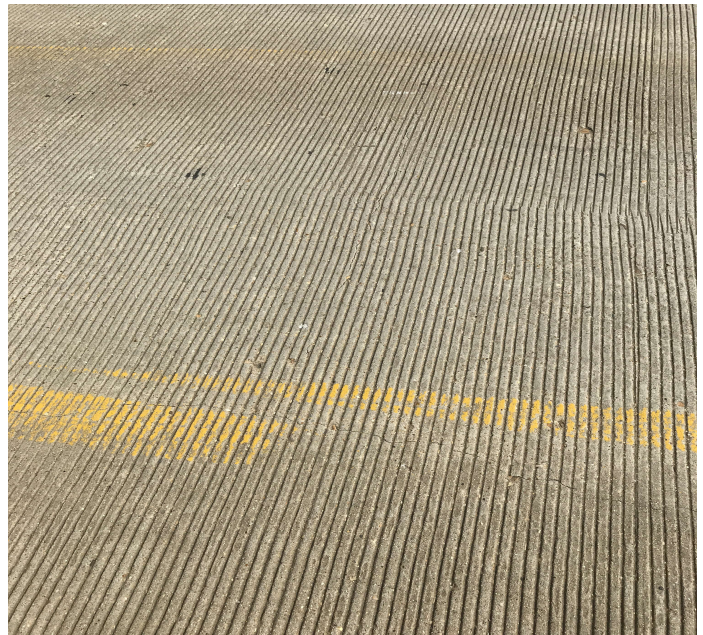
Span 7: Heavy cracking (longitudinal, diagonal, and transverse) in the 3-feet closest to Bent 8.

PHOTO 1 Description Deck - Span 7: Cracking

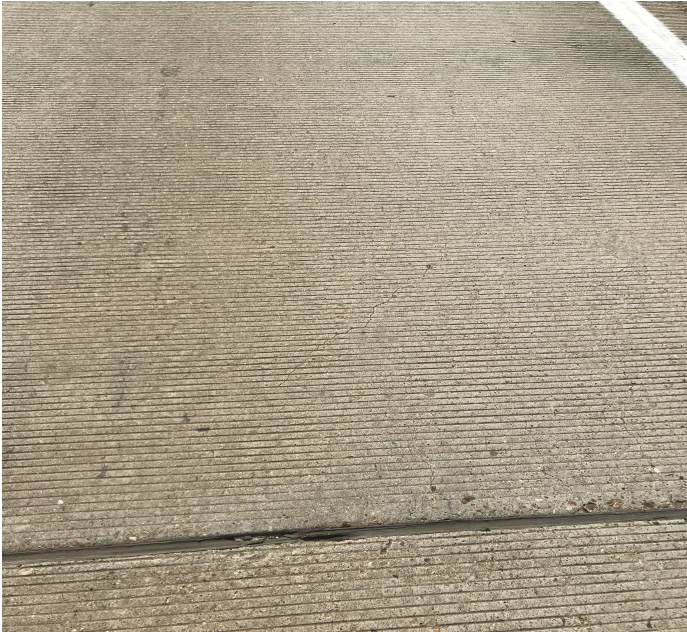
PHOTO 2 Description Deck - Span 5: Cracking

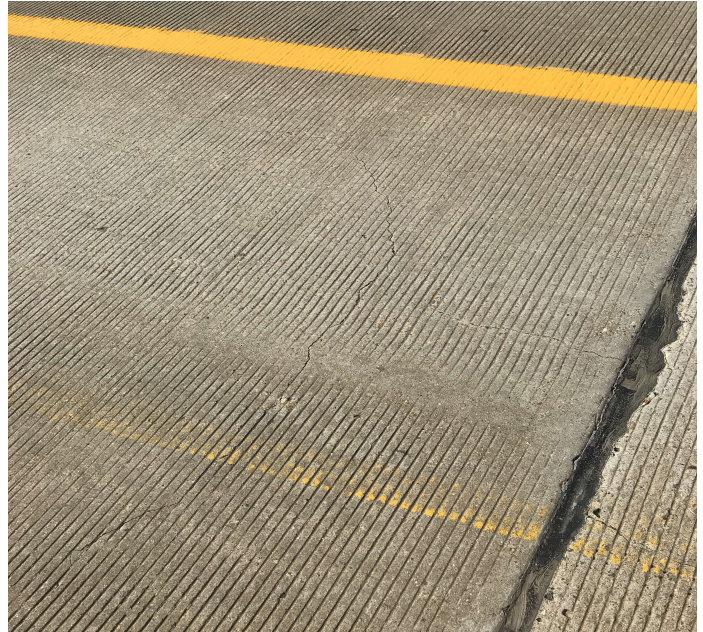
PHOTO 4 Description Deck - Span 7: Cracking

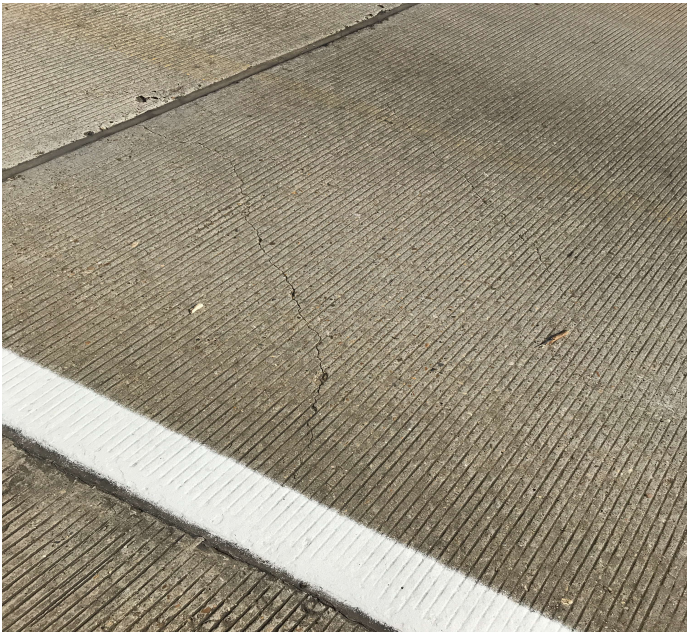
PHOTO 3 Description Deck - Span 7: Cracking

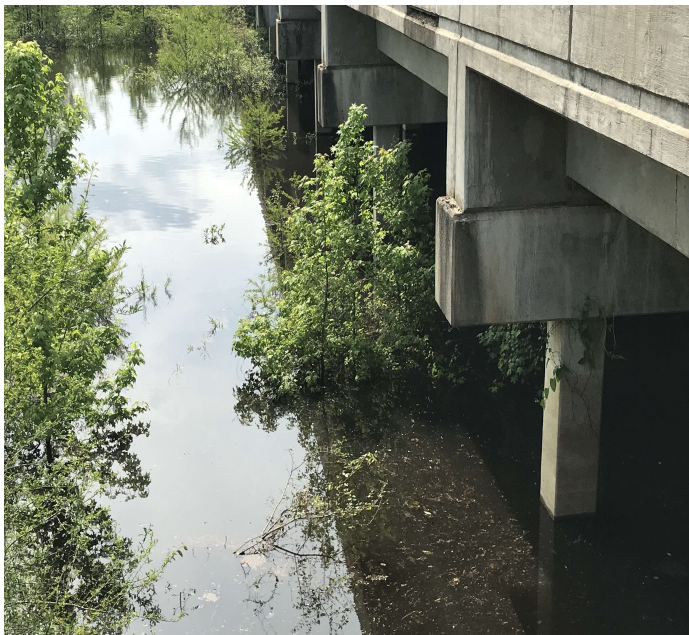
All spans have trees and vegetation growing under bridge.

PHOTO 1 Description End-slope - Span 6 right : Vegetation

David: catch this one this summer when it is dry and remove all the vegetation

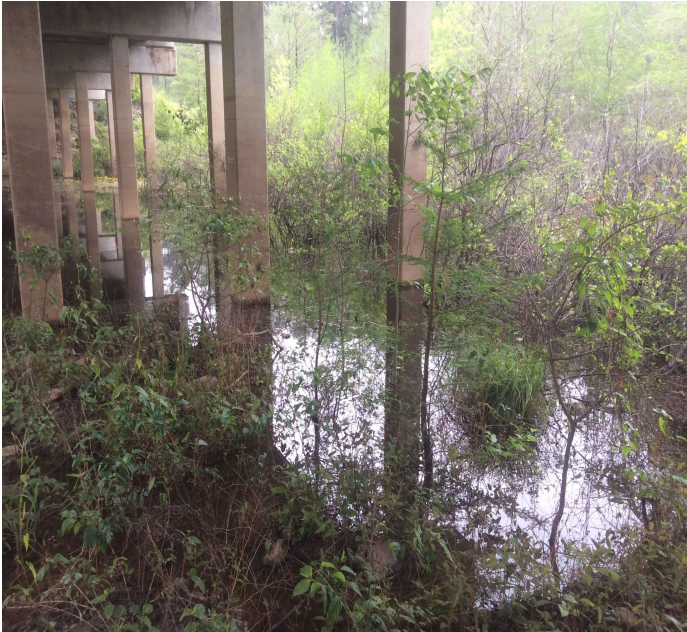
PHOTO 3 Description Span 2 trees growing under the bridge.
Common all spans.

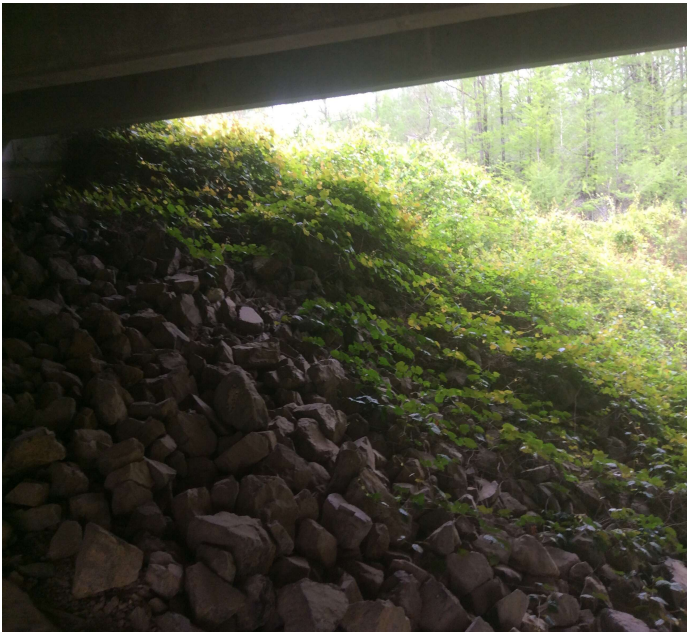
PHOTO 4 Description Span 1 vegetation and vines growing
under bridge.
