Bridge Inspection Report

00511

US 64/sec15/L1.03

DRAINAGE DITCH

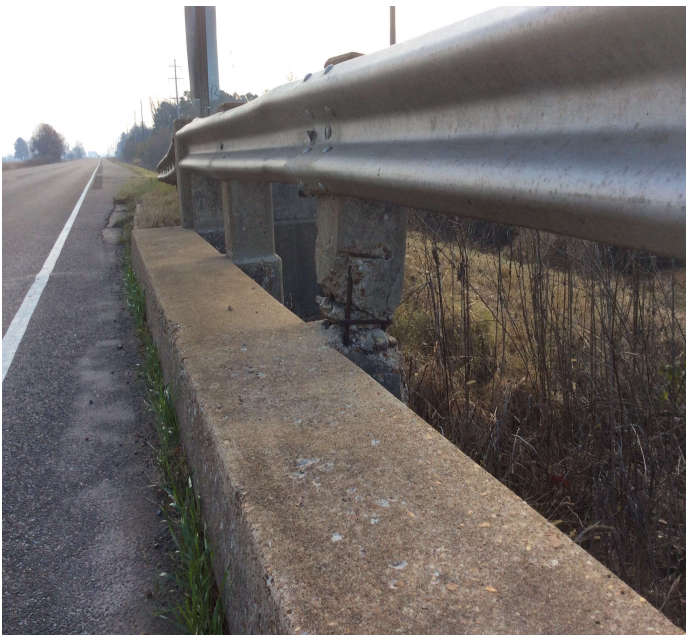
SPAN #3 RIGHT SIDE 3RD POST FROM ABUTMENT 2 IS BROKEN AT BASE WITH EXPOSED REBAR WITH MINOR RAIL DAMAGE.

PHOTO 1 Description Right side 3rd post from abutment 2.

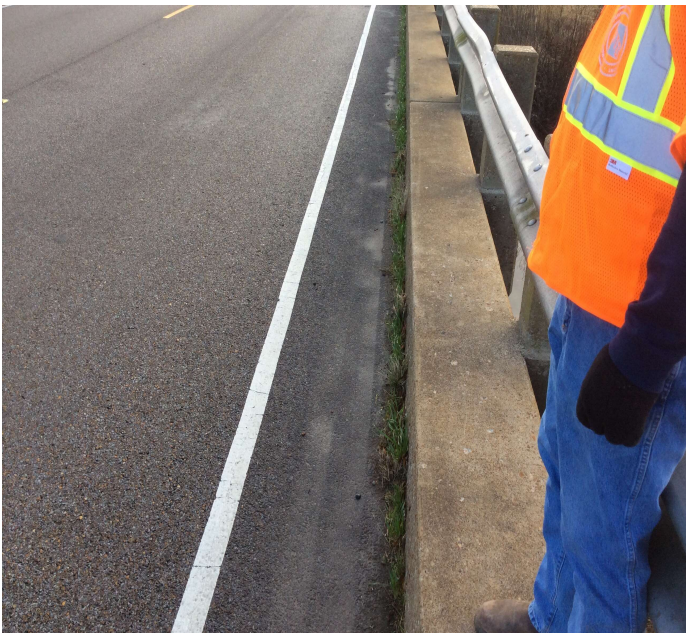
Vegetation is growing in gutters.

PHOTO 1 Description Vegetation is growing in gutters.
