Bridge Inspection Report

00512

US 64/sec15/L2.49
over
DRAINAGE CANAL

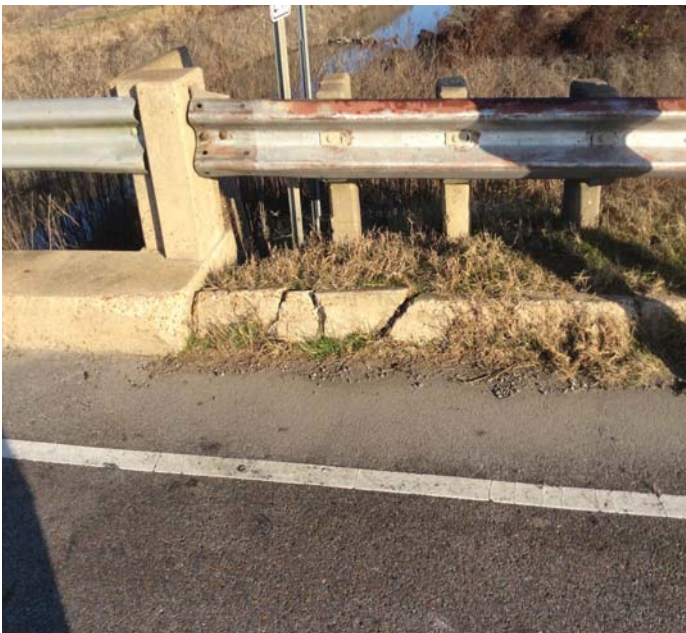
ABUTMENT #2 LEFT SIDE CURB IS BROKEN AT BRIDGE END.

PHOTO 1 Description Abutment 2 left approach curb.

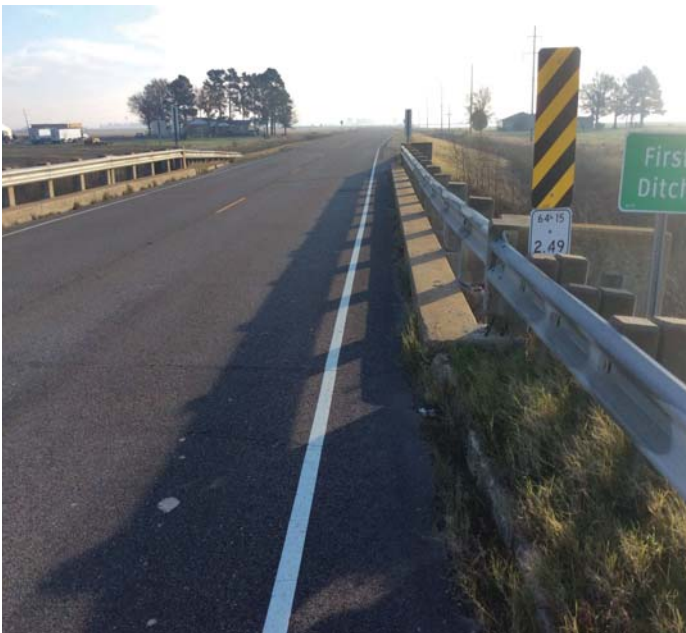
Vegetation is growing in gutters full length of bridge.

PHOTO 1 Description Vegetation is growing in gutters.
