Bridge Inspection Report

00513
US 64/sec15/L4.20
over
DRAINAGE CANAL

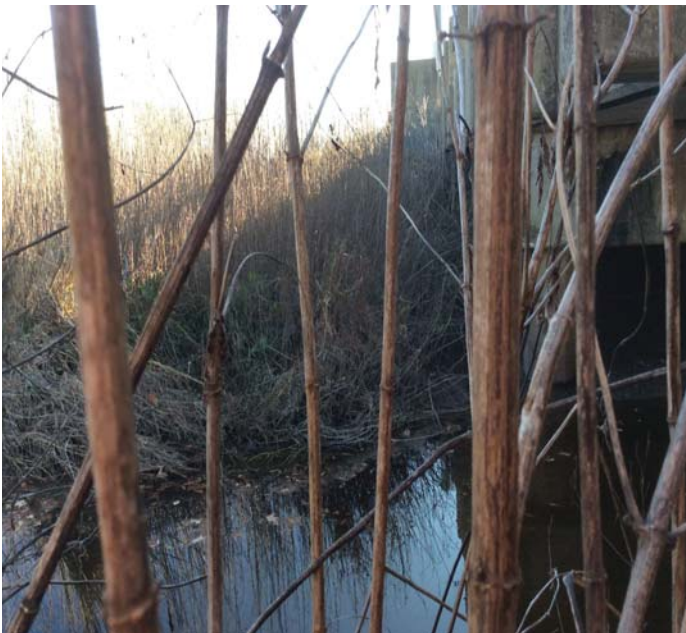
Vegetation is beside and under bridge.

PHOTO 1 Description Typical vegetation

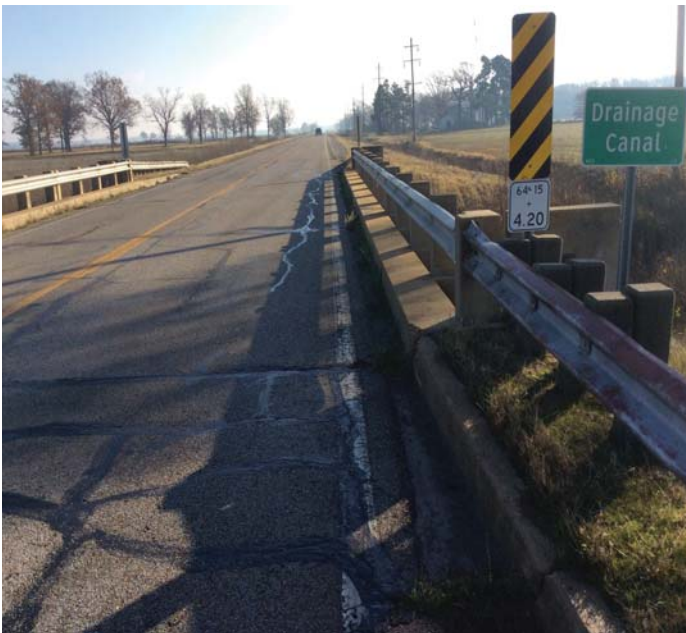
Vegetation is growing in gutters.

PHOTO 1 Description Vegetation is growing in gutters.

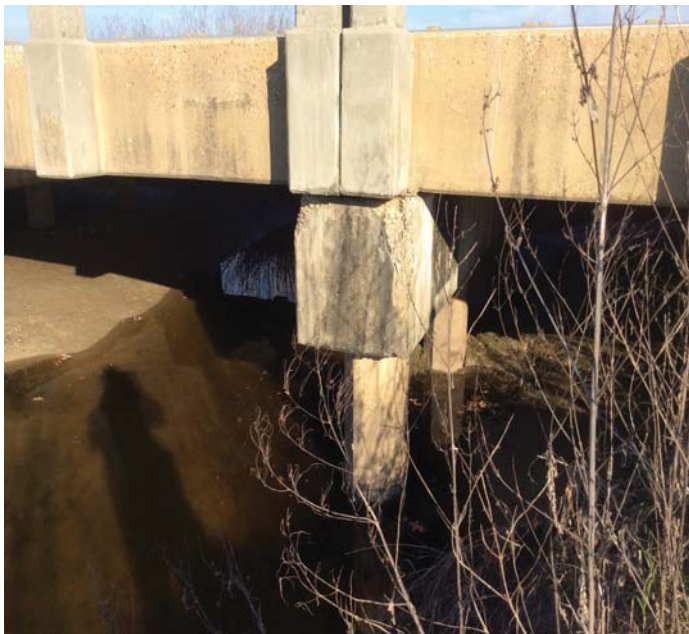
BENT #3 CAP AHEADFACE RIGHT END HAS 1' SPALL WITH NO REBAR EXPOSED.

PHOTO 1 Description Bent 3 cap right end

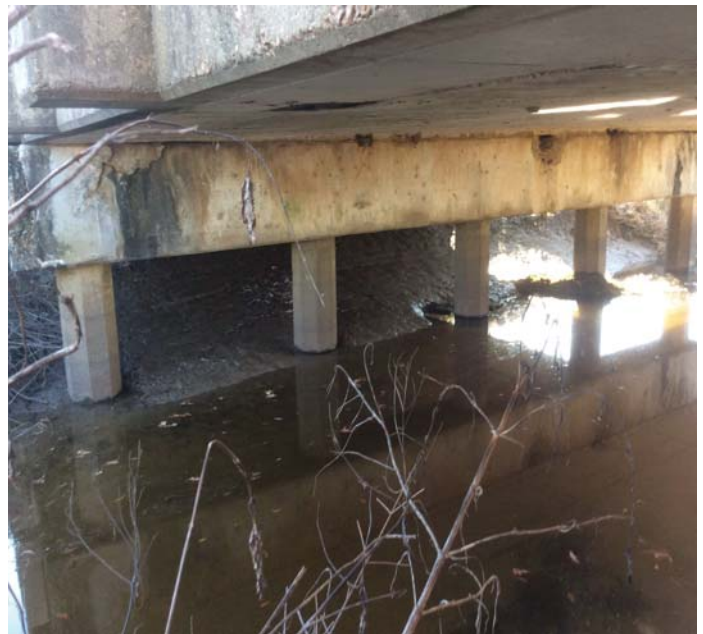
BENT #3 CAP BACKFACE HAS 4' DELAMINATION AT TOP WITH NO REBAR EXPOSED, 2' SPALL AT TOP BETWEEN PILE #3 & 4 WITH NO REBAR EXPOSED & 1' DELAMINATION BETWEEN PILE #4 & 5.

PHOTO 2 Description Bent 3 back face

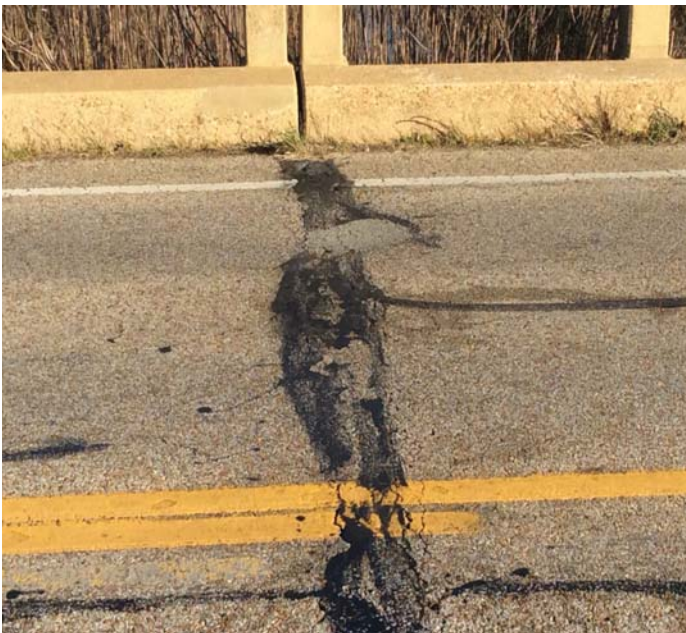
SPAN #1 LEFT LANE AT BENT #2 HAS 1' POTHOLE IN WHEEL PATH

PHOTO 1 Description Span 1 pot hole repair.

Pot hole has been repaired since last inspection.
