Bridge Inspection Report

00515
US 64/sec15/L6.52
over
BRUSHY CREEK

Structure Number: 00515

Facility Carried: US 64/sec15/L6.52

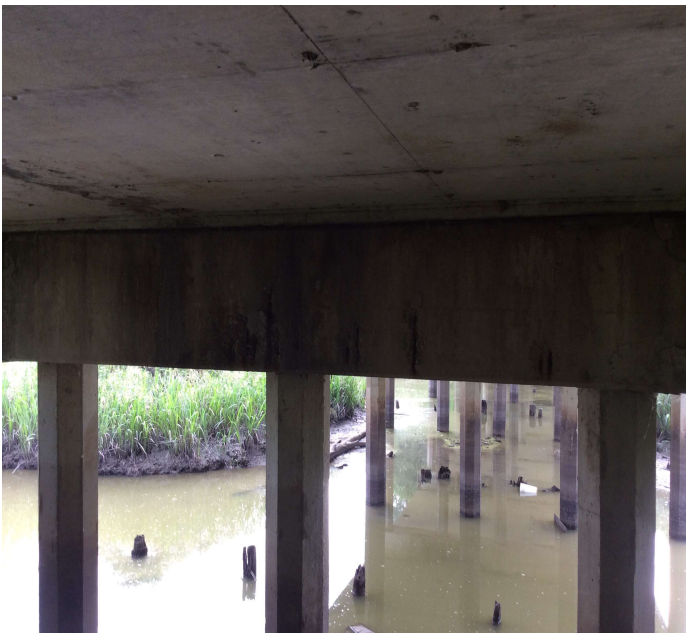
BENT 2 - 8 CAPS HAVE SEVERAL AREAS OF CRACKS, DELAMINATIONS & SPALLS WITH EXPOSED REBAR.

PHOTO 1 Description Typical caps

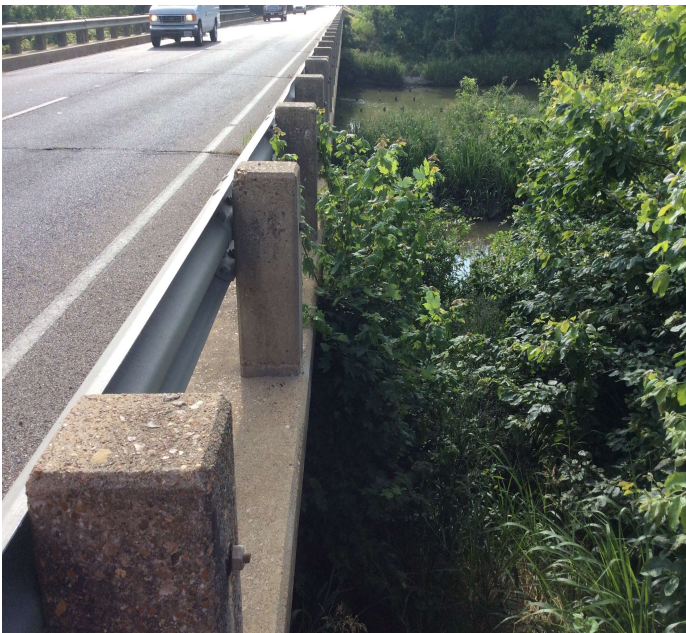
ABUTMENT #1 & 2 RIGHT & LEFT SIDES HAVE VEGETATION GROWING UNDER & BESIDE BRIDGE.

PHOTO 1 Description Vegetation growing beside bridge.

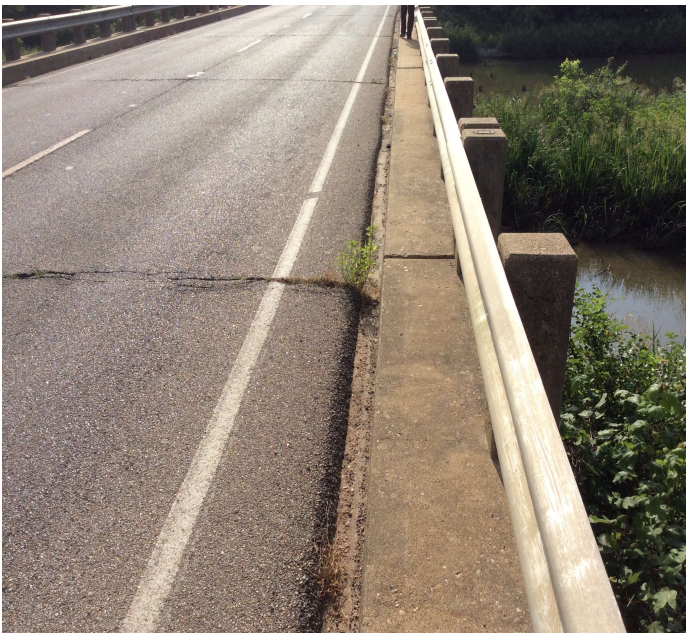
DECK LEFT & RIGHT GUTTERS HAVE VEGETATION GROWING IN THEM.

PHOTO 1 Description Vegetation growing in gutters.

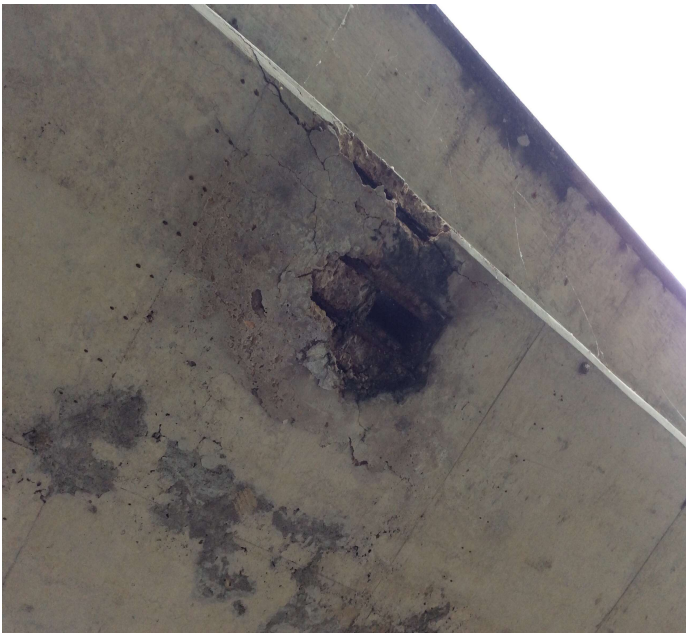
SOFFIT

SP. 4 RT

SP. 5 RT

SP. 6 LT & RT

SP. 7 RT

SP. 8 RT

SOFFIT IS SPALLED AT DECK DRAINS WITH EXPOSED REBAR.

PHOTO 1 Description Typical spalled drain area.

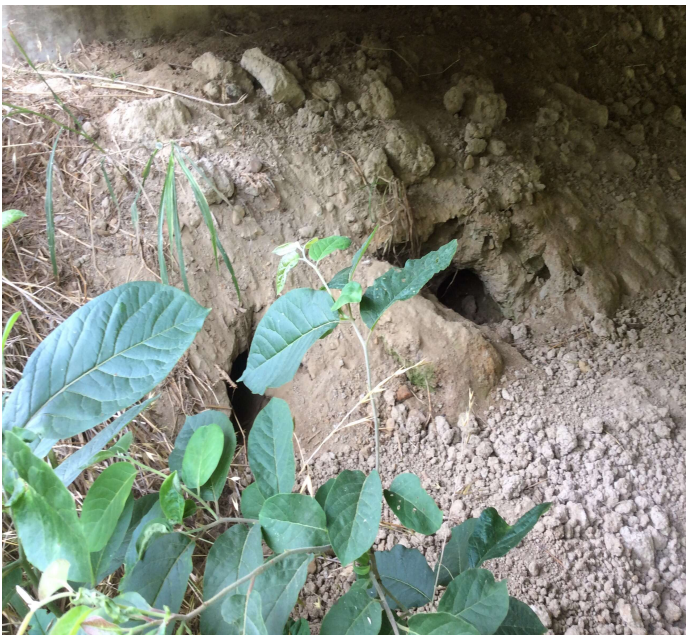
ABUTMENT #1 SLOPE HAS 2 LARGE ANIMAL HOLES ON RIGHT & LEFT SIDE.

PHOTO 1 Description Typical animal holes.
