Bridge Inspection Report

00516

US 64/sec15/L6.65

BRUSHY CREEK RE.

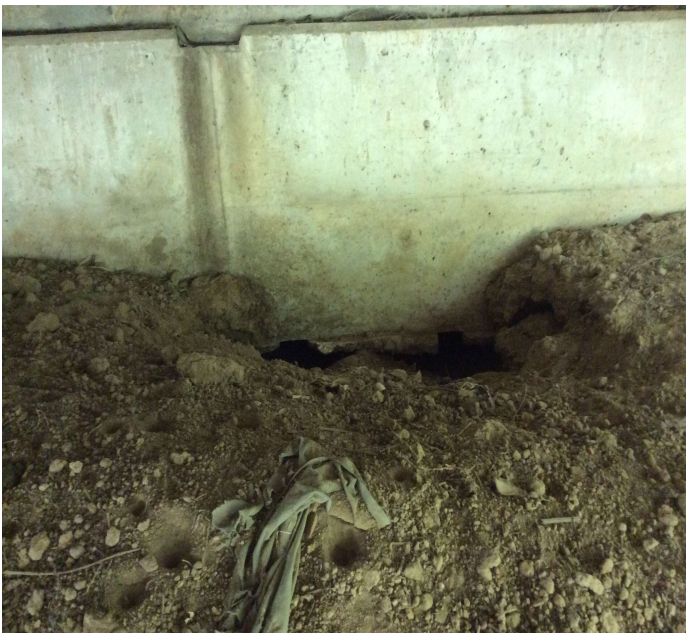
Abutment 2 right side has 3 large animal holes.

Abutment 1,2 right, left side has 3 large animal holes.

PHOTO 1 Description Abutment 2 right side has 3 large animal holes.

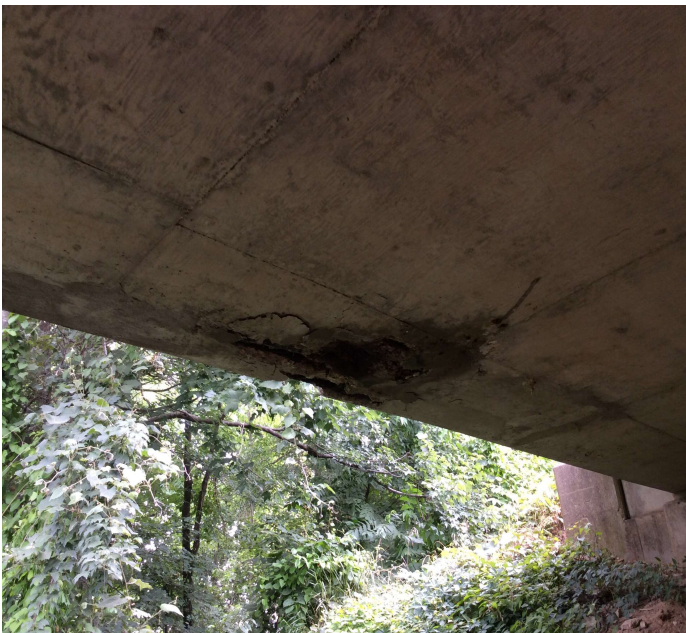
Several deck drains have spalls and delams around them.

PHOTO 1 Description Typical deck drain.

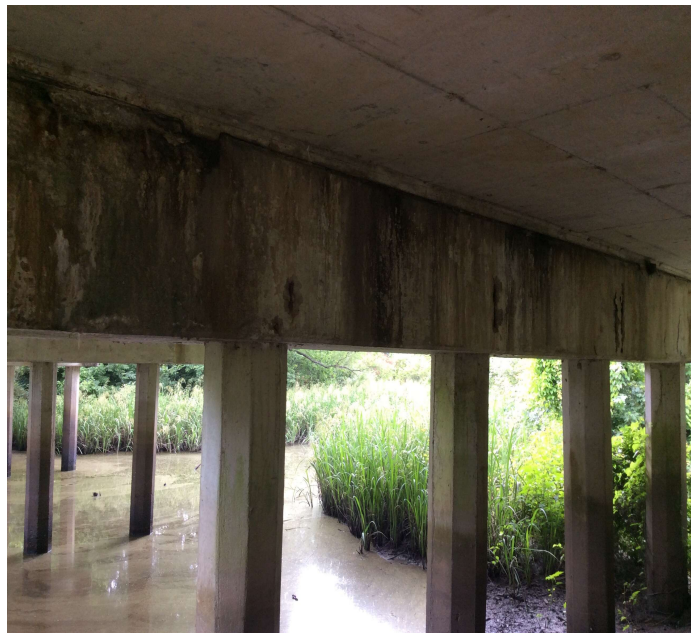
BENT #2 - 5 CAPS HAVE SEVERAL AREAS OF CRACKS, DELAMINATIONS & SPALLS WITH EXPOSED REBAR.

PHOTO 1 Description Typical cap

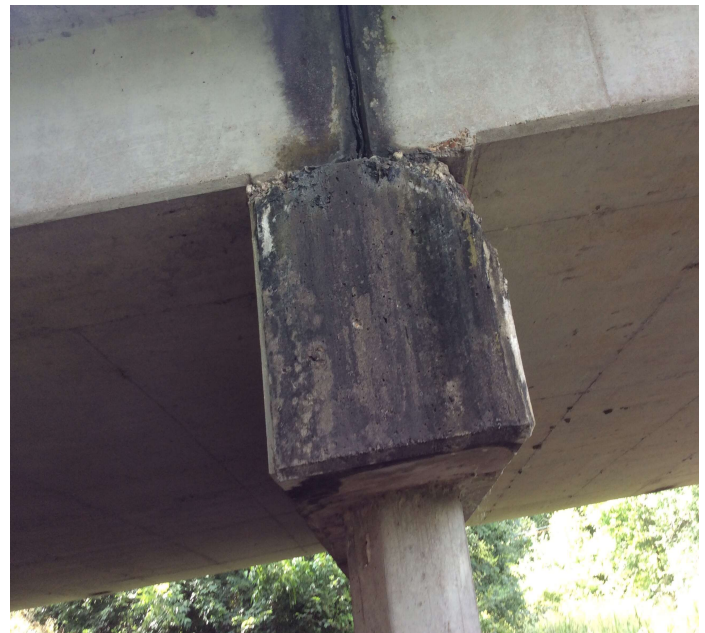
PHOTO 2 Description Typical cap.

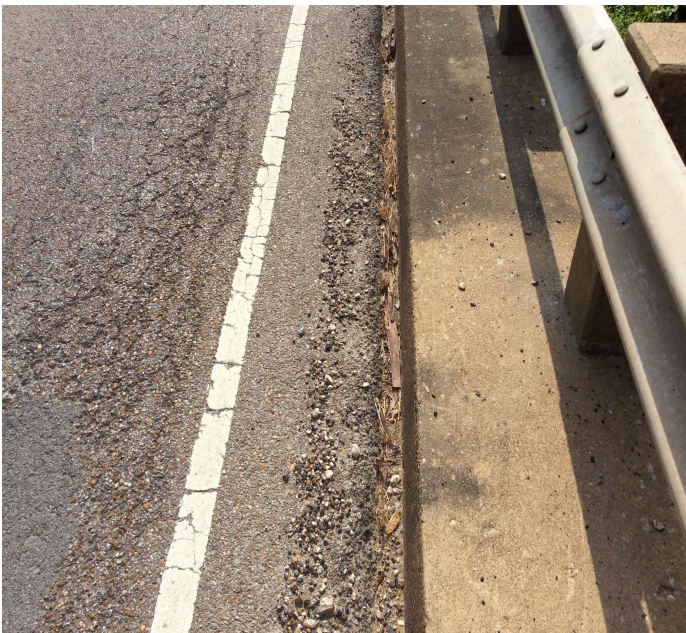
LEFT & RIGHT GUTTERS HAVE VEGETATION GROWING IN THEM.

PHOTO 1 Description Vegetation has been killed since last inspection.

Vegetation has been killed since last inspection.
