# Bridge Inspection Report

00517

US 64/sec15/L7.4

LANGUILLE RELIEF

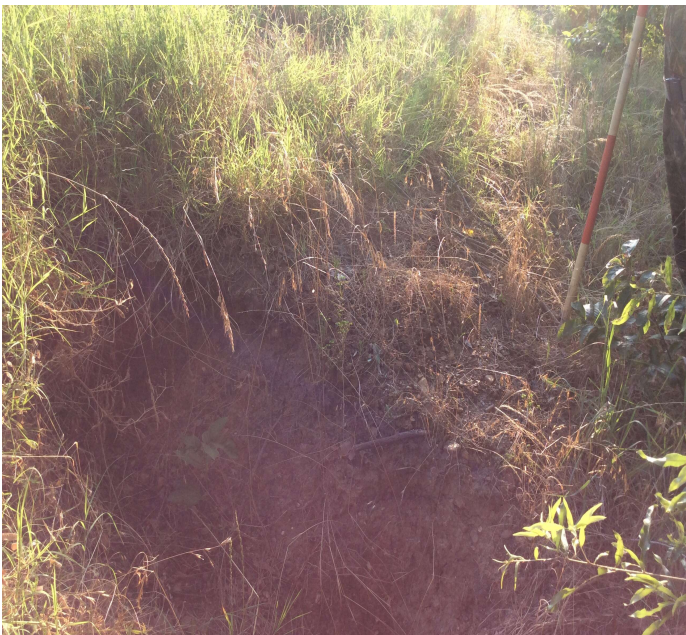
Abutment 1 right side slope 20' from end of bridge has 4' long 2' deep erosion area.

PHOTO 1      Description      Abutment 1 right side slope 20' from end of bridge has 4' long 2' deep erosion area.

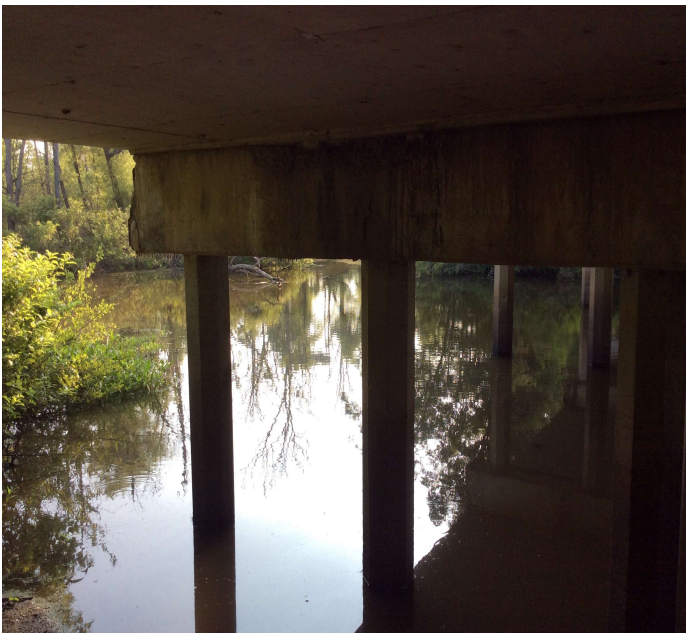
234 - Reinforced Concrete Pier Cap	1- Ben.	122	ft.	103	19	0	0
	BENT #2 CAP AHEAD FACE HAS 1' SPALL ABOVE PILE #2 & 2' SPALL ABOVE PILE #4. BENT #2 CAP BACK FACE ABOVE PILE #2 AT TOP HAS 4' SPALL WITH REBAR EXPOSED. BENT #2 CAP RIGHT & LEFT END IS SPALLED AT TOP WITH NO REBAR EXPOSED. BENT #3 CAP LEFT & RIGHT ENDS ARE SPALLED AT TOP WITH NO REBAR EXPOSED. BENT #3 CAP AHEAD FACE ABOVE PILE #1 HAS 6" POPOFFS WITH REBAR EXPOSED. BENT #3 CAP AHEAD FACE BETWEEN PILE #2 & 4 HAS LONGITUDINAL CRACK AT TOP BENT #3 CAP AHEAD FACE ABOVE PILE #4 HAS 1' DELAMINATION BENT #4 BACK FACE LEFT END HAS 2' SPALL WITH EXPOSED REBAR. Bent 4 backface over pile #2 w / 2' spall & exp. rebar BENT #5 BACK FACE RIGHT END HAS 2' SPALL WITH EXPOSED REBAR BENT #5 BACK FACE LEFT END IS CRACKED/ DELAMINATED BENT #5 CAP BOTTOM CHORD IN FRONT OF PILE #3 IS CRACKED/ DELAMINATED.						
1080 - Delamination/Spall/Patched Area		5			5

BENT #2 - 5 CAPS HAVE SEVERAL AREAS OF CRACKS, DELAMINATIONS & SPALLS WITH EXPOSED REBAR.

PHOTO 1    Description    Bent 2 cap back face

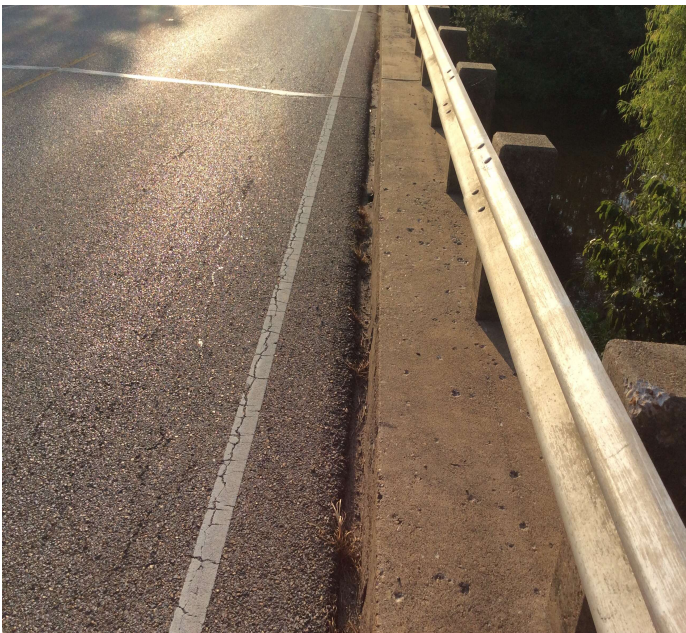
LEFT & RIGHT GUTTERS HAVE VEGETATION GROWING IN THEM.

PHOTO 1    Description    Gutters vegetation has been removed.

Sprayed since last inspection.

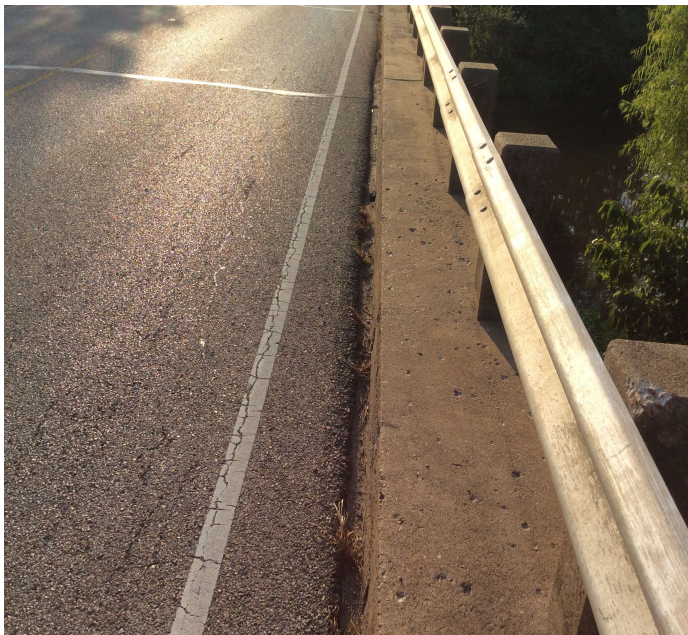
ABUTMENT #1 & 2 RIGHT & LEFT SIDES HAVE VEGETATION GROWING UNDER & BESIDE BRIDGE.

PHOTO 1      Description      Gutters vegetation has been removed.

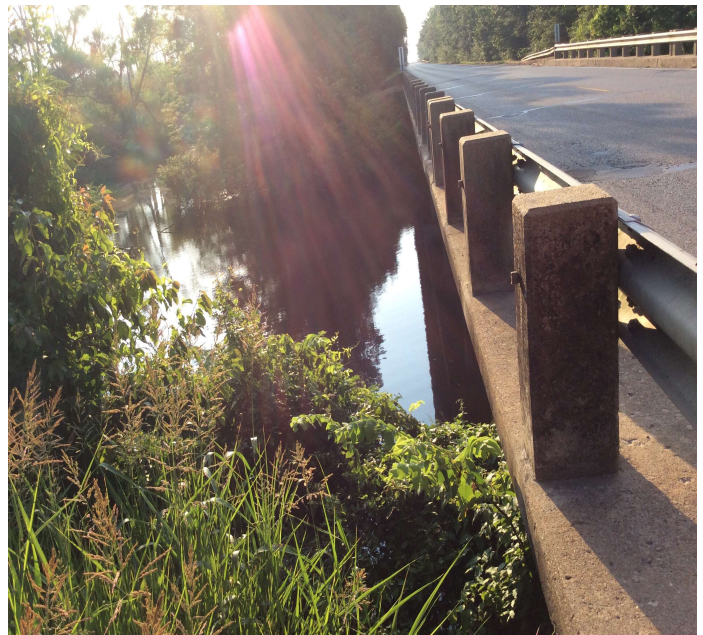
PHOTO 2      Description      Typical vegetation.

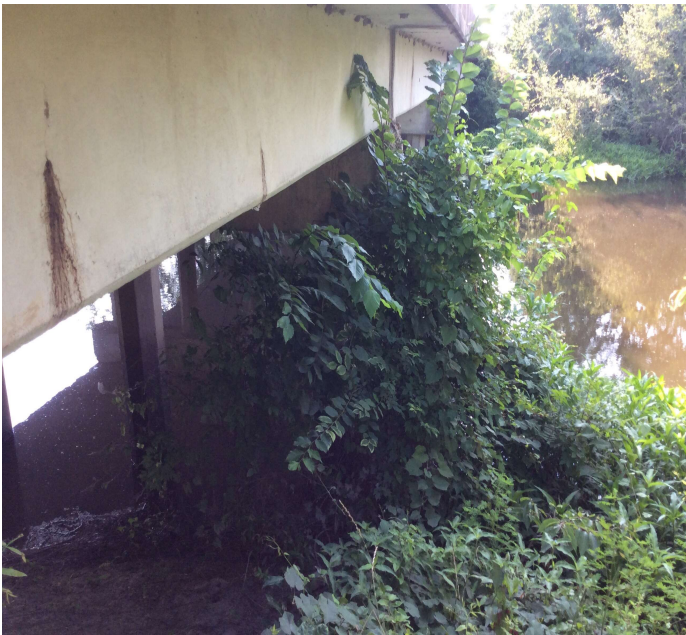
PHOTO 3      Description      Vegetation.

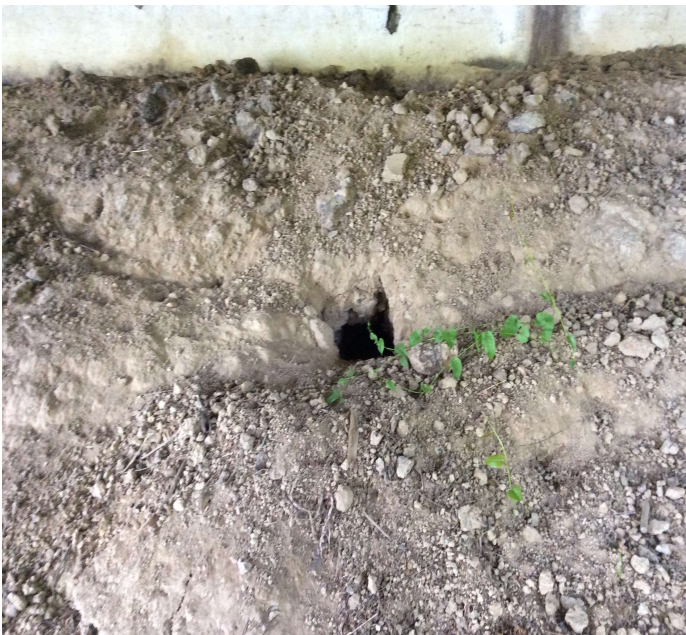
ABUTMENT #2 SLOPE HAS 5 LARGE ANIMAL HOLES.

PHOTO 1      Description      Typical animal hole.
