Bridge Inspection Report

00518

US 64/sec15/L7.61

LANGUILLE RELIEF

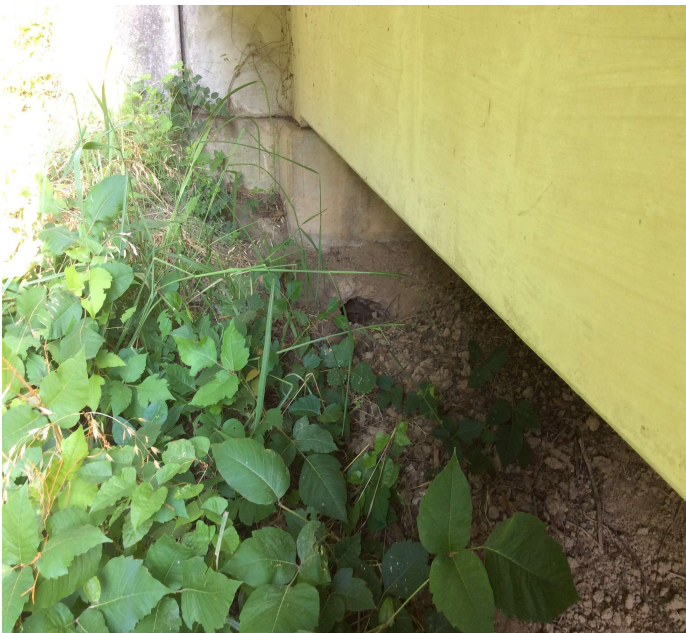
VEGETATION & LARGE TREES ARE GROWING UNDER & BESIDE BRIDGE IN SPAN #4 RIGHT SIDE.
Several animal holes under each abutment.

Each abutment has several animal holes under them.

PHOTO 1 Description Typical animal hole.

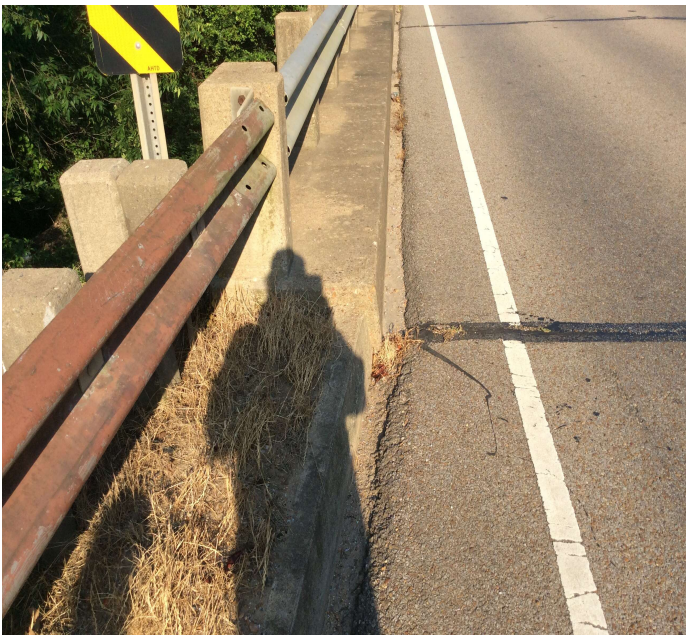
LEFT & RIGHT GUTTERS HAVE VEGETATION GROWING IN THEM.

PHOTO 1 Description Gutters have been sprayed since last inspection.

Gutters have been sprayed since last inspection.

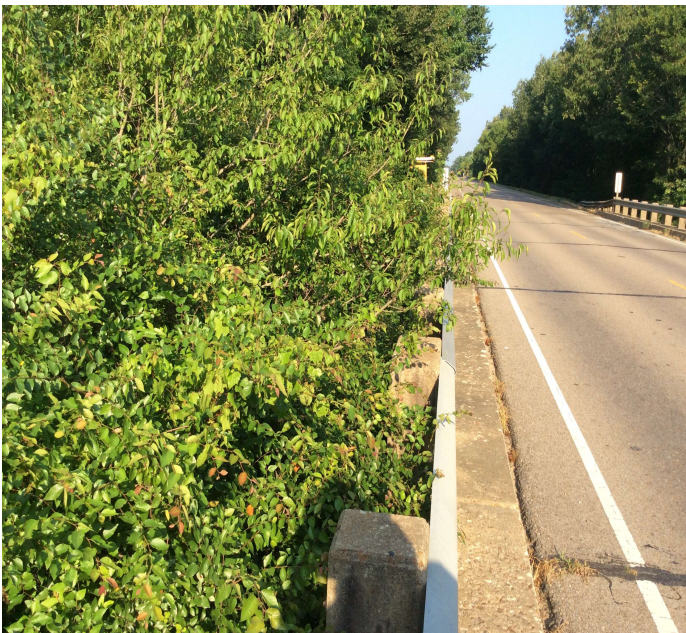
VEGETATION & LARGE TREES ARE GROWING UNDER & BESIDE BRIDGE IN SPAN #4 RIGHT SIDE.

PHOTO 1 Description Vegetation.
