Bridge Inspection Report

00519

US 64/sec15/L7.76

LANGUILLE RIVER

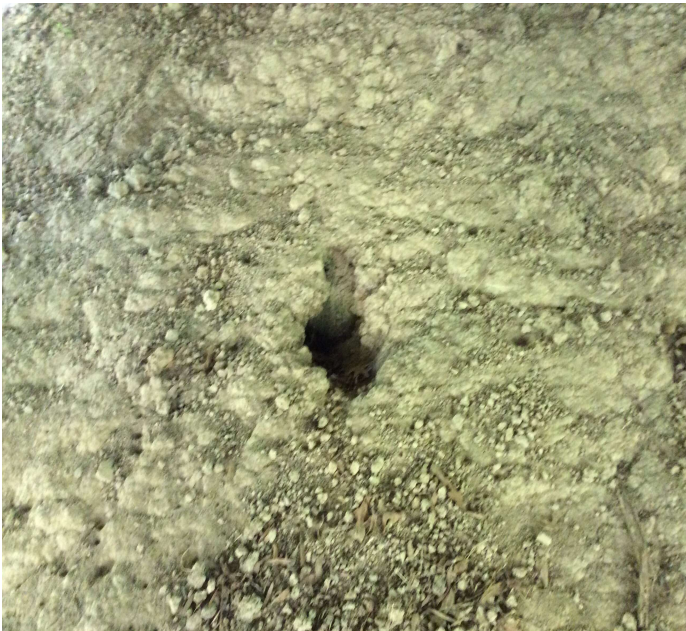
Abutment slopes have several animal holes.

PHOTO 1 Description Typical animal hole.

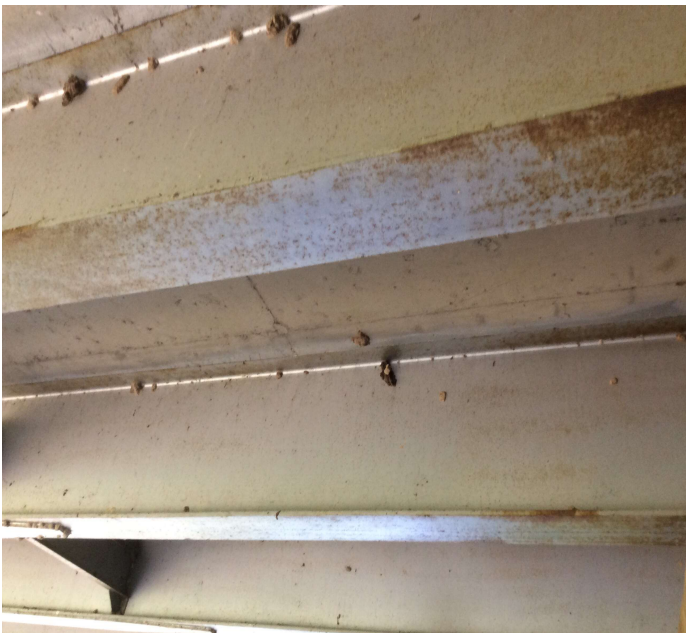
SPAN #3 STEEL GIRDERS HAVE FRECKLED RUST FORMING WITH SOME LIGHT PITTING.

PHOTO 1 Description Typical girder.

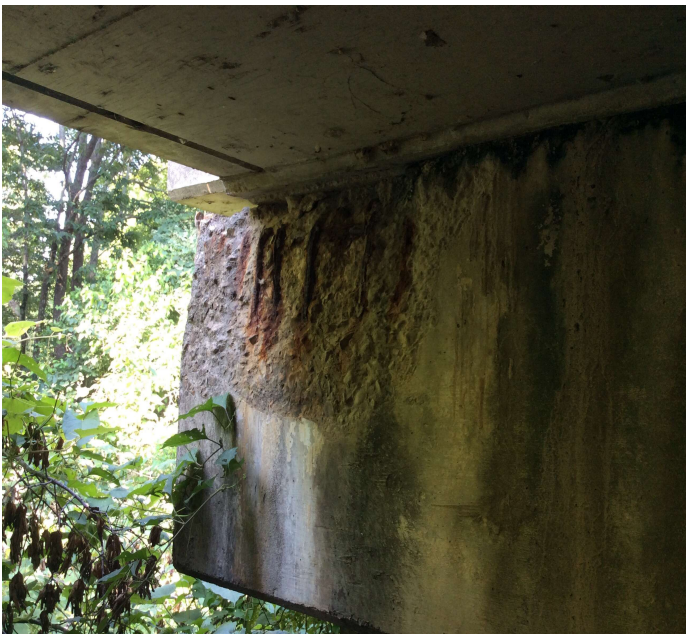
RIGHT END OF BENT #4 CAP ON SPAN #4 SIDE HAS A 2'X2' X3" DEEP SHELLLED OFF AREA WITH EXPOSED REBAR.

BOTTOM OF BENT #4 CAP AROUND PILE #4 HAS 2 SMALL (8"X8") SHELLLED OFF AREAS WITH MINOR SECTION LOSS TO REBAR.

PHOTO 1 Description Bent 4 cap.
