# Bridge Inspection Report

**00520**

**US 64/sec15/L10.79**

**GREGORY DITCH**

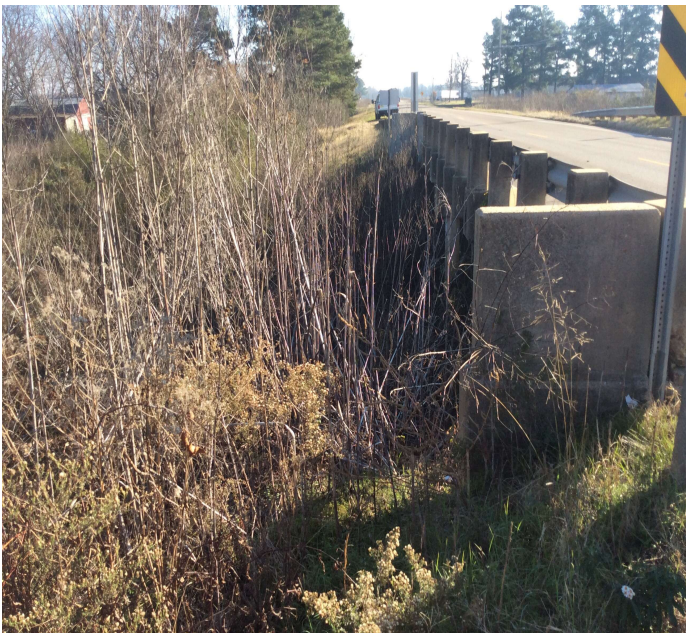
Vegetation is beside bridge and under bridge.

PHOTO 1    Description    Vegetation beside bridge.

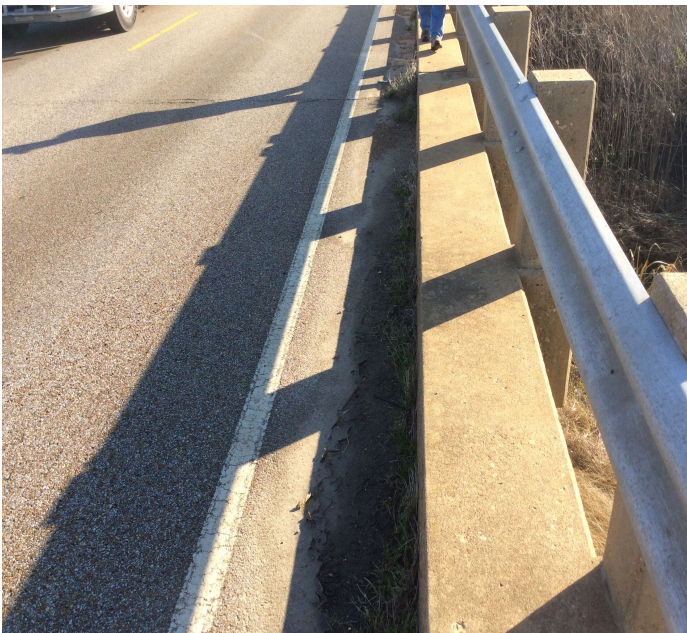
Vegetation is growing in gutters.

PHOTO 1    Description    Vegetation is growing in gutters.

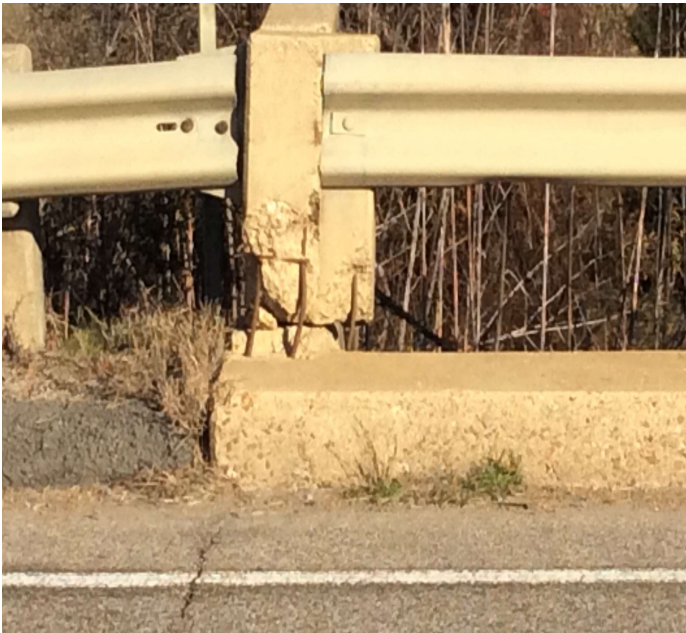
ABUTMENT #1 LEFT SIDE FIRST POST IS BROKEN AT BASE WITH EXPOSED REBAR.

PHOTO 1      Description      Abutment 1 left first post

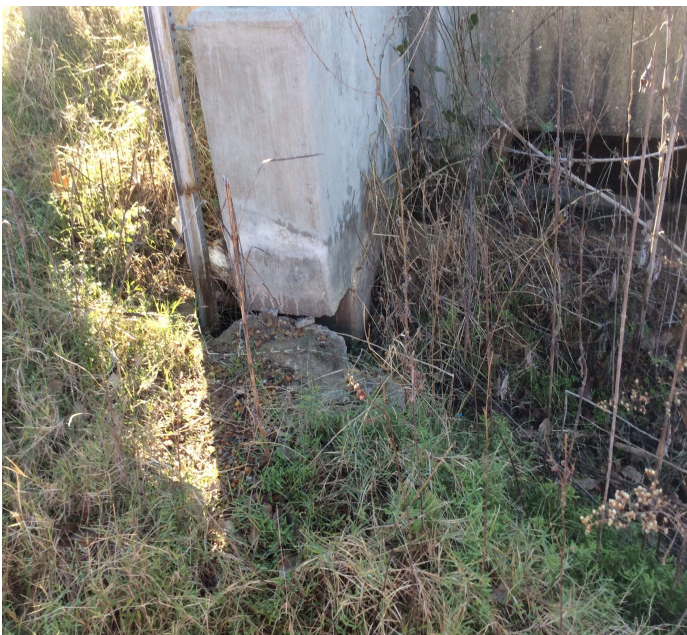
ABUTMENT #2 LEFT SIDE SLOPE IS ERODED AROUND MONUMENT POST WITH DEPTHS UP TO 1' EXTENDING DOWN SLOPE.

PHOTO 1      Description      Abutment 2 left monument post erosion.
