# Bridge Inspection Report

00521

US 64/sec15/L11.31

CANEY CREEK

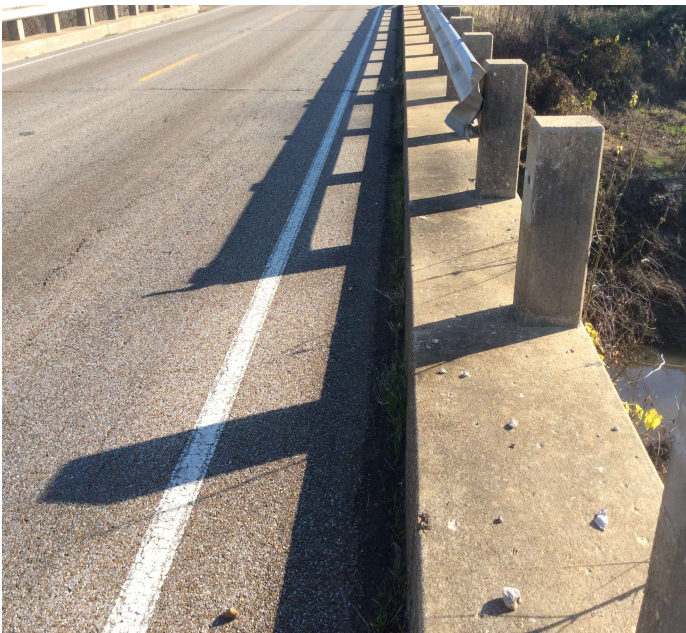
Priority: D - Routine

Vegetation is growing in gutters.

PHOTO 1    Description    Vegetation is growing in gutters.
