Bridge Inspection Report

02124
US 64/sec16/L8.52
over
MAGGOT SLOUGH

Structure Number: 02124

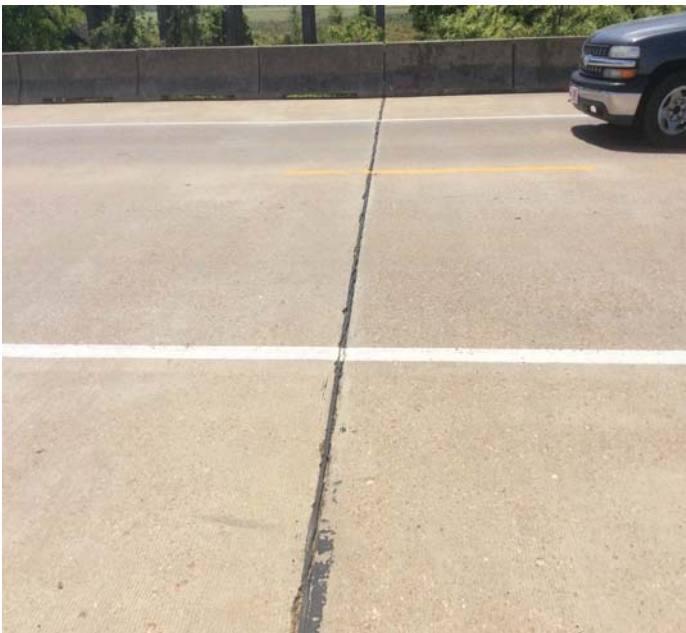
Joint material is cracked allowing non compressible to enter.

PHOTO 1 Description Typical joint.

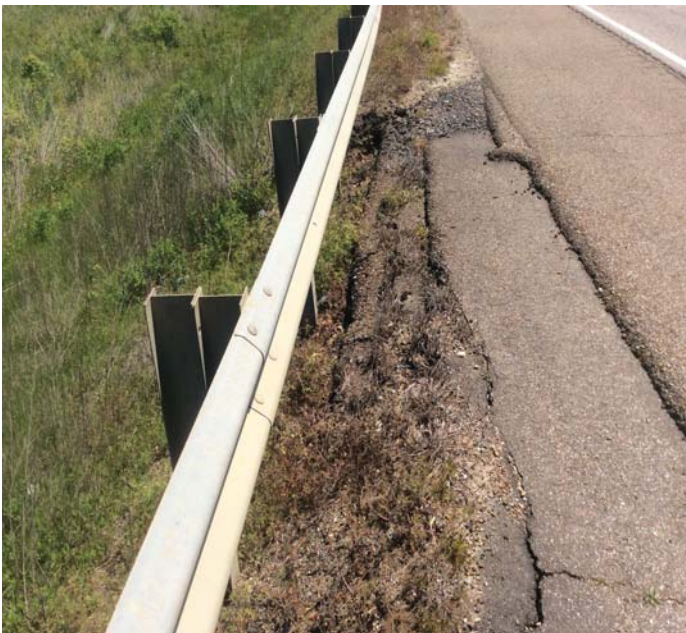
Abutment 2 left side 40' from bridge end approach shoulder and rail is being undermined for 20'.

PHOTO 1 Description Abutment 2 left side 40' from bridge end approach shoulder and rail is being undermined for 20'.

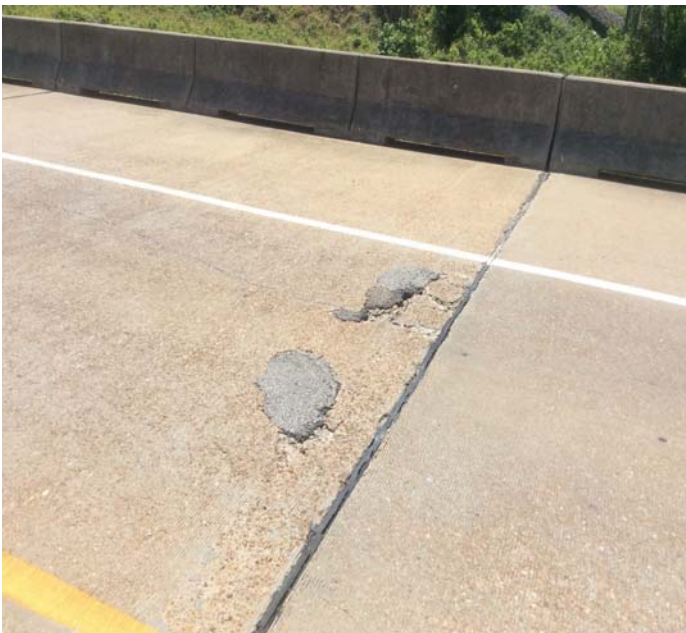
DECK HAS 2 1' SPALLS WITH NO EXPOSED REBAR AT BENT #5 IN THE RIGHT LANE WITH PATCHES FAILING.

PHOTO 1 Description Spalls at bent 5.

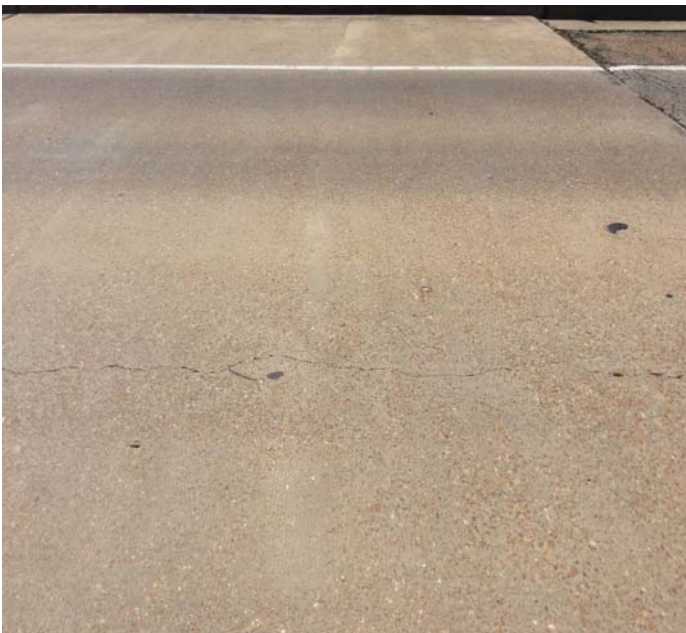
DECK ALL SPANS HAVE 2 OPEN LONGITUDINAL CRACKS IN DECK NEAR CENTER LINE.

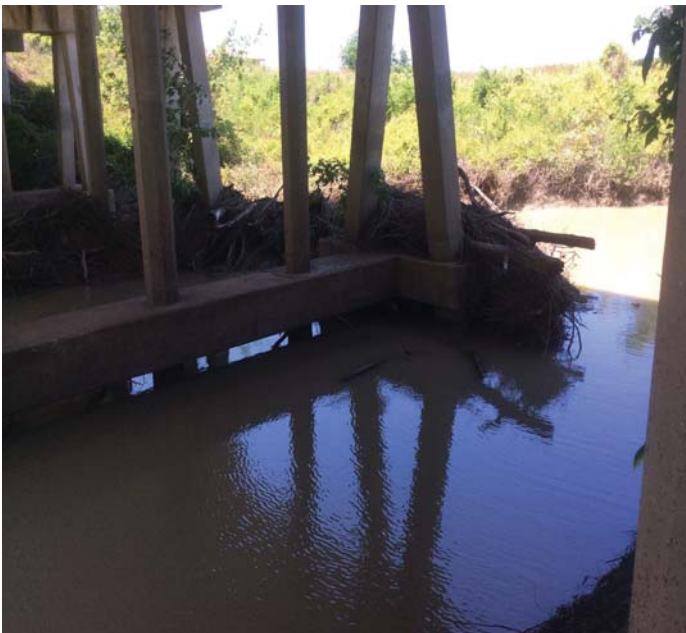
LARGE DRIFT ACROSS CHANNEL AT BENT #4,5 AND 6 LEFT SIDE.

PHOTO 1 Description Drift left side of bridge.

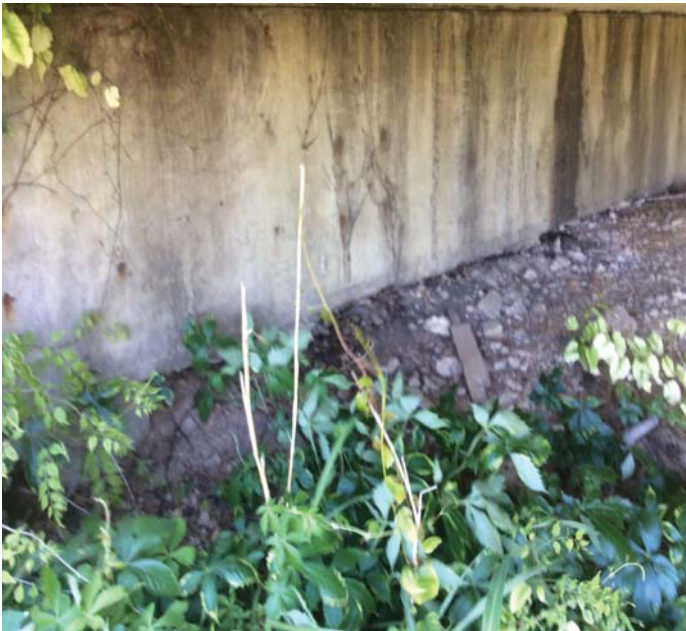
ABUTMENT #2 CAP IS UNDERMINED 6" - 1' FULL LENGTH EXPOSING PILE #1 AND 6.

PHOTO 1 Description Abutment 2 cap undermined.

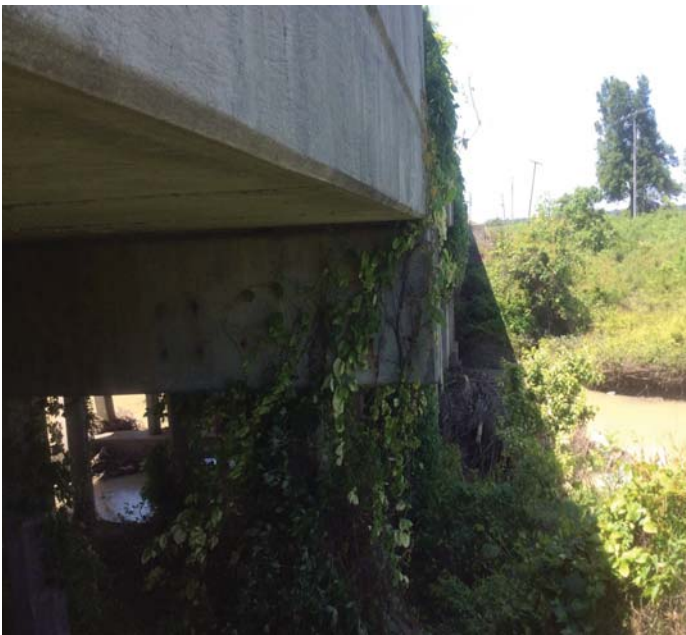
VEGETATION IS GROWING ON BENT #6 AND 7 COLUMNS.

PHOTO 1 Description Vegetation growing onto bents.
