Bridge Inspection Report

03819
US 64
over
BAYOU DEVIEU RELIEF

Structure Number: 03819

Facility Carried: US 64

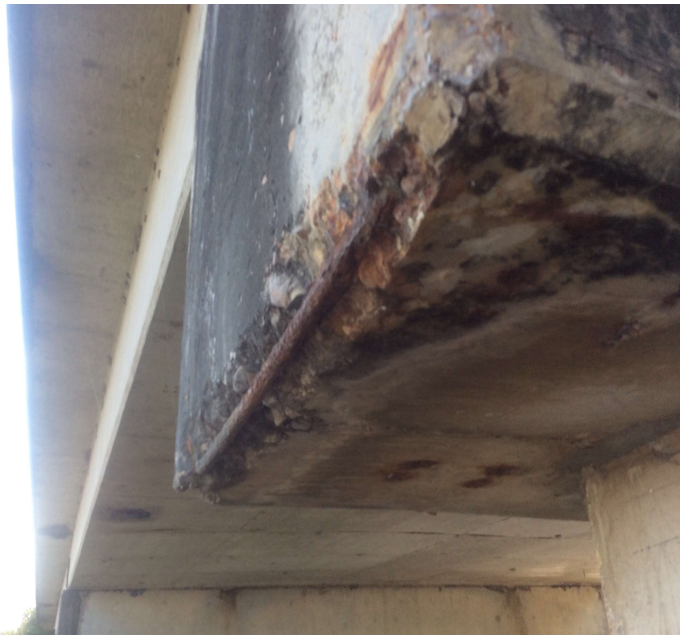
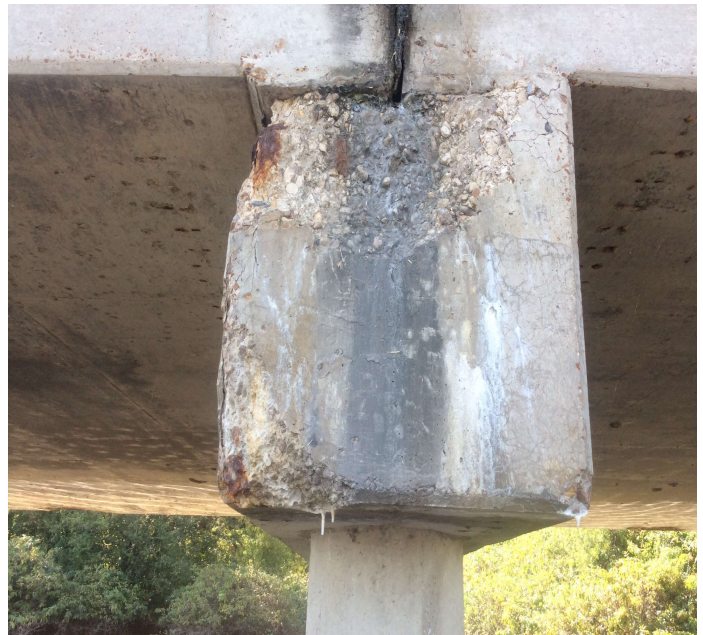
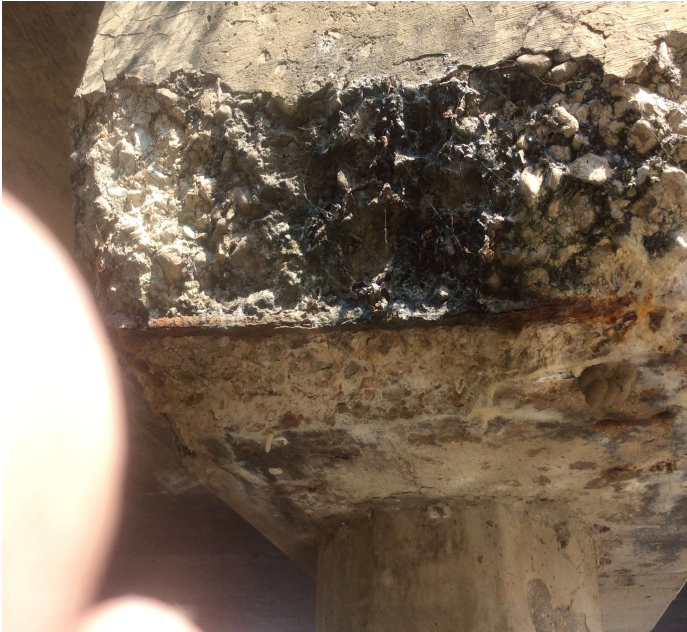
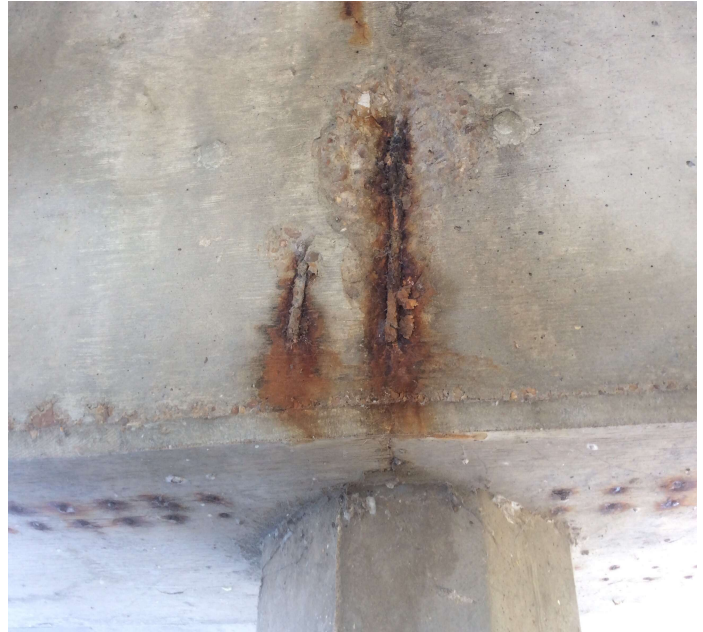
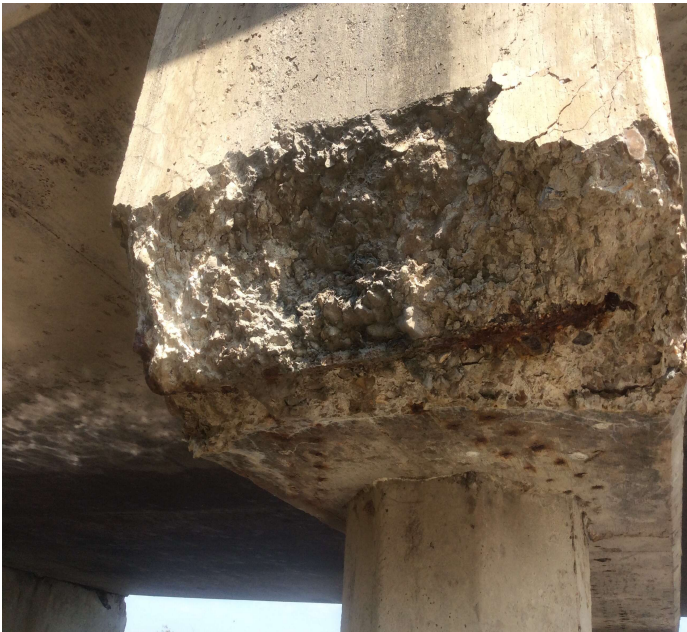
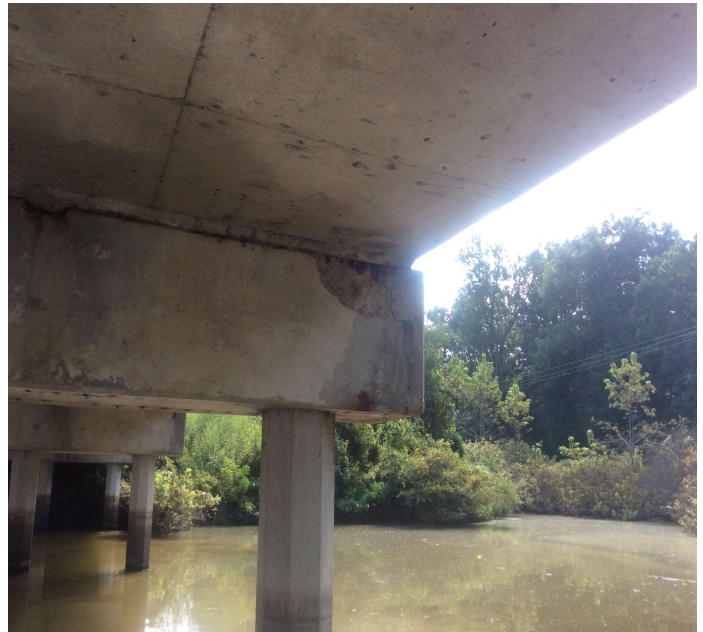
CAPS

BENTS # 2,4,6,7,8,9,10,11

SPALLS TO FACE OF CAPS WITH EXPOSED REBAR

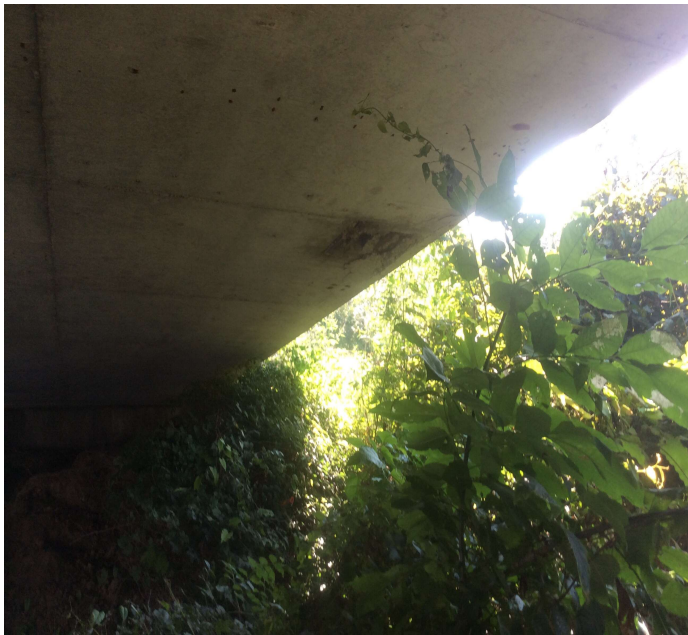
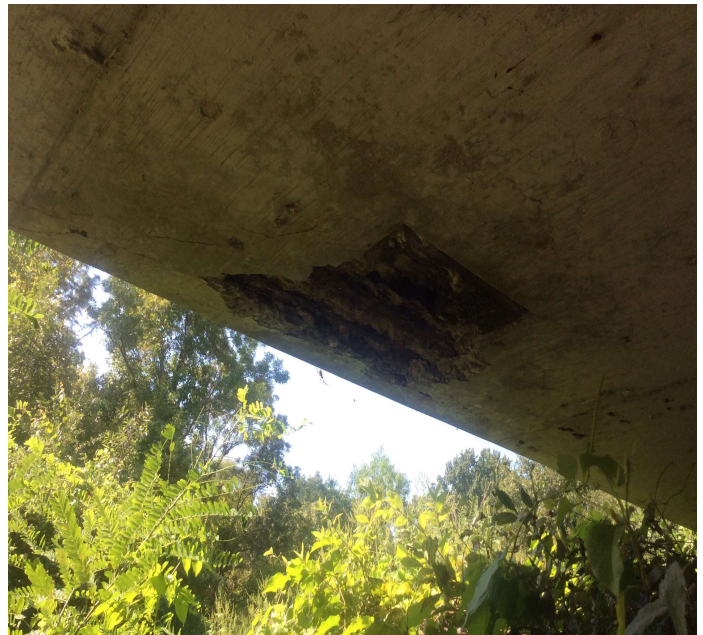
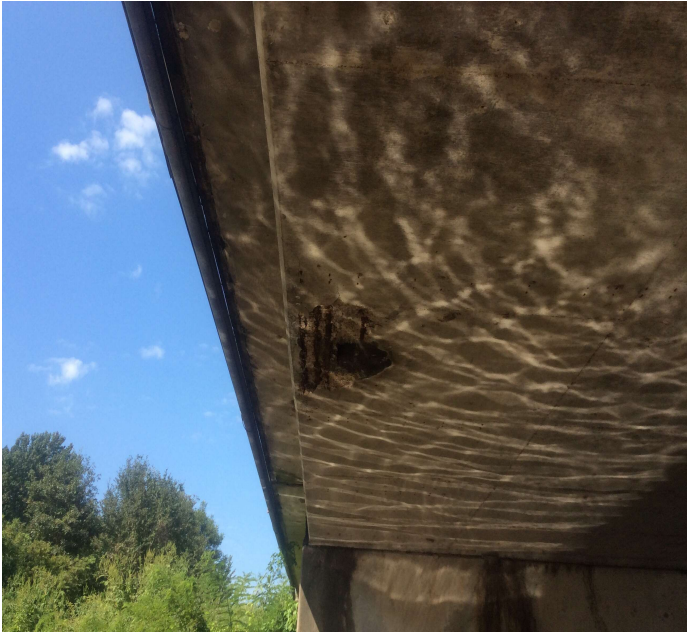
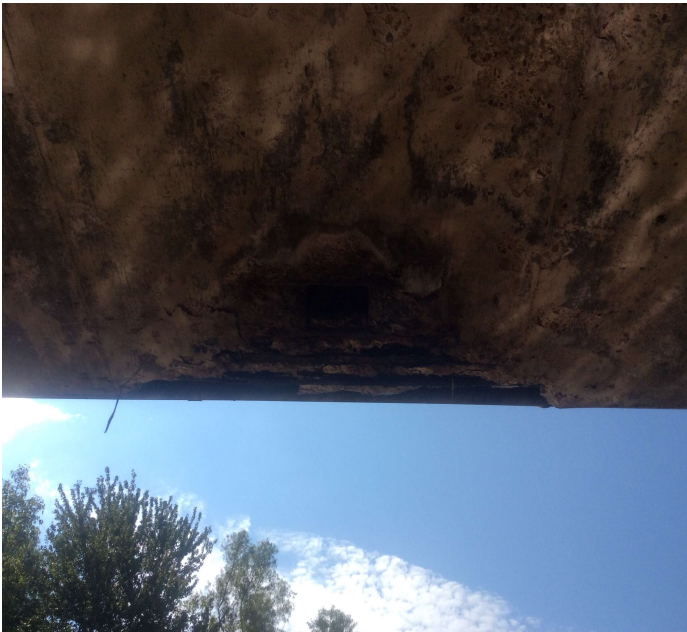
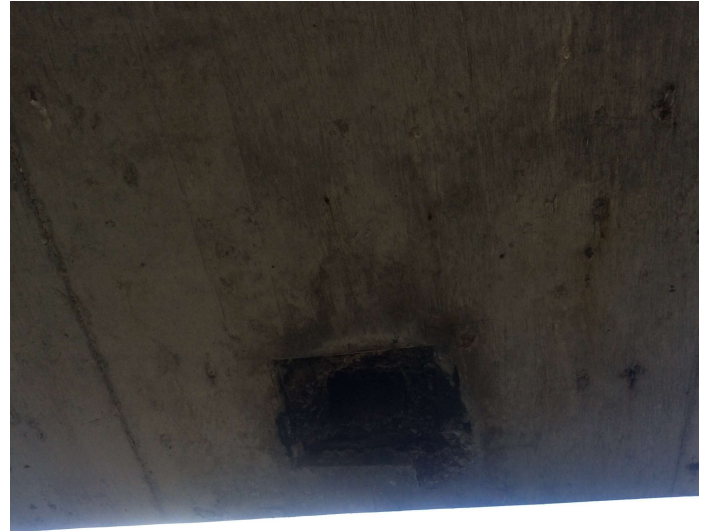
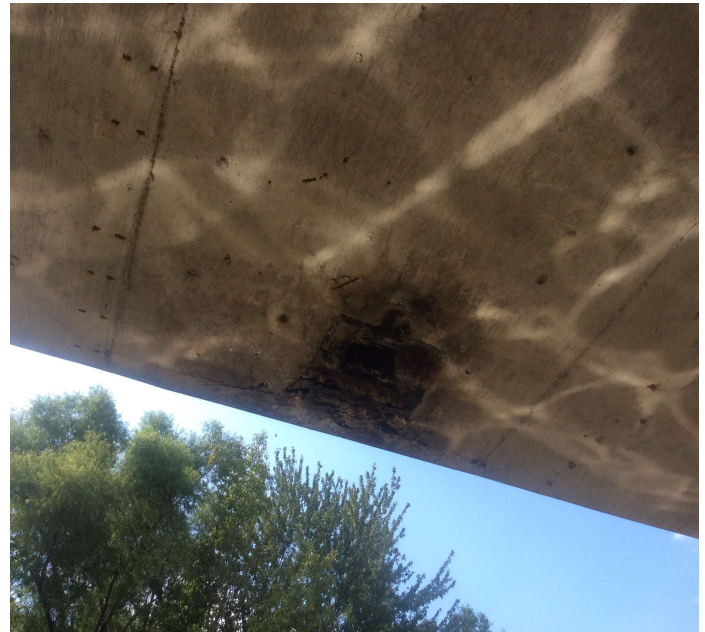
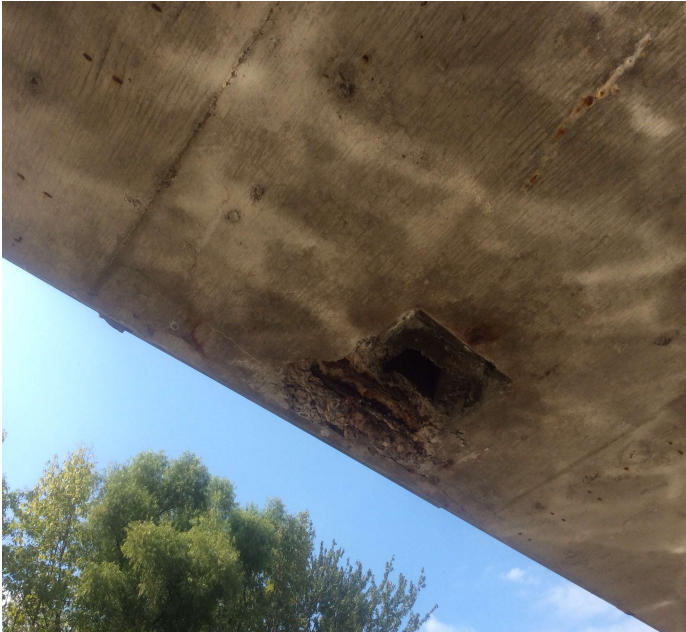
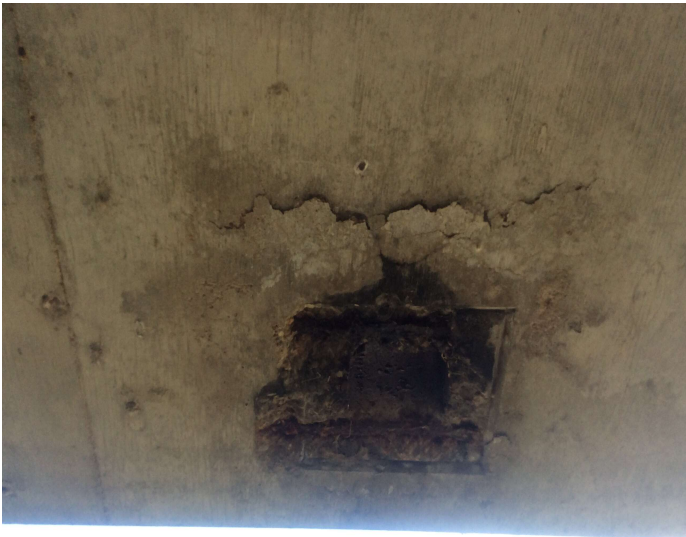
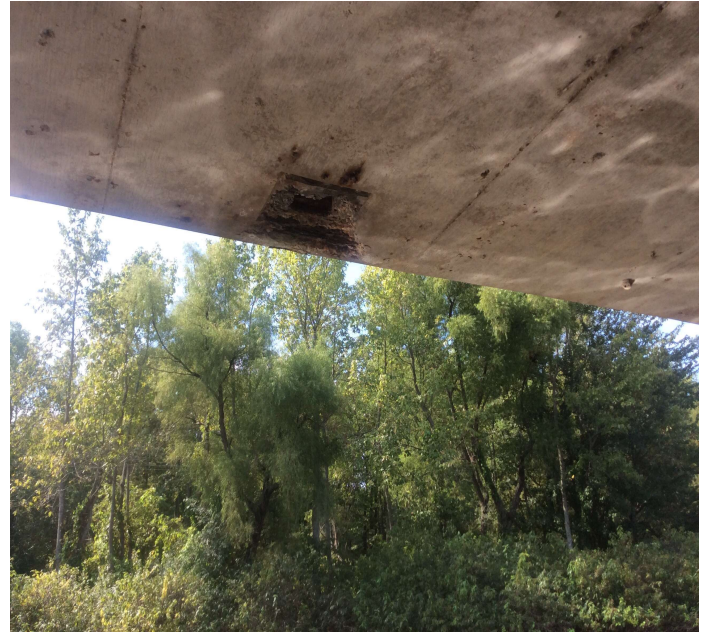
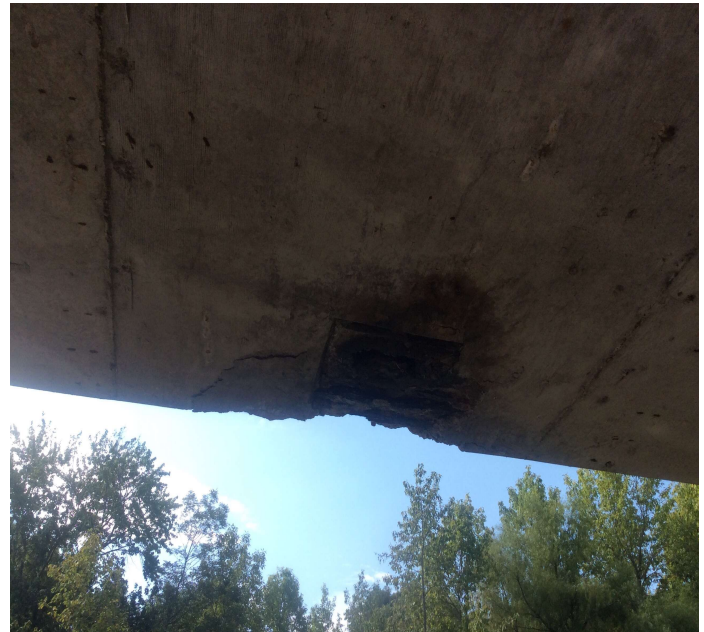
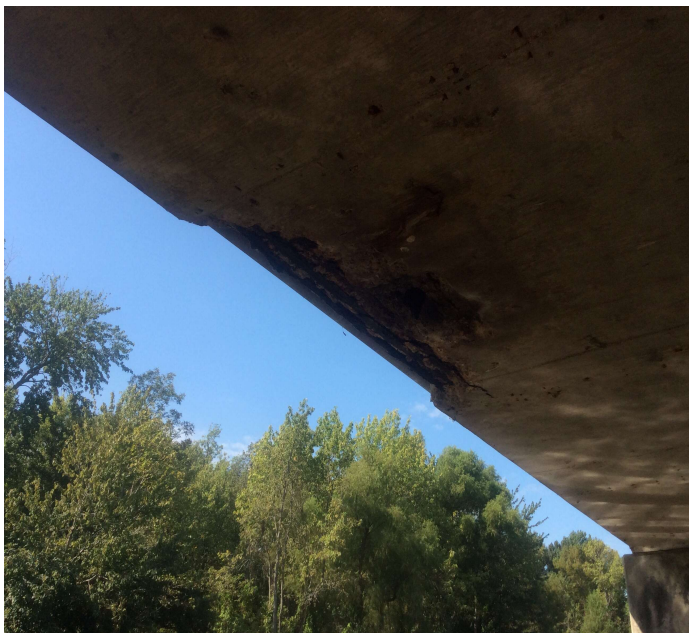
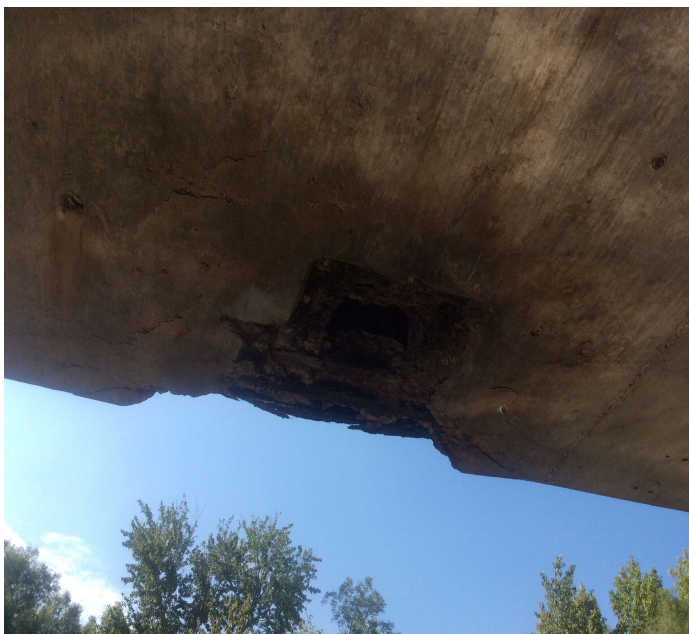
Deficiency Description:
SOFFIT

ALL SPANS

AREA AROUND DRAINS HAVE SPALLED WITH EXPOSED REBAR

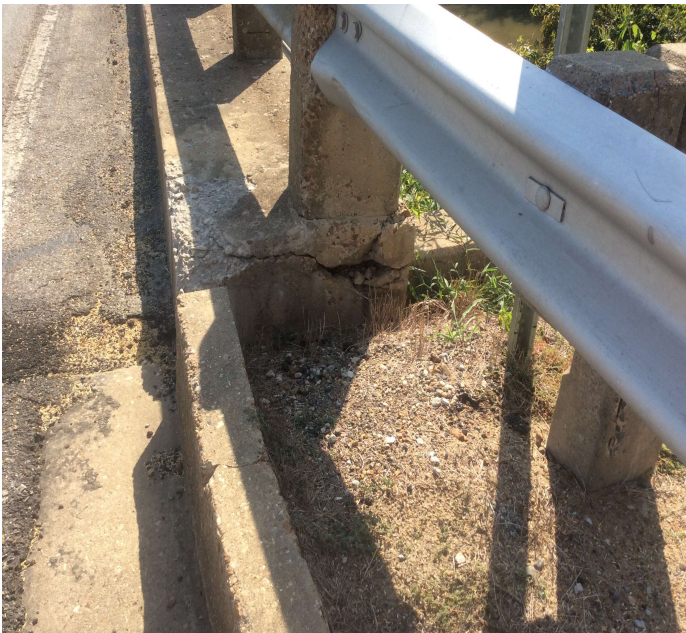
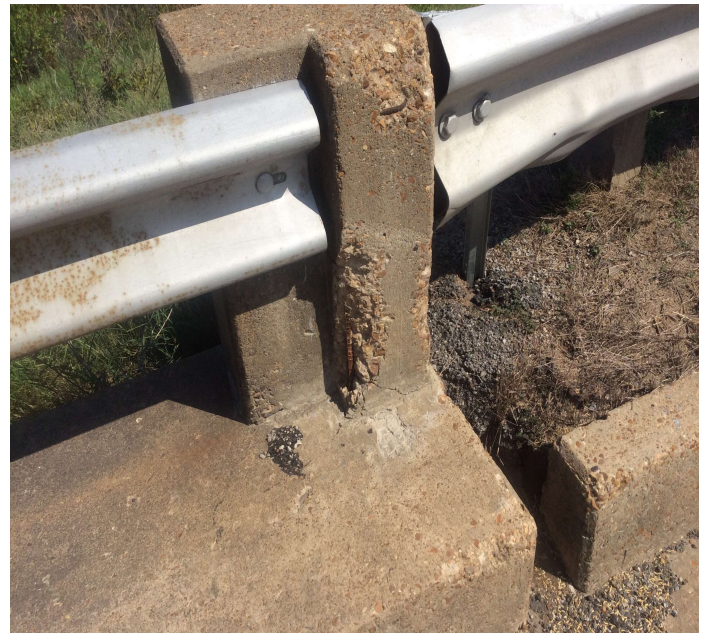
END POSTS

ABUTMENT #1 RIGHT ABUTMENT #2 LEFT

POSTS BROKEN AT BASE

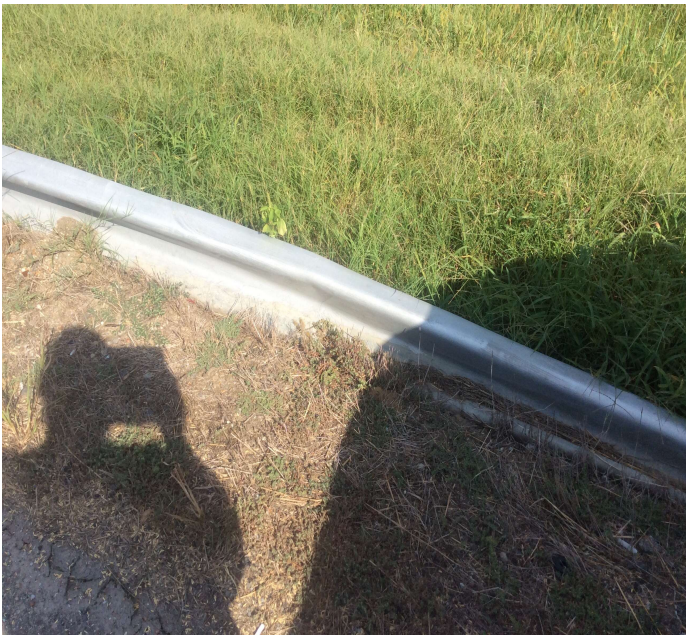
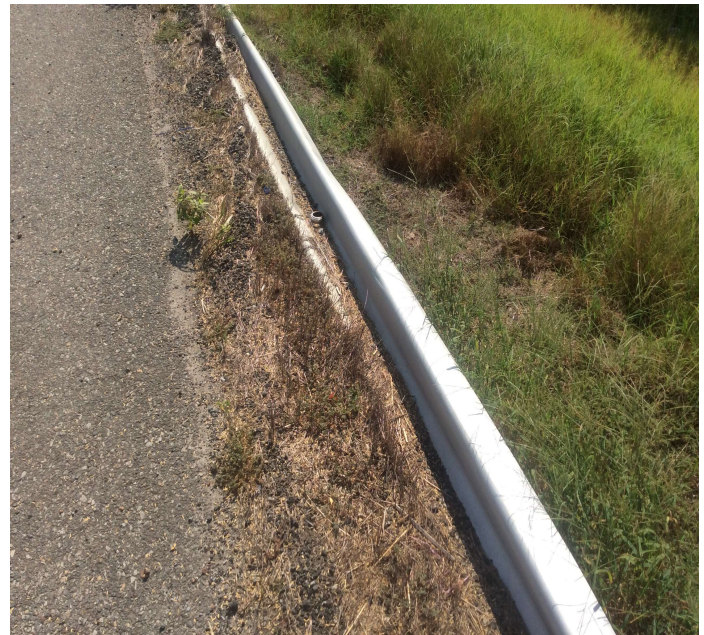
APPROACH RAIL

ABUTMENT #2 BOTH SIDES

BOTH TURN DOWNS DAMAGED BY COLLISION

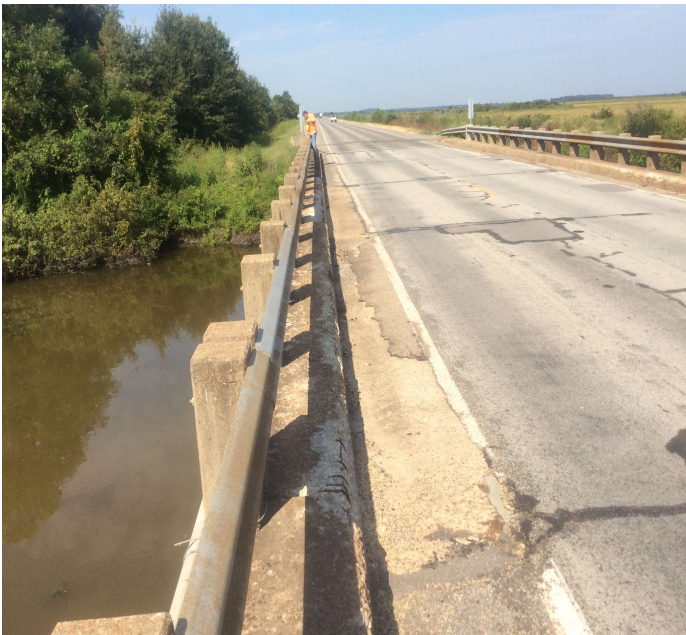
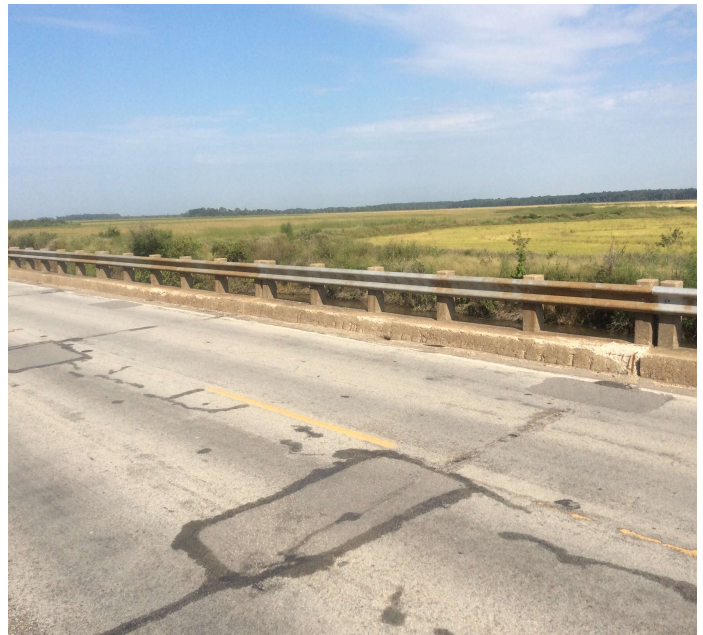
CURB

SPANS #3 AND #4 RIGHT SIDE

CURBS HEAVILY SCALED WITH EXPOSED REBAR.
