Bridge Inspection Report

03819
US 64
over
BAYOU DEVIEW RELIEF

Structure Number: 03819

Facility Carried: US 64

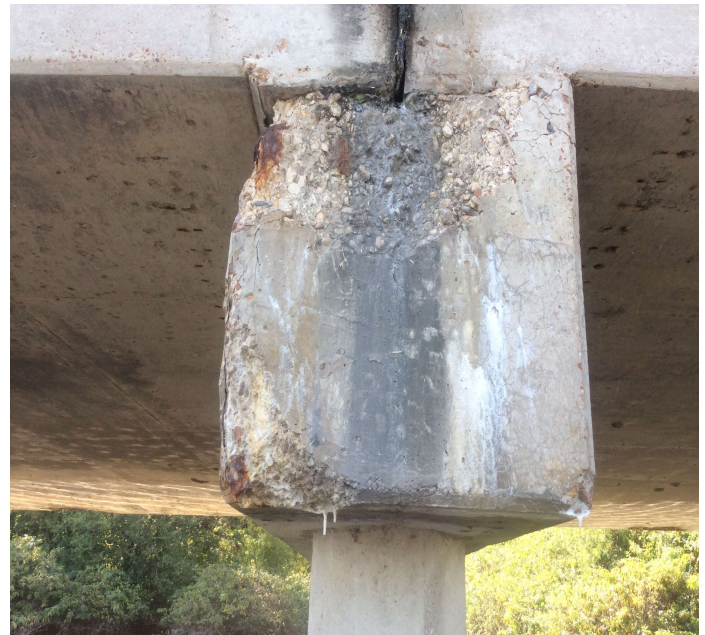
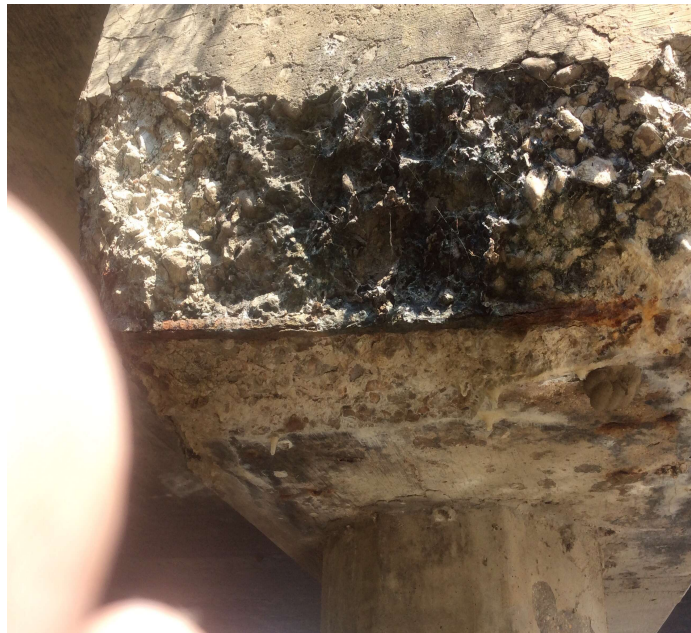
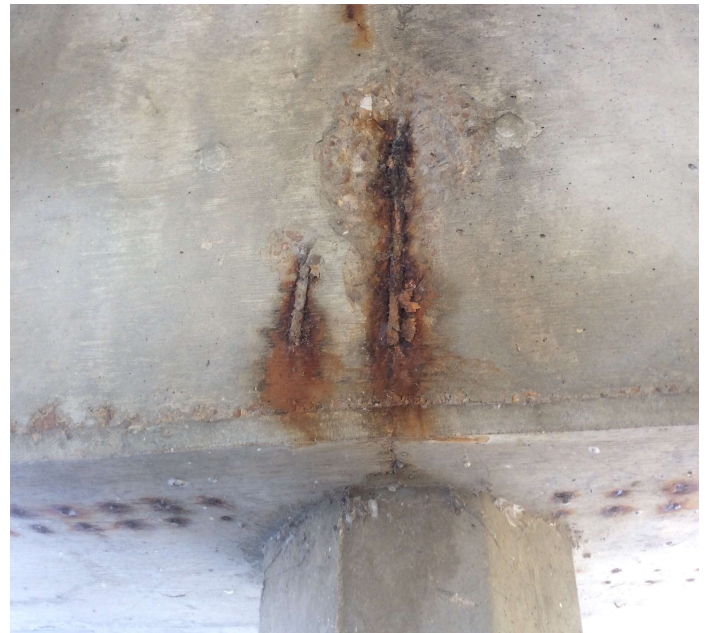
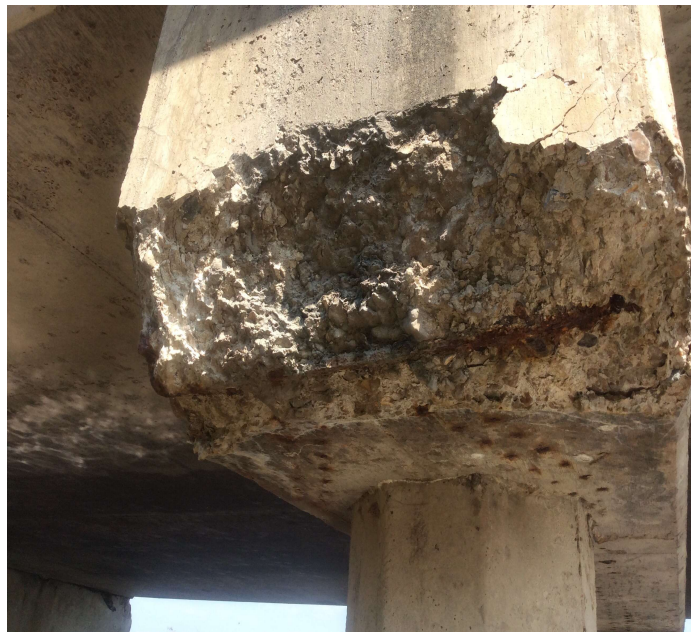
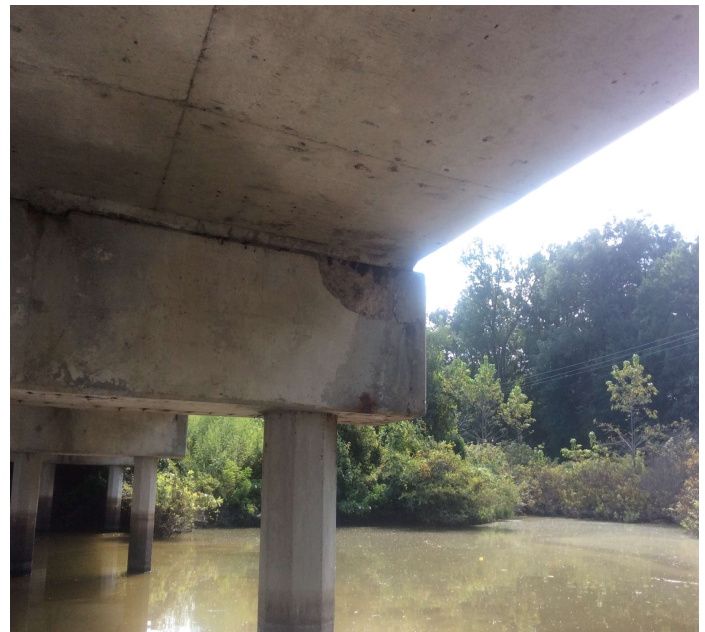
BENTS # 2,4,6,7,8,9,10,11

CAPS

SPALLS TO FACE OF CAPS WITH EXPOSED REBAR

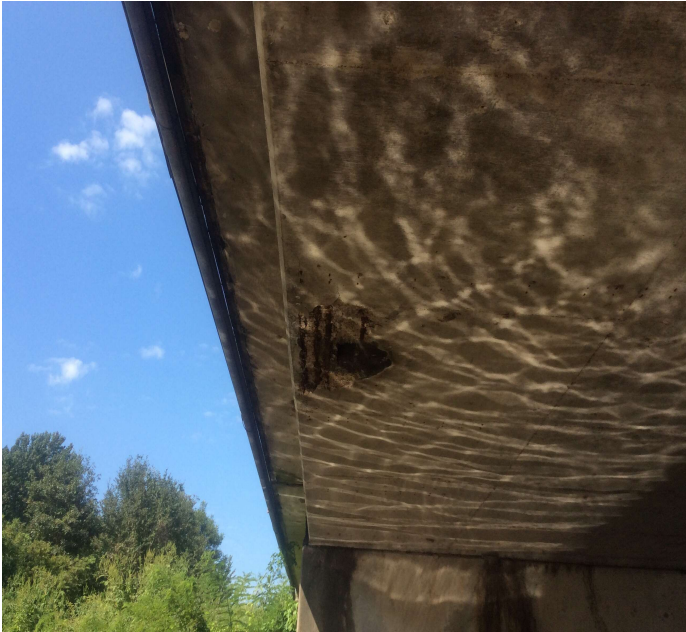
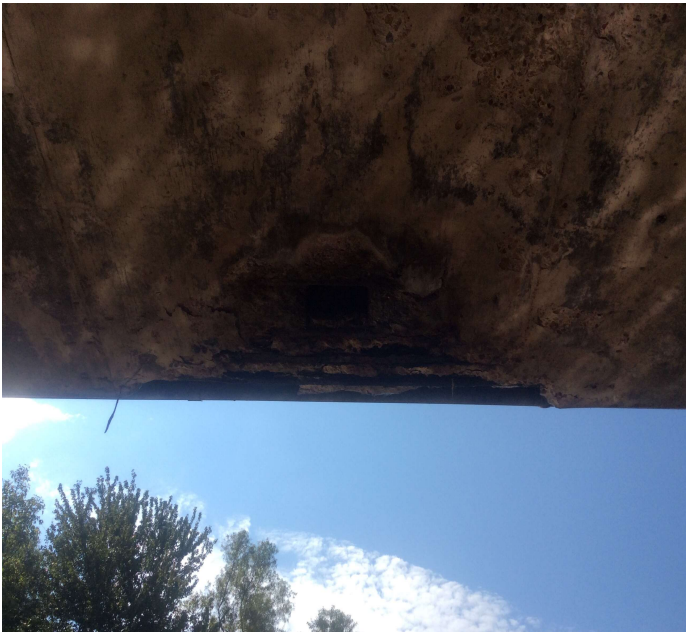
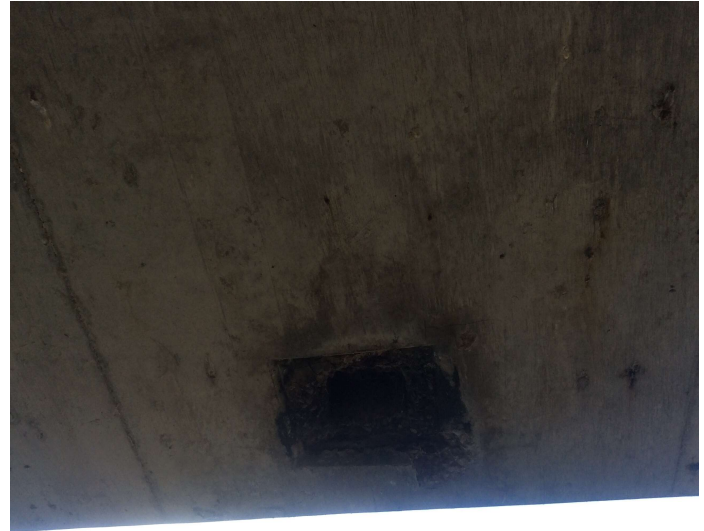
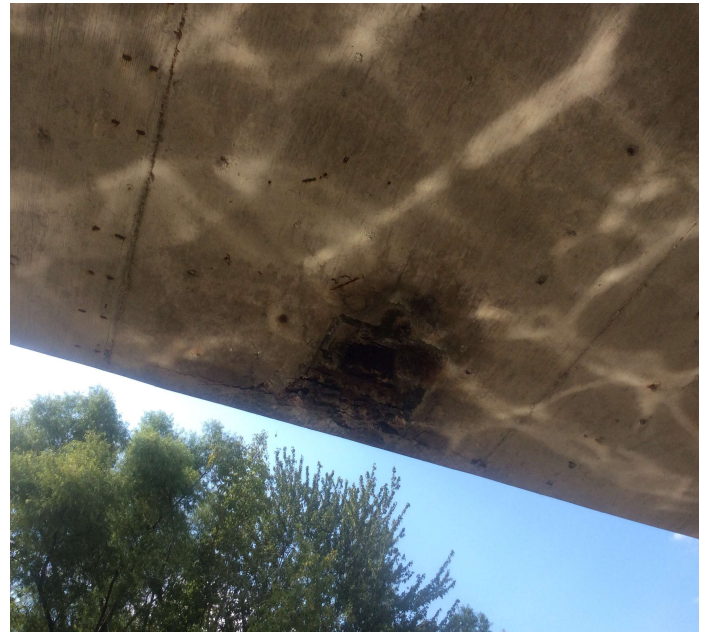
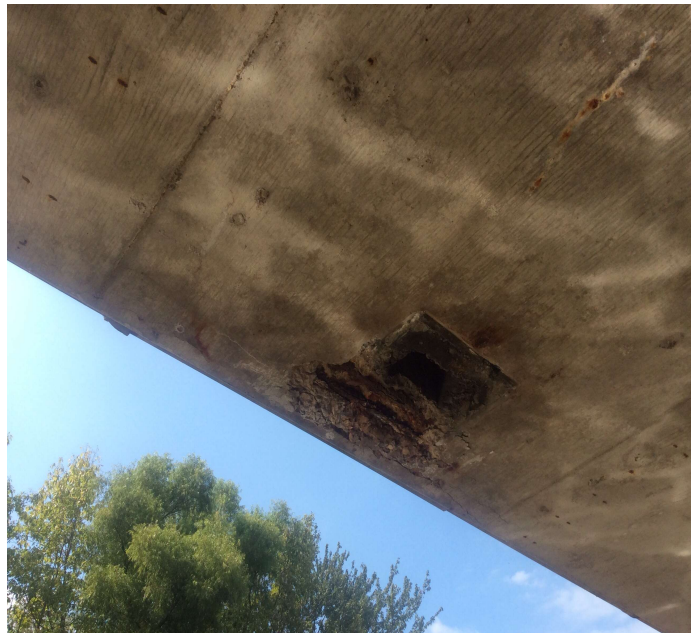
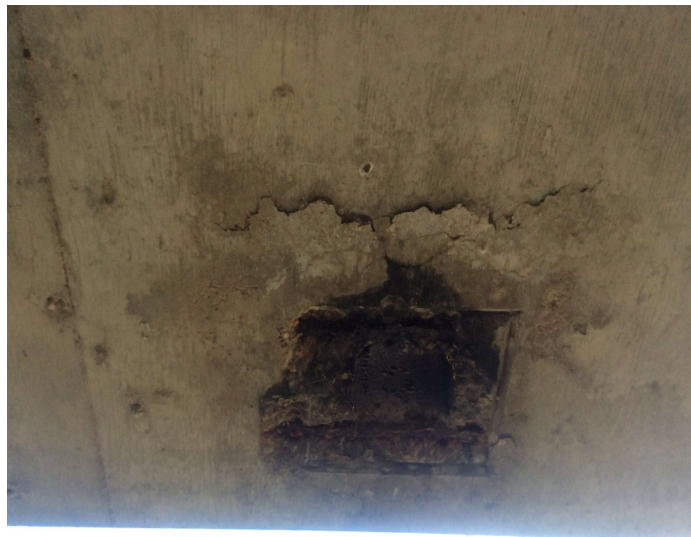
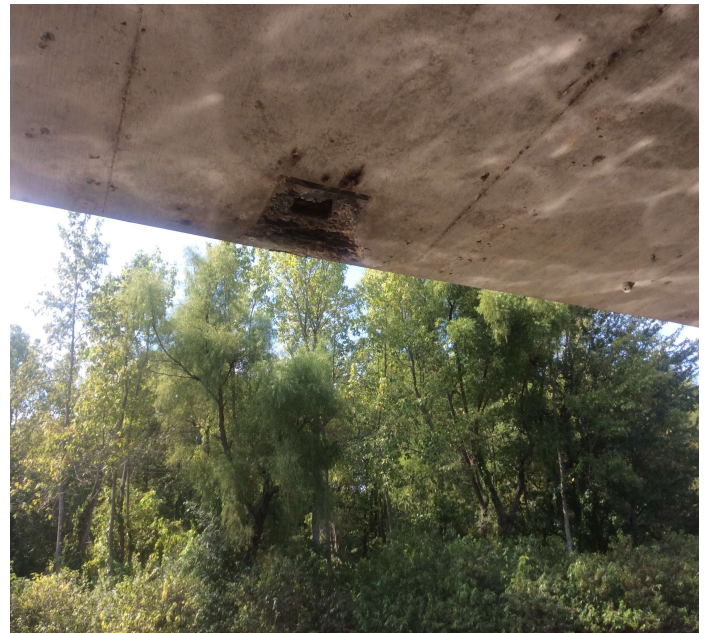
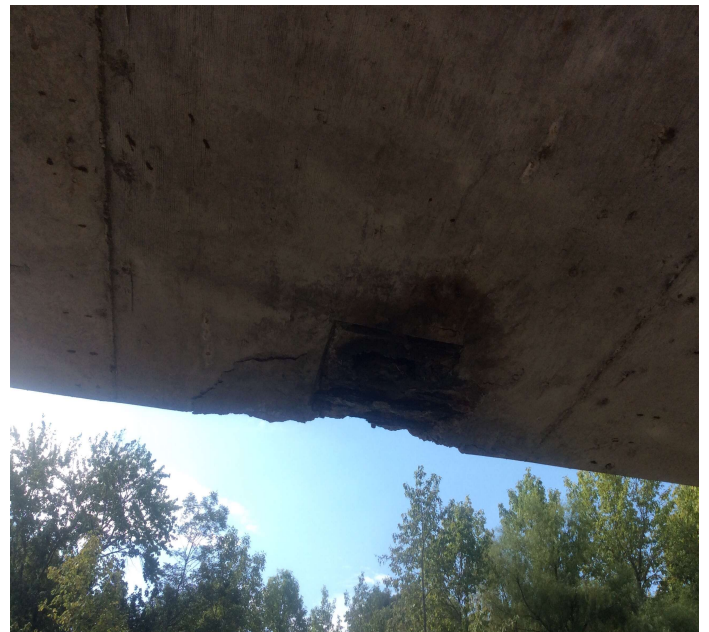
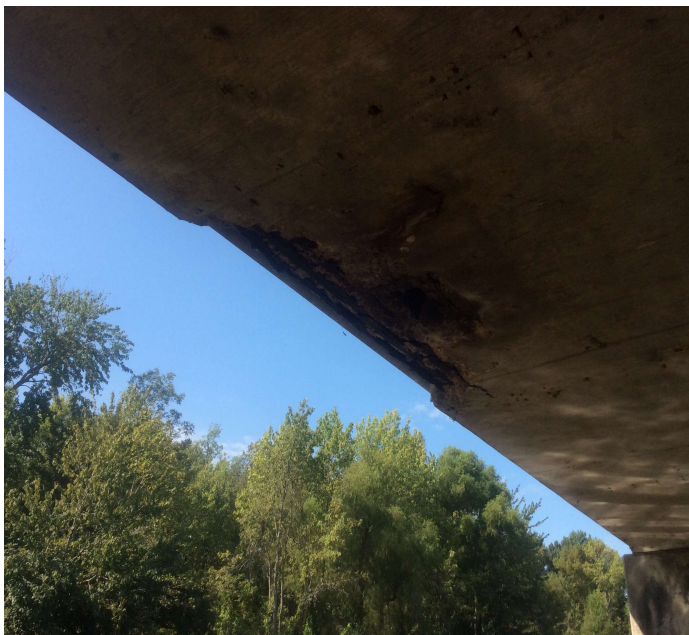
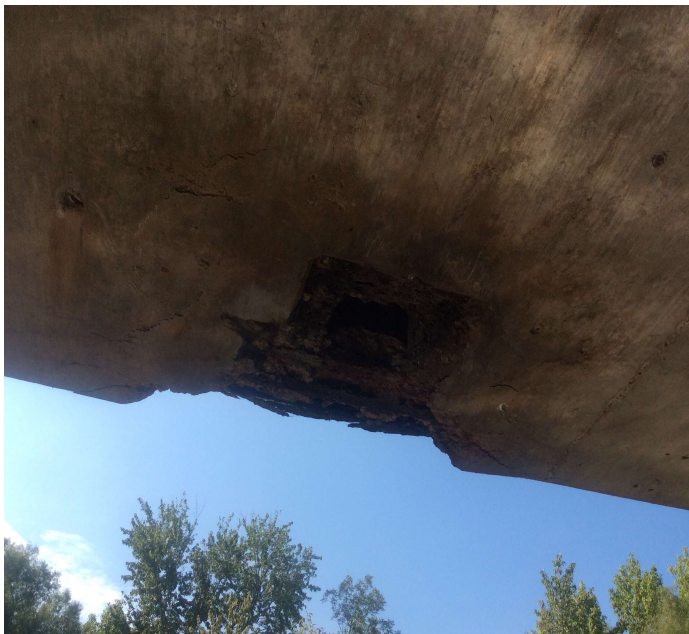
ALL SPANS

Deficiency Description:
SOFFIT

AREA AROUND DRAINS HAVE SPALLED WITH EXPOSED REBAR

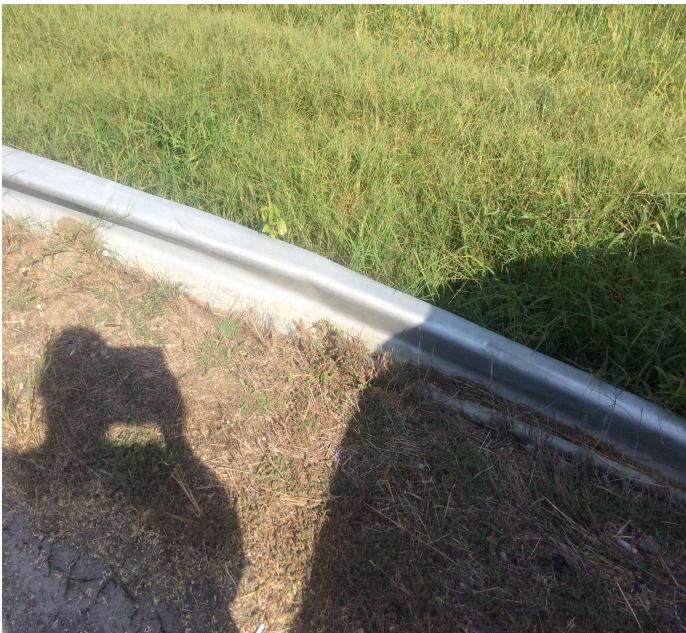
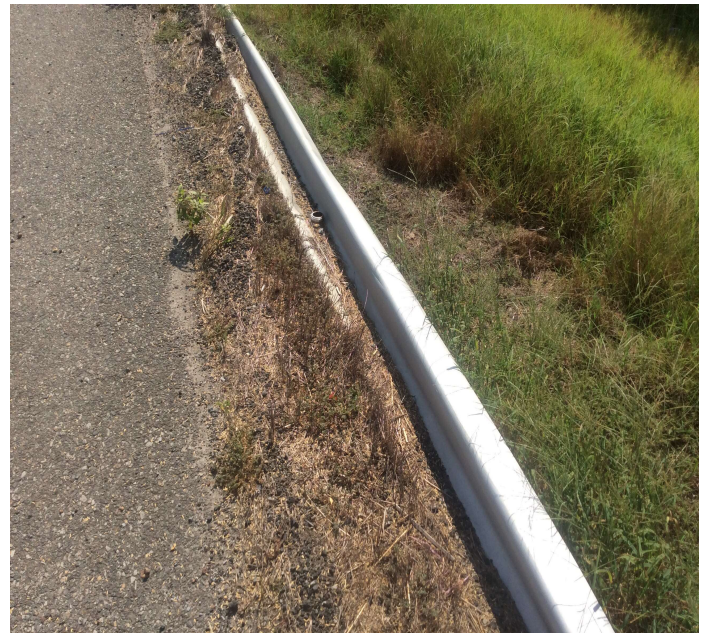
ABUTMENT #2 BOTH SIDES

APPROACH RAIL

BOTH TURN DOWNS DAMAGED BY COLLISION
