Bridge Inspection Report

03821
US 64
over
DRAINAGE DITCH

Structure Number: 03821

Facility Carried: US 64

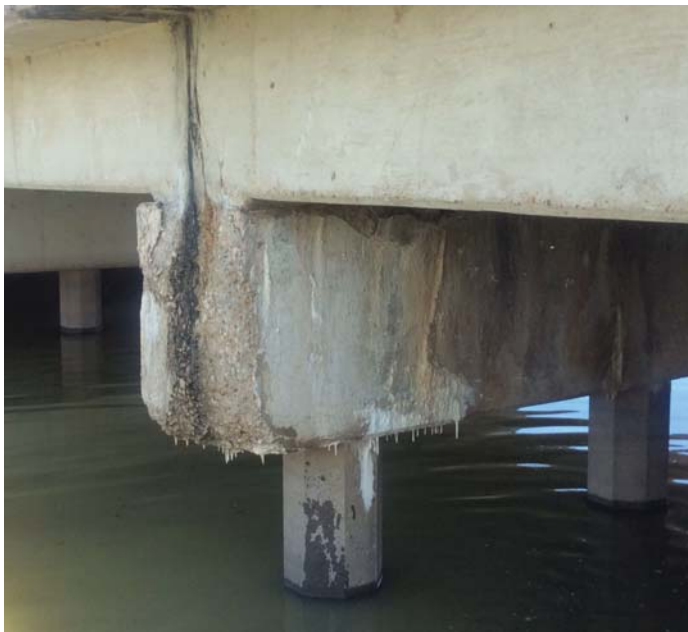
BENT #3 BOTH ENDS
ENDS OF CAP SPALLED

PHOTO 1 Description Bent#3 cap right end

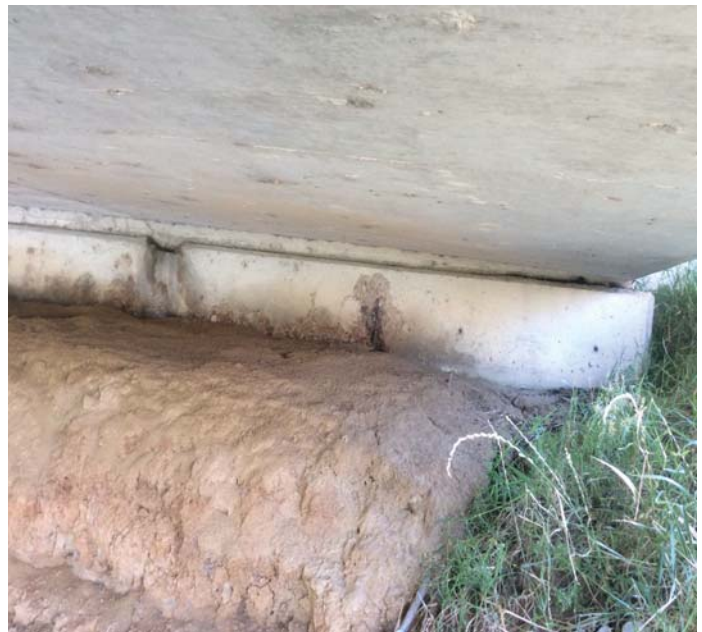
215 - Reinforced Concrete Abutment	1- Ben.	81	ft.	80	0	1	0
Abutment #2 cap has 1' spall on right end with exposed rebar due to poor coverage							
1090 - Exposed Rebar		1				1	
227 - Reinforced Concrete Pile	1- Ben.	10	each	10			
234 - Reinforced Concrete Pier Cap	1- Ben.	61	ft.	58	0	3	0
<p>Bent #3 cap sack face above pile #4 has small spall with exposed rebar.</p> <p>Both ends of bent #3 cap are spalled due to chemical exposure with exposed rebar.</p>							
1090 - Exposed Rebar		3				3	
330 - Metal Bridge Railing	1- Ben.	150	ft.	150			
515 - Steel Protective Coating		450	sq. ft.	0	0	450	0
3440 - Effectiveness (Steel Protective Coatings)		450				450

PHOTO 2 Description Abutment #2 cap right end

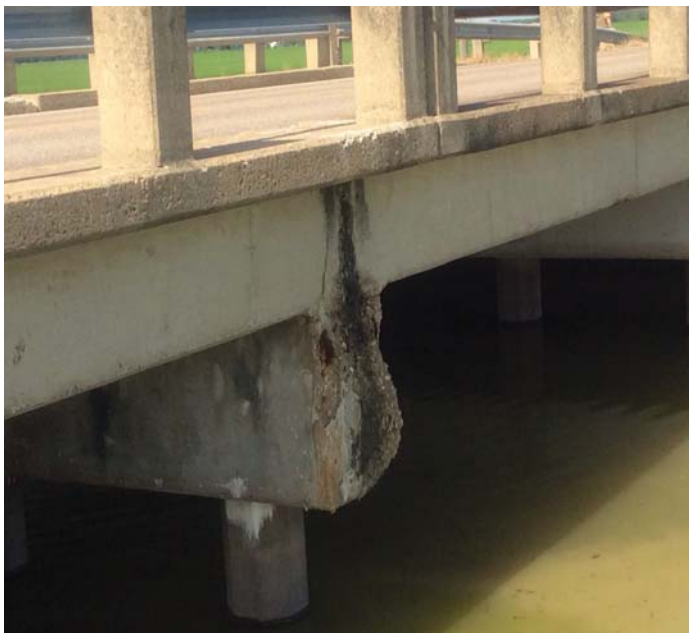
PHOTO 3	Description	Bent #3 right end of cap and side of slab.
---------	-------------	--

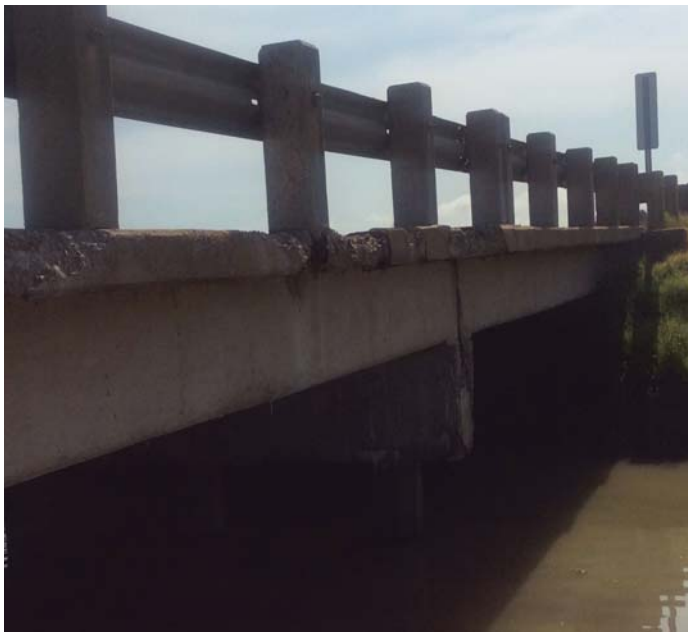
RIGHT OVERHANG AT BENT #2

SEVERAL SPALLS AND DELAMINATIONS

PHOTO 1 Description Right overhang span #2

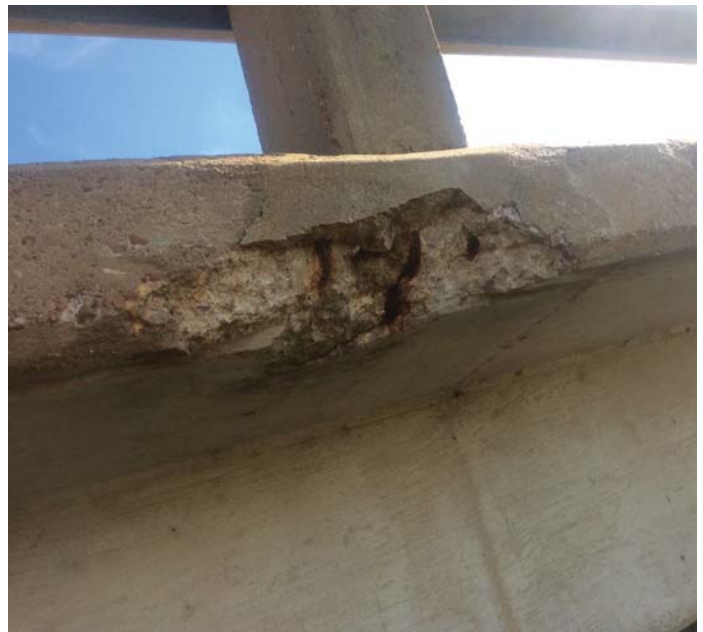
SOFFIT AT SPAN #1,2

PHOTO 2 Description Soffit of overhang right side span #1

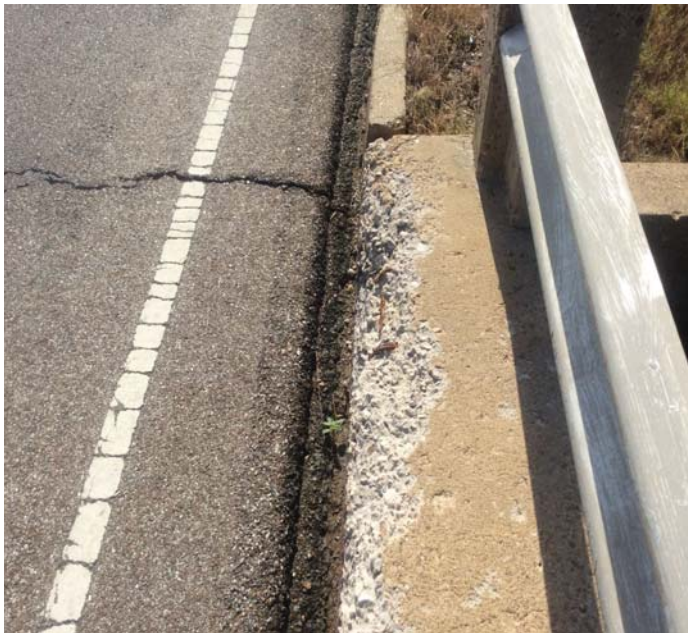
PHOTO 1 Description Right curb abutment #2

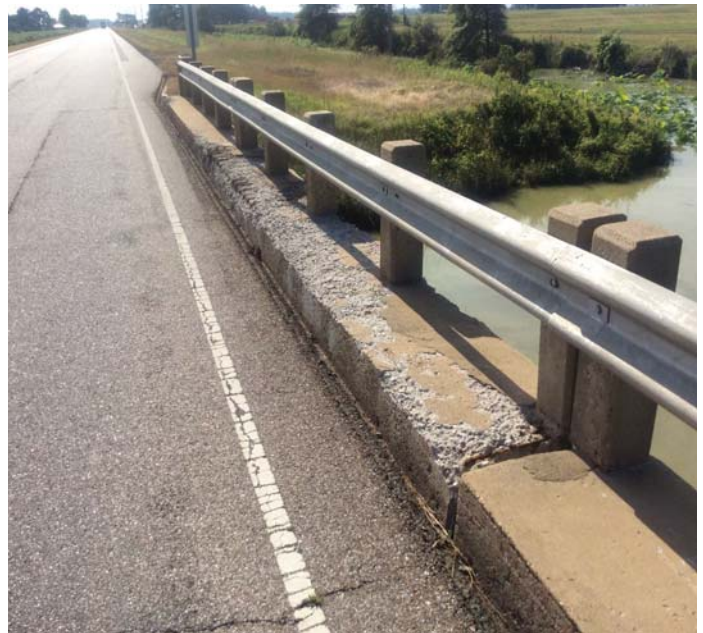
CONCRETE CURB
SPAN #2 RIGHT SIDE

SPALLED WITH EXPOSED REBAR

PHOTO 2 Description Span #2 right curb

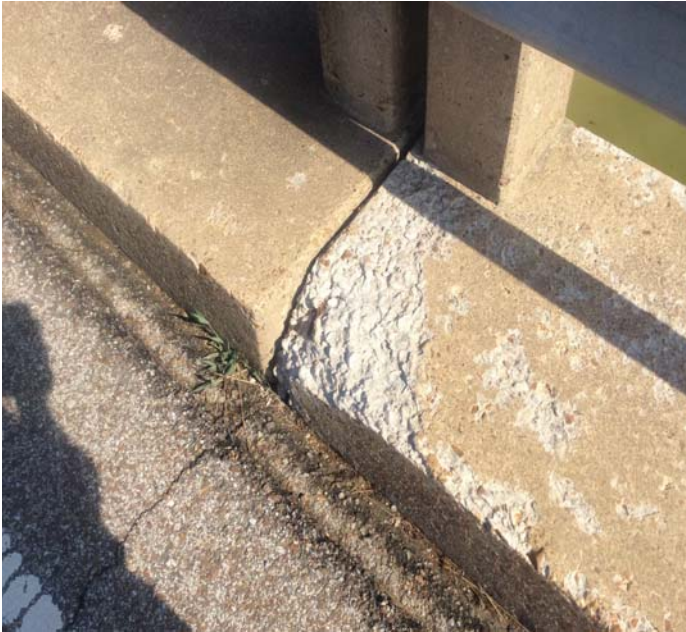
PHOTO 3 Description Span #3 at bent #3 left curb.

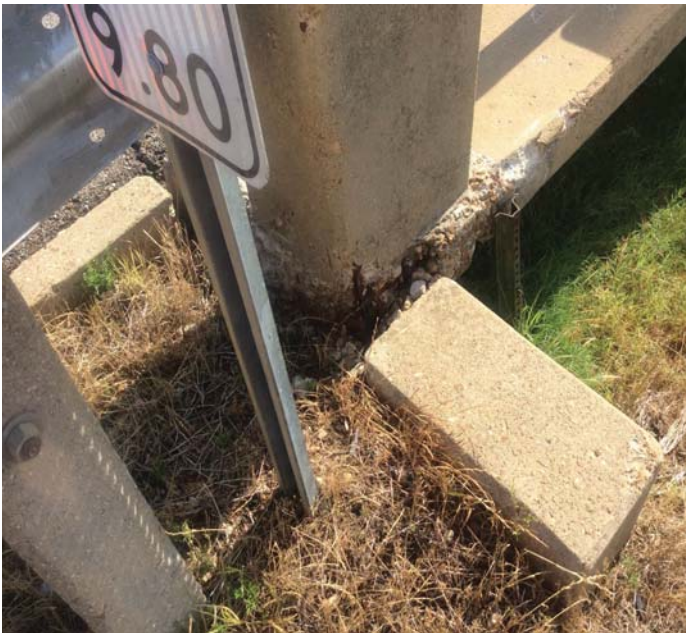
SPALLED AT OVERHANG WITH EXPOSED REBAR.

PHOTO 1 Description Abutment-#1 right end post

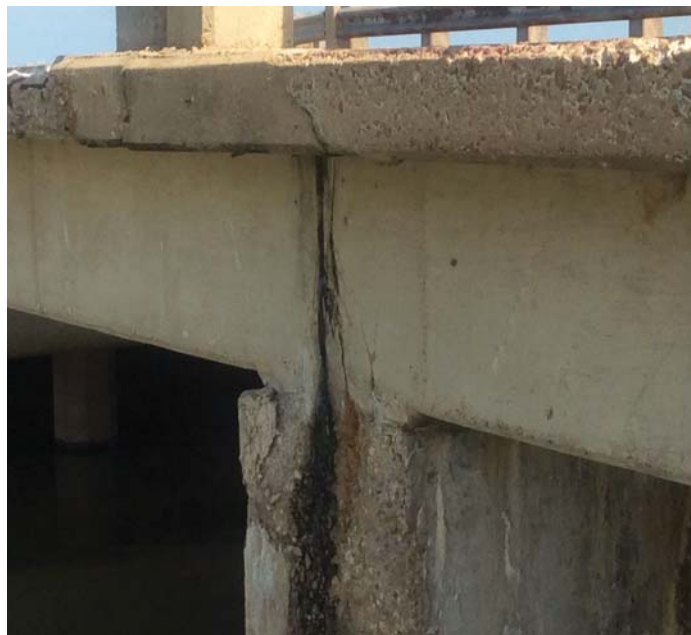
DECK SLABS HAVE LARGE OPEN CRACKS ON SIDES ST ENDS OF SPANS.

PHOTO 1 Description Side of slab bent #3 right side.

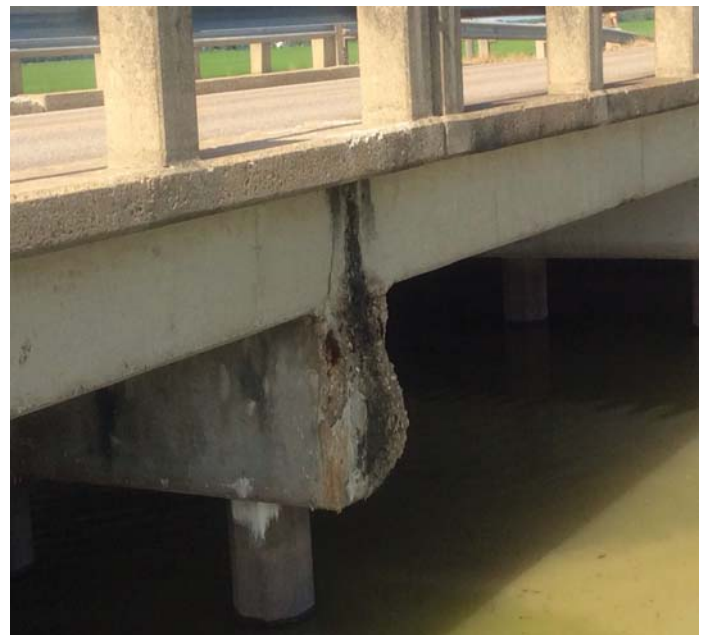
PHOTO 2 Description Bent #3 right end of cap and side of slab.
