# Bridge Inspection Report

03923  
US 64  
over  
MAPLE CREEK

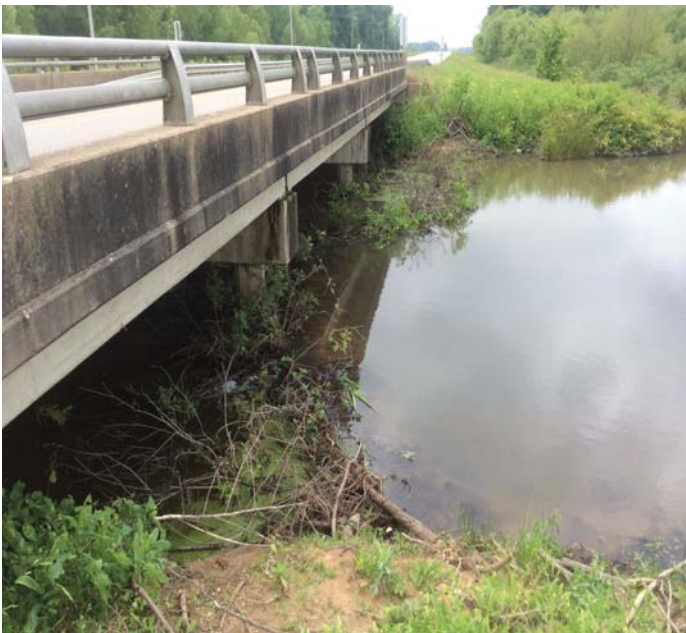
Priority: C - Important

Large beaver dam on left side of bridge full length

PHOTO 1    Description    Large beaver dam left side of bridge

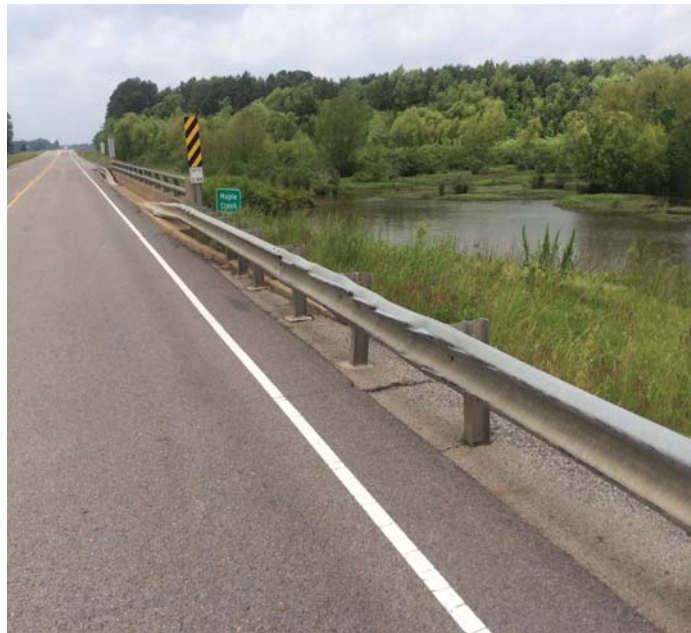
APPROACH RAIL

ABUTMENTS #1&2  
LEFT

MINOR COLLISION DAMAGE

PHOTO 1      Description      Abutment #2 left approach rail

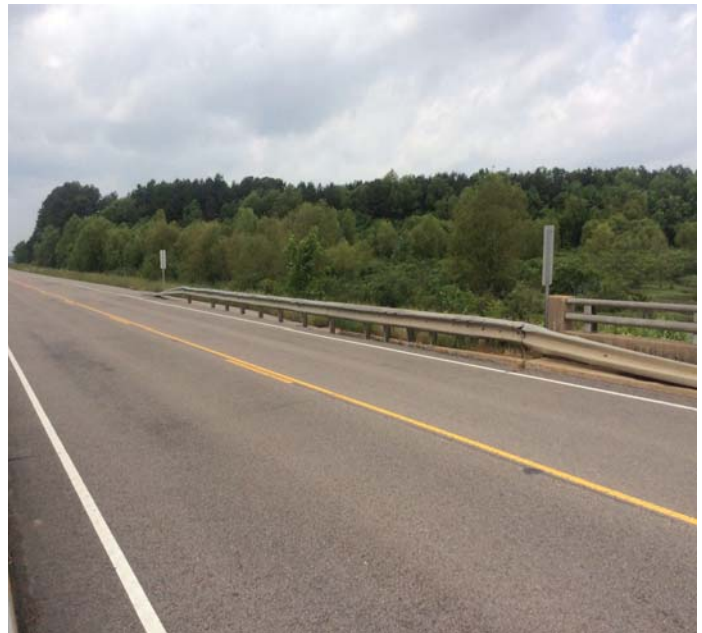
PHOTO 2      Description      Abutment #1 left approach rail traffic damage

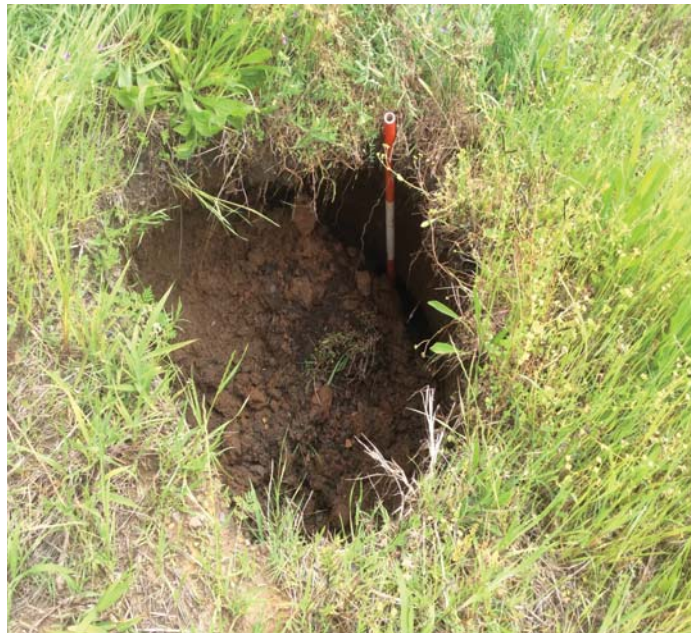
ABUTMENT #2 LEFT  
AT SIDE DRAIN AND BRIDGE END

SEVERAL HOLES ERODED IN SIDE SLOPE AT SIDE DRAIN AND AT BRIDGE END

PHOTO 1      Description      Erosion abutment #2 left side at drain

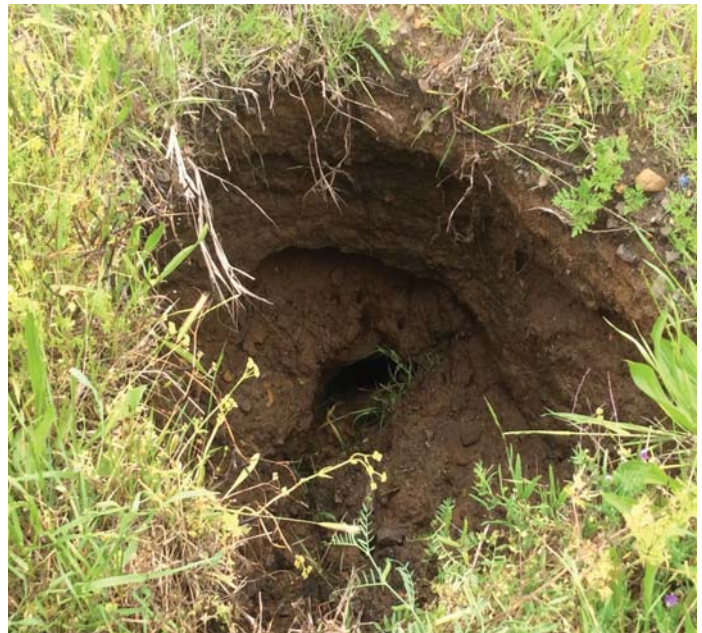
PHOTO 2      Description      Erosion abutment #2 left side at drain

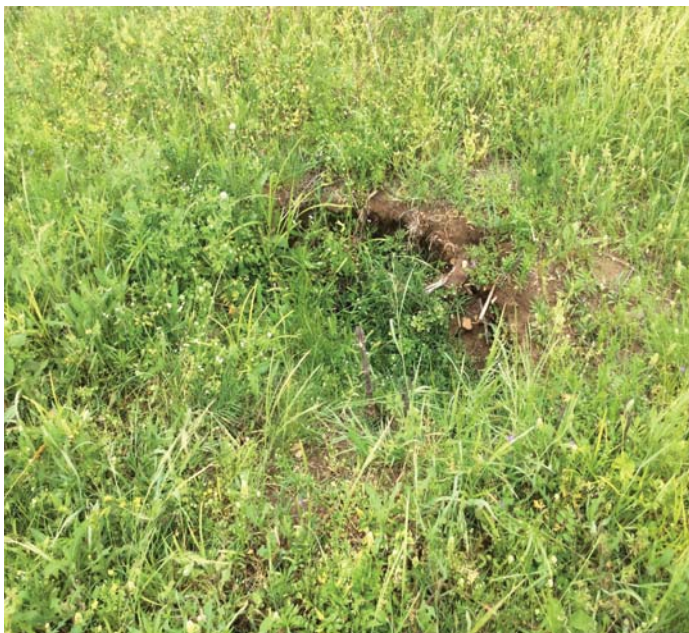
PHOTO 3      Description      Hole in slope abutment #2 left side

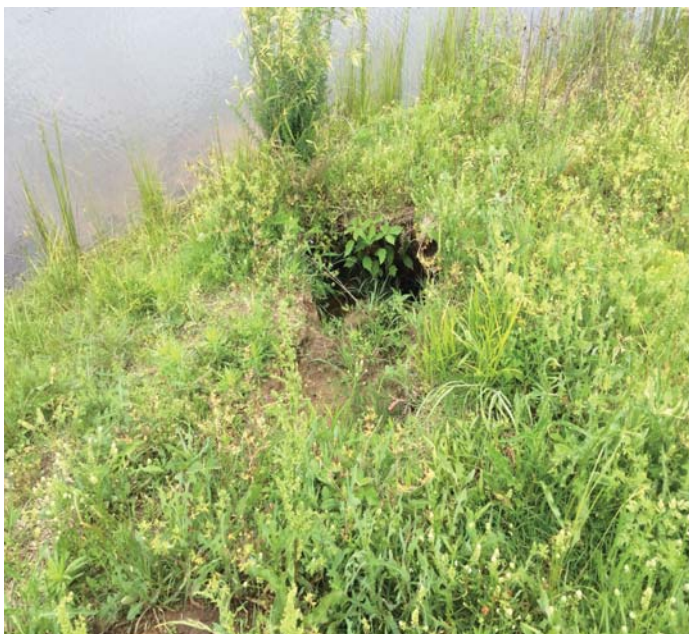
PHOTO 4      Description      Hole in slope abutment #2 left side

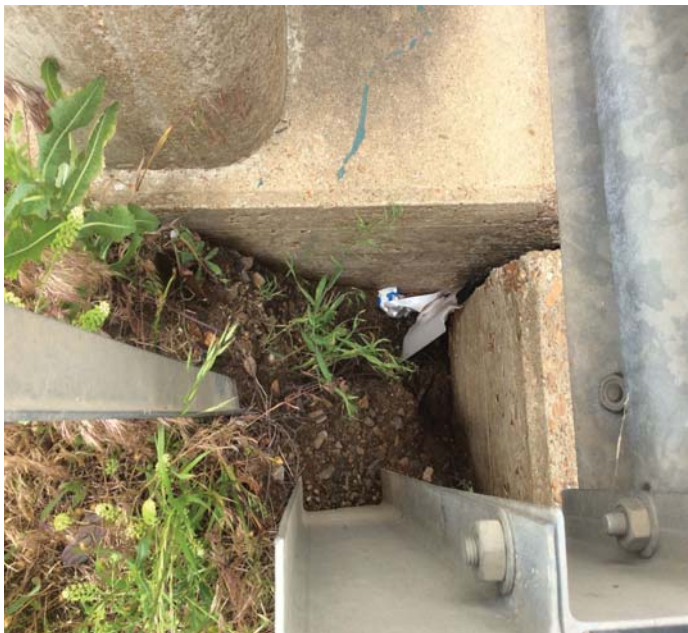
Approach gutters have holes eroded under them both sides of Abutment #2

PHOTO 1      Description      Erosion under approach gutter  
abutment #2 right side

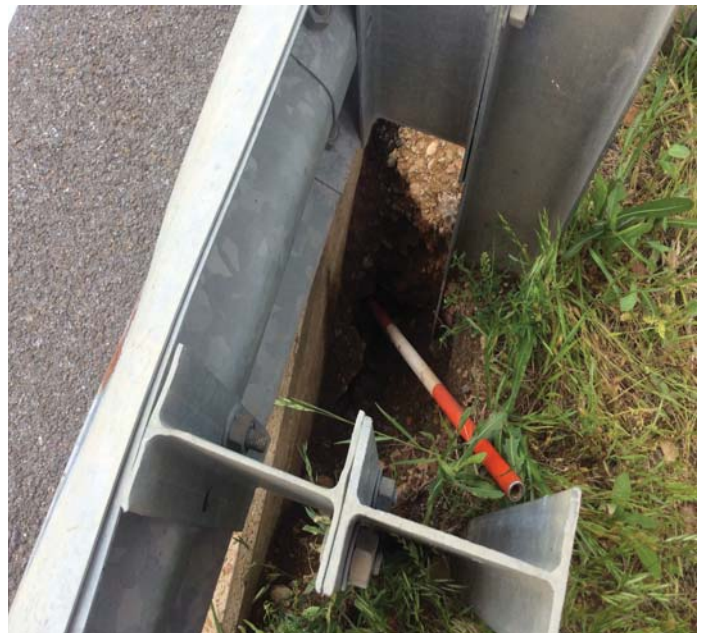
PHOTO 2      Description      Hole eroded under approach curb  
abutment #2 left side

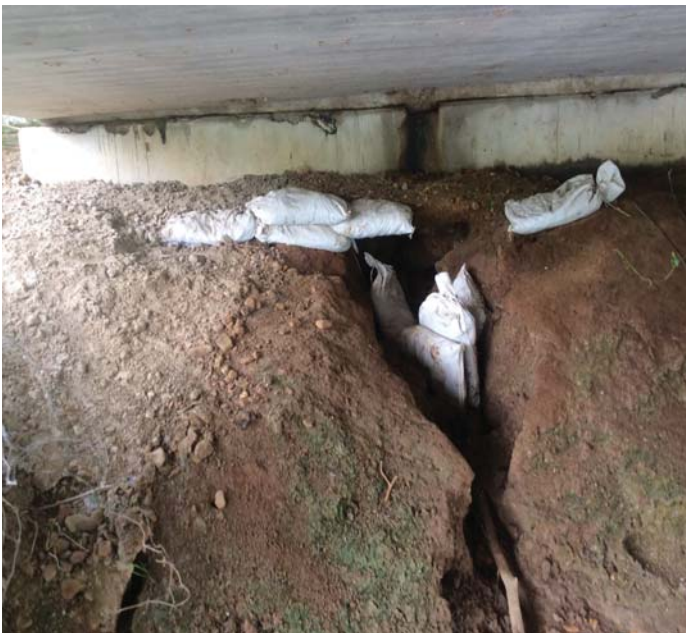
Erosion control has failed at abutment #2 left side.

PHOTO 1      Description      Erosion at abutment #2 left side.
