Bridge Inspection Report

06665
US64/Sec-16/L-7.04
over
ST FRANCIS BAYOU

Structure Number: 06665

Facility Carried: US64/Sec-16/L-7.04

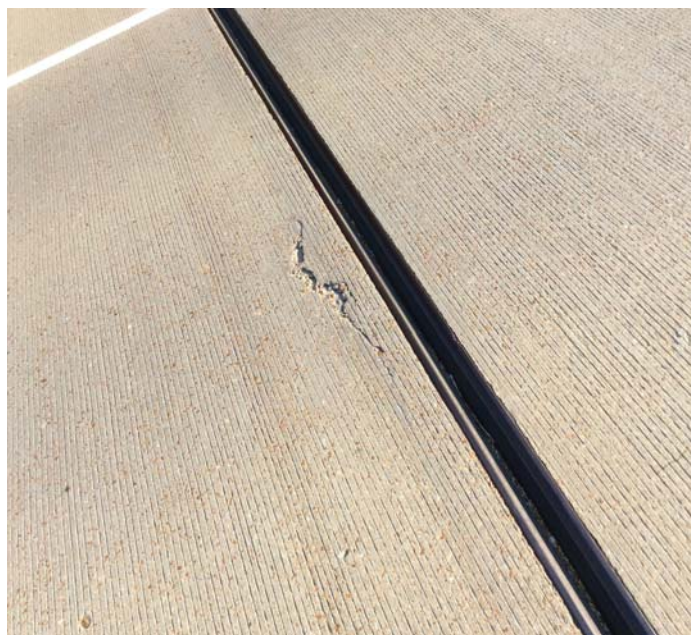
DECK ALL SPANS HAVE OPEN TRANSVERSE AND LONGITUDINAL CRACKS.
Span 3 deck left lane at bent 4 two foot long crack / delam.

PHOTO 1 Description Span 3 deck left lane at bent 4 two foot long crack / delam.

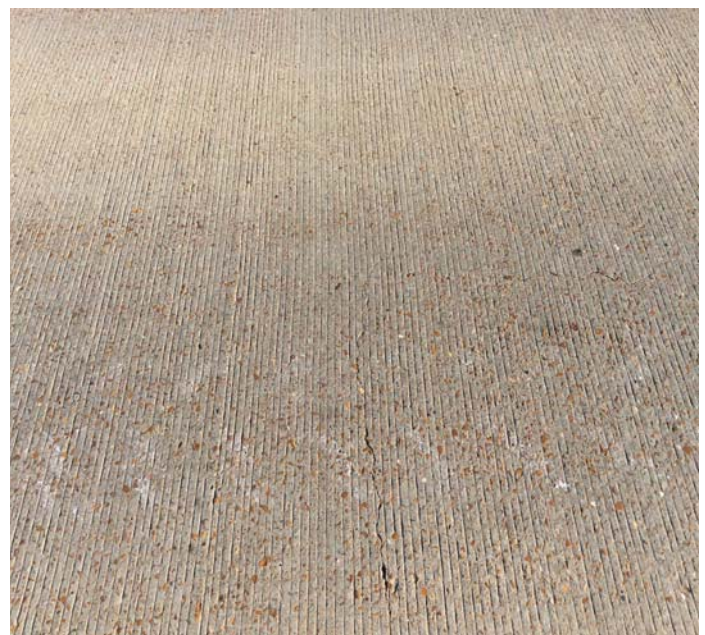
PHOTO 2 Description Typical deck cracks.

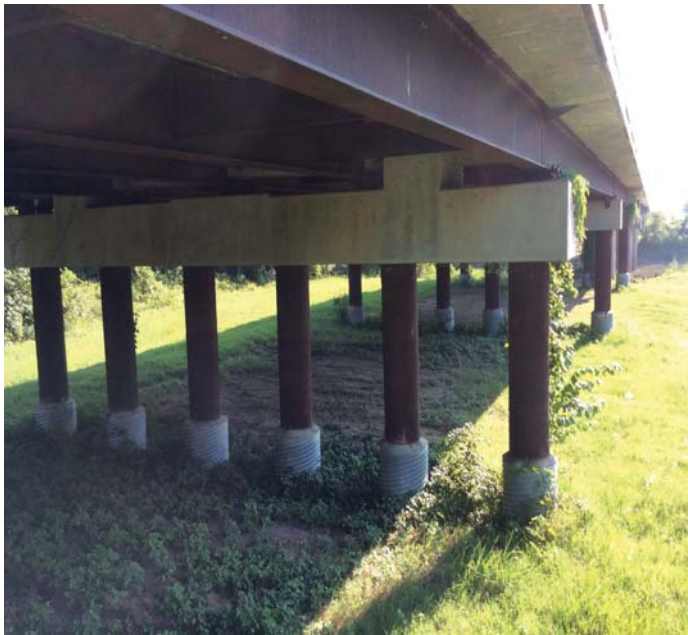
THESE BENTS HAVE VEGETATION GROWING UP PILING.

PHOTO 1 Description Bent 4 vegetation.

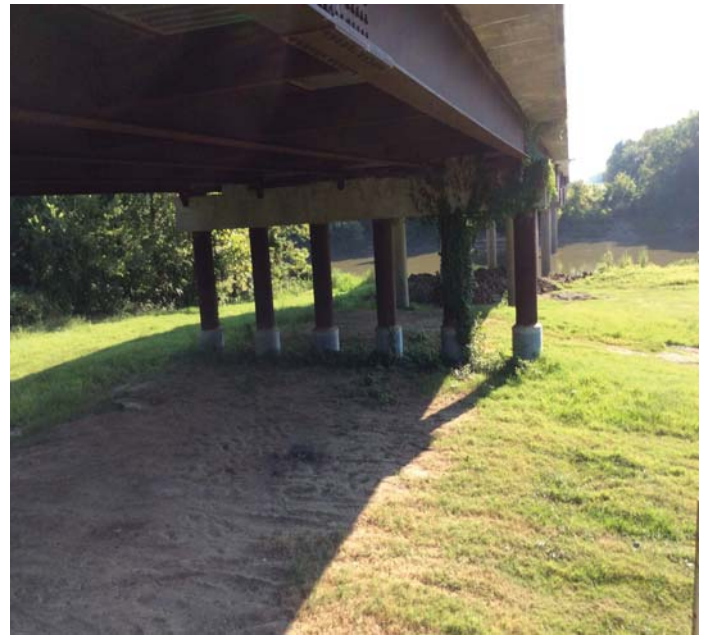
PHOTO 2 Description Vegetation bent 6

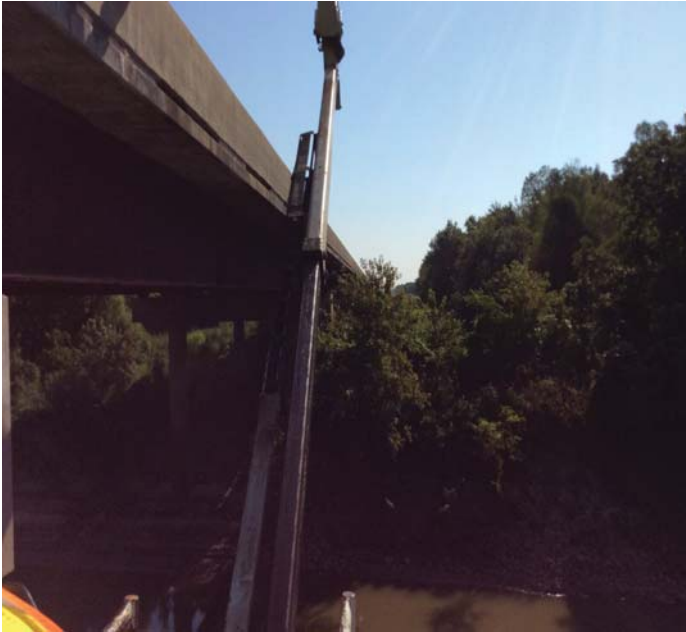
TREE GROWING BESIDE SP. #10 BT. #11 RIGHT SIDE OF BRIDGE.

PHOTO 3 Description Tree growing beside bridge right side span 10 near bent 11.

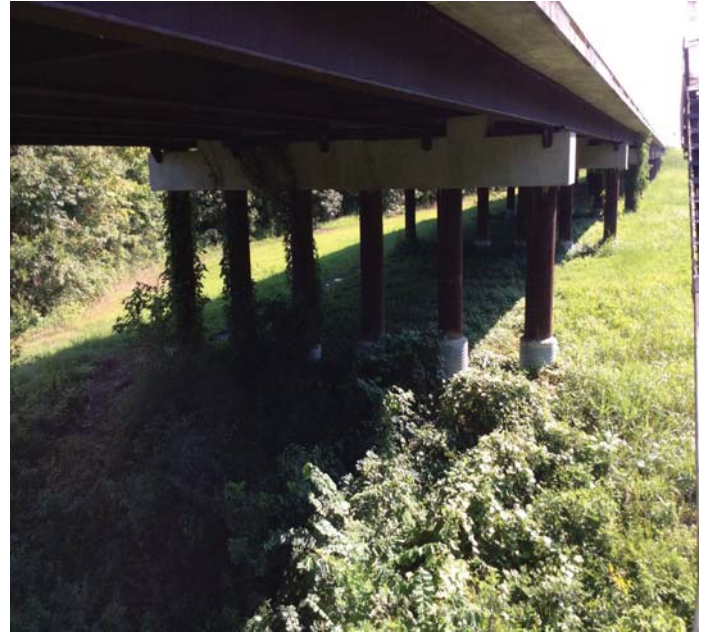
PHOTO 5 Description Bent 17 vegetation.

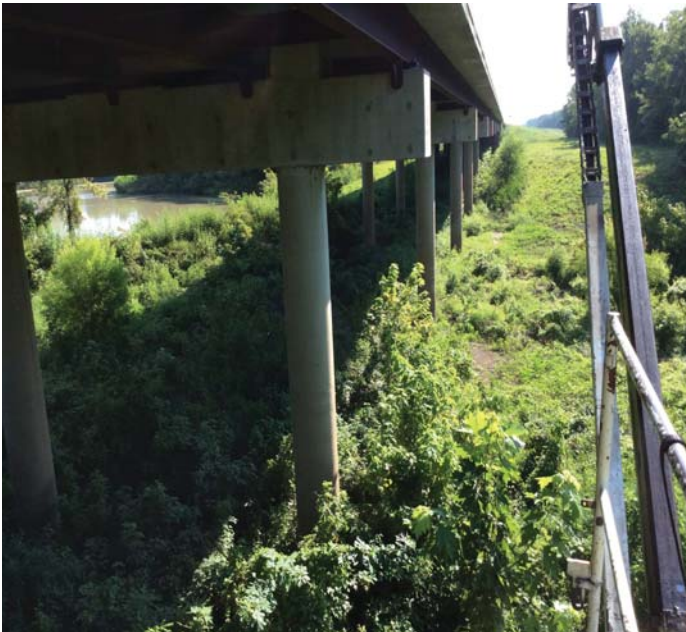
Small trees and vegetation growing under spans 11-26.

PHOTO 4 Description Small trees and vegetation growing under spans 11-26.

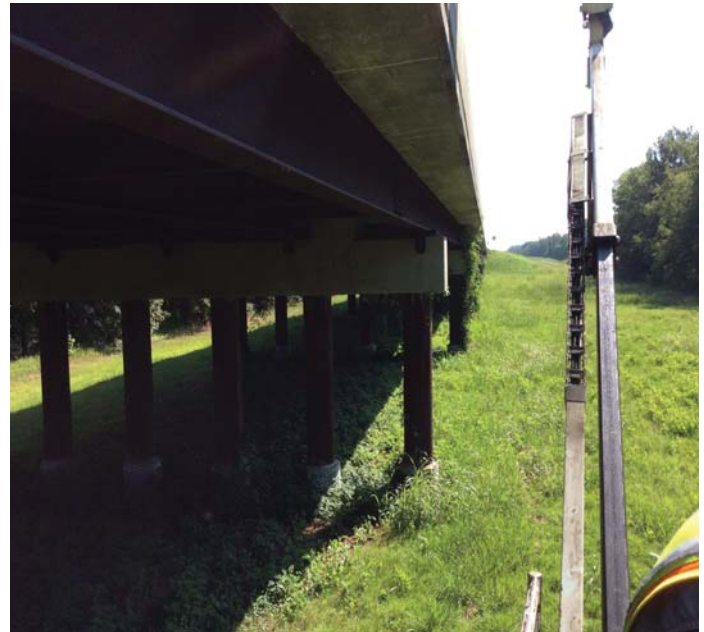
PHOTO 6 Description Bent 18, 19 vegetation.

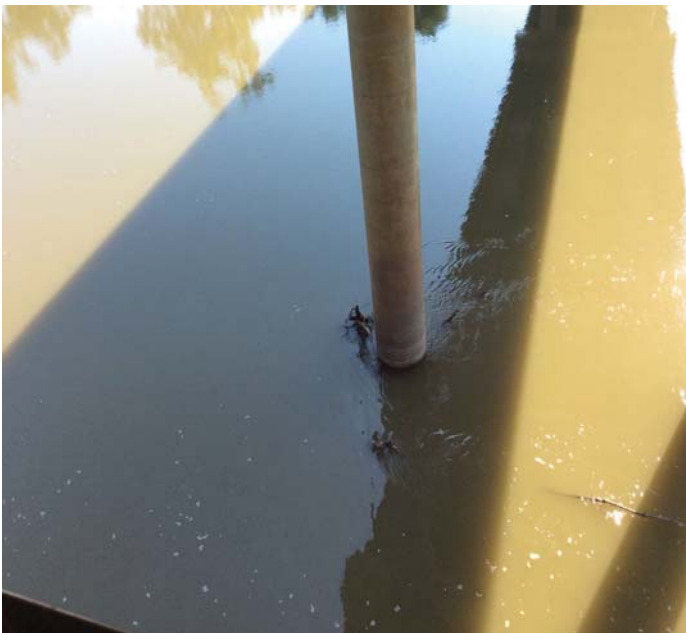
BENT #9 SMALL DRIFT

PHOTO 1 Description Bent 9 small drift.
