Bridge Inspection Report

**06748
US 64
over
White River**

Structure Number: 06748

Facility Carried: US 64

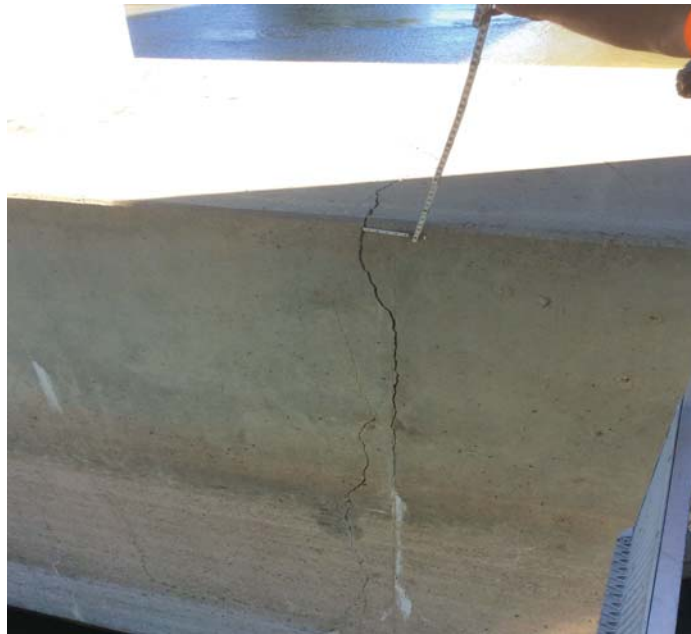
Pier 1 between columns 2 & 3 are two large vertical cracks that reflect through the pier wall. The crack is up to 1/2" in width. Similar cracks occur between columns 1 & 2 and also at pier 2 between the columns with a width up to a 1/8". (Photo linked)

PHOTO 1 Description Pier 1 between column 2 & 3: large vertical crack (1/2" thick) in the sub cap. A crack similar between column 1 & 2.

HBM Crew to epoxy inject and seal cracks at low water to water line

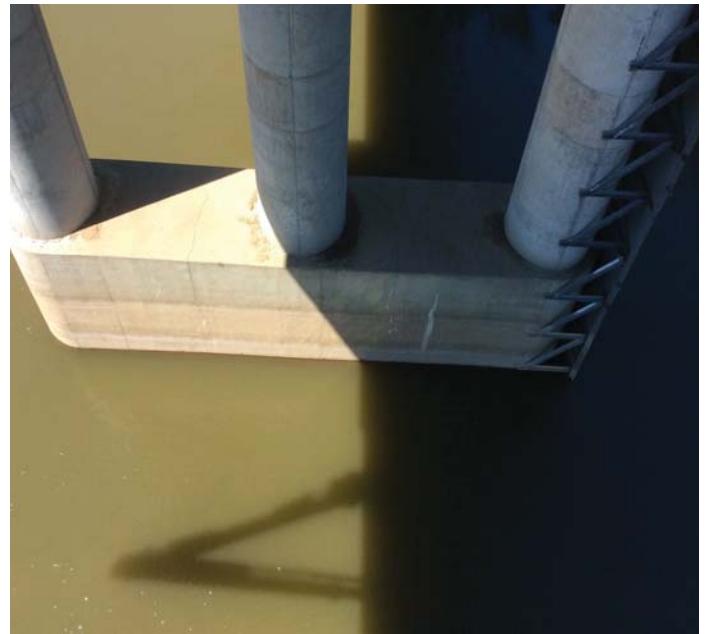
PHOTO 2 Description Back side Pier 1 sub cap: view looking from above at the large vertical cracks reflect through the pier.

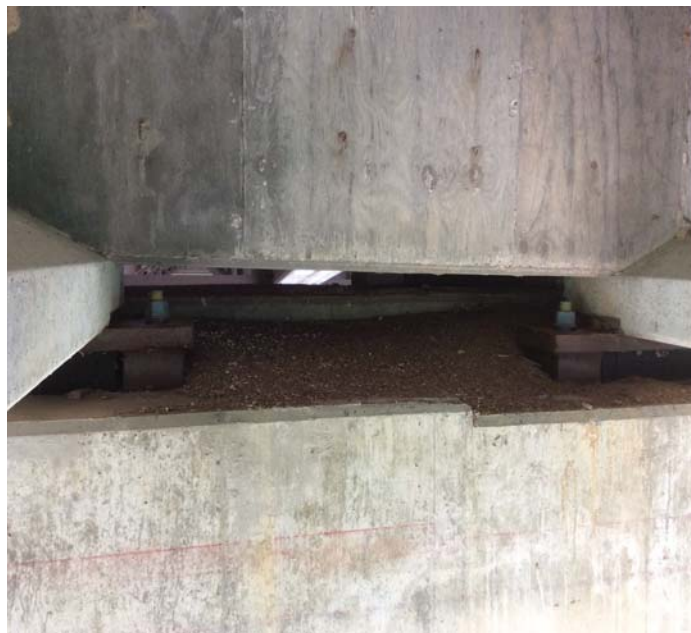
Bent 12 and 13: Heavy amounts of dirt and debris on seat.

PHOTO 1 Description Bent 12: top of cap has a large amount of debris that has accumulated on it and around the bearings. This is the only joint on this bridge where this deficiency occurs.

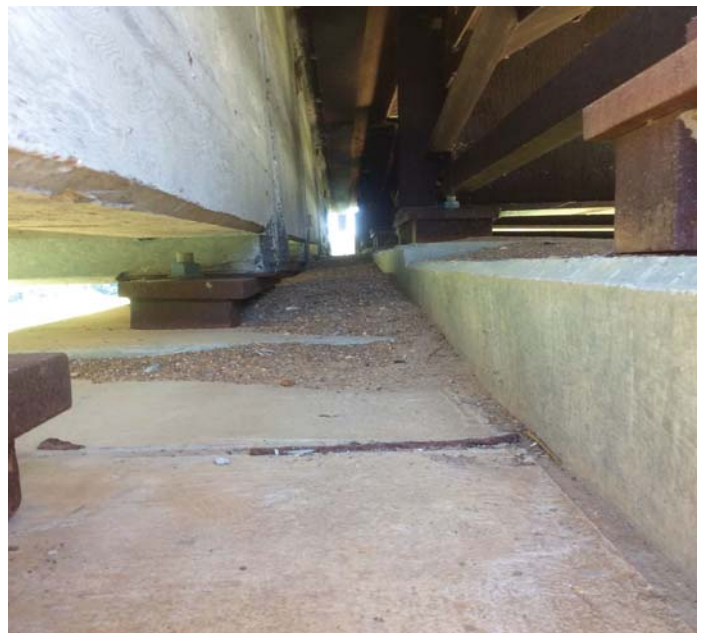
PHOTO 2 Description Bent 12 cap (side view): debris accumulating on top of cap and against the bearings.

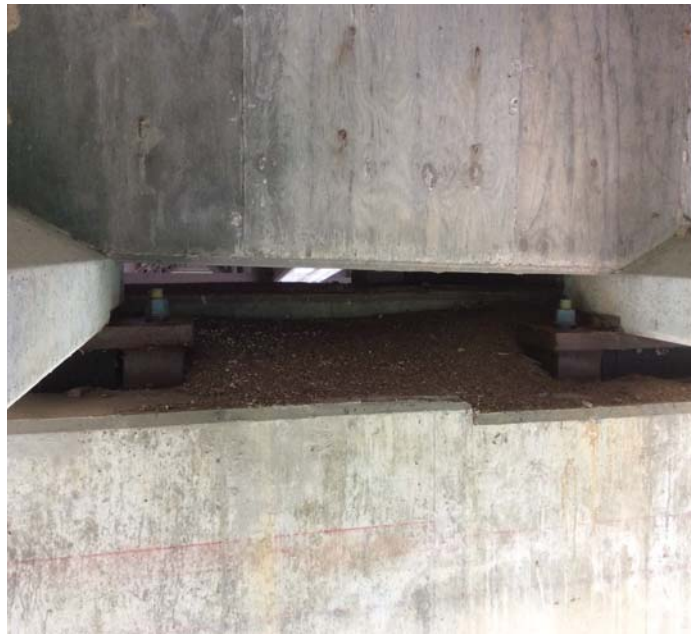
Debris in all the joints.

PHOTO 1 Description Bent 12: top of cap has a large amount of debris that has accumulated on it and around the bearings. This is the only joint on this bridge where this deficiency occurs.

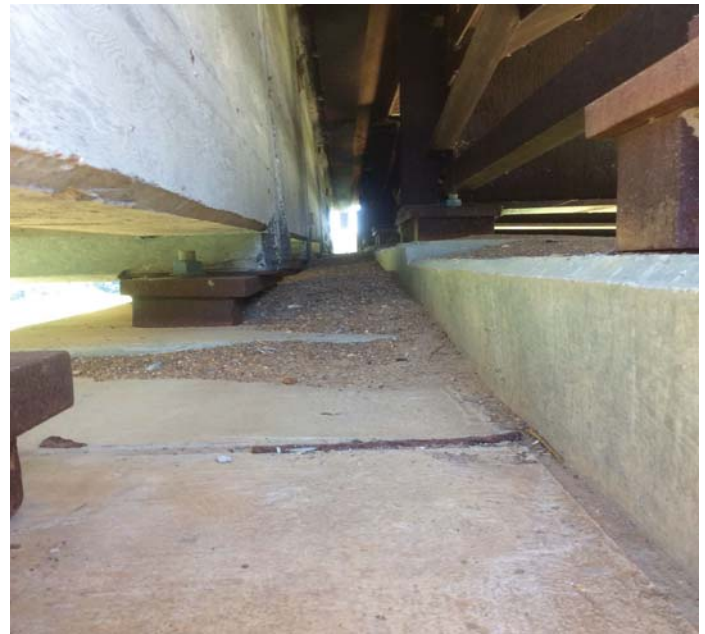
PHOTO 2 Description Bent 12 cap (side view): debris accumulating on top of cap and against the bearings.

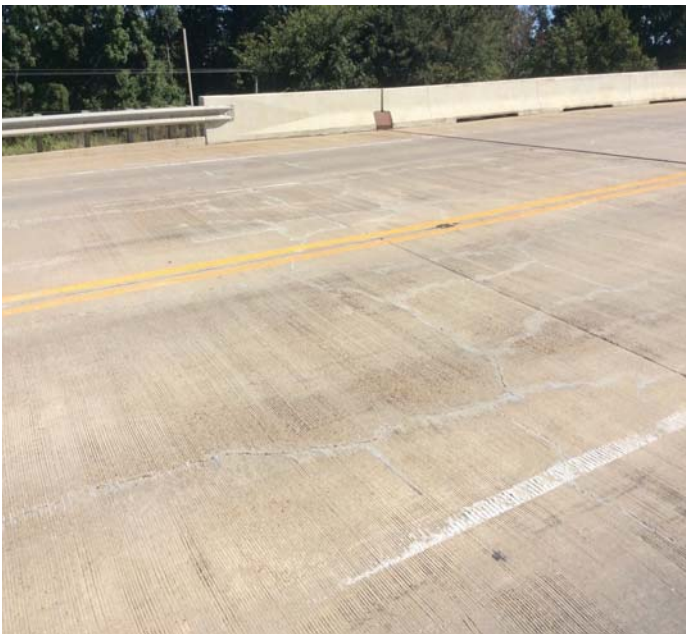
Both approach slabs are cracked. Cracks have been sealed in the past. Epoxy is starting to fail. Asphalt is cracked at both approaches.

PHOTO 1	Description	West approach slab has multiple sealed cracks. The epoxy is beginning to fail. Similar condition at the East approach.
---------	-------------	--

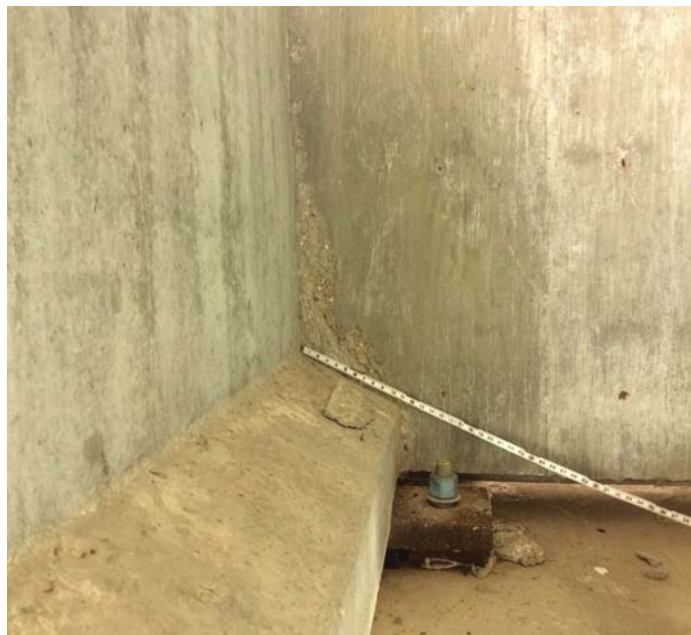
Girders are cracking where made continuous over bents, typical condition through out bridge.

PHOTO 1 Description Span 9, backside of bent 10 where the prestressed units are made continuous, Spalls and delaminations are beginning to form around the girders. This is typical through out the bridge.

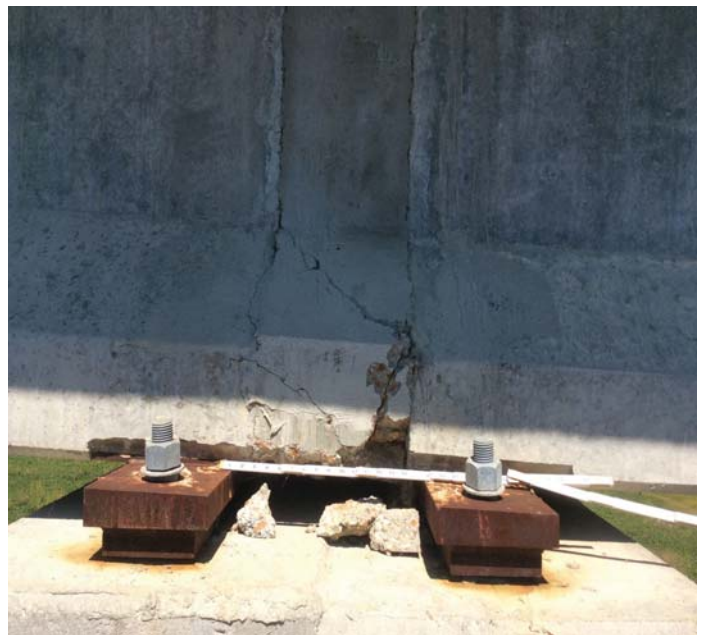
PHOTO 2 Description Bent 19 right side: spall and crack where prestressed girders are made continuous. Typical condition.

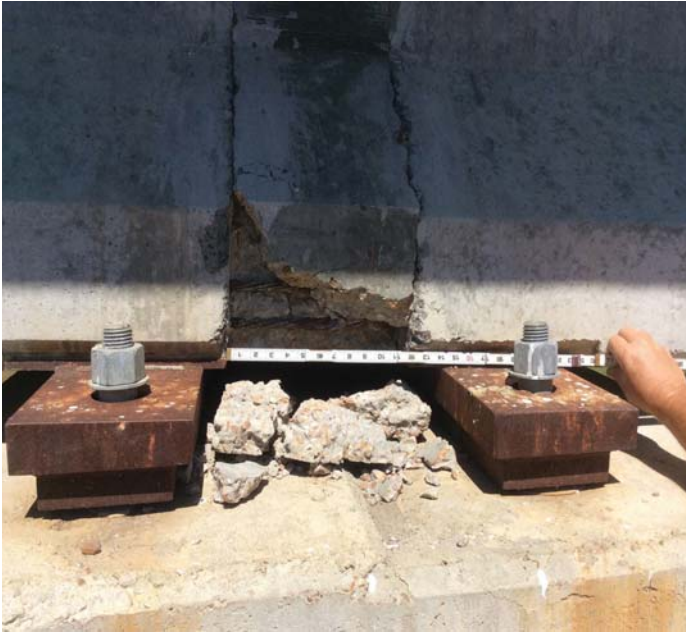
PHOTO 3 Description Rt. side bent 26: spall that is exposing reinforcing strands where the concrete girders are made continuous. Spalling and cracking in this area was typical throughout the prestressed units. This location was the worst case.

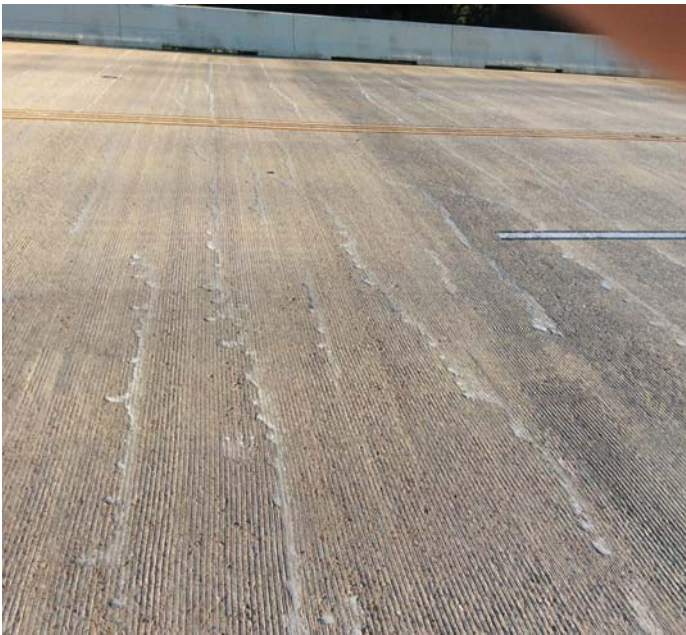
Deck cracks have been sealed in the past. Epoxy is starting to fail.

PHOTO 1 Description Span 3: the deck has numerous transverse cracks at 3 foot spacing that have been sealed in the past. Some of the seal is beginning to fail.

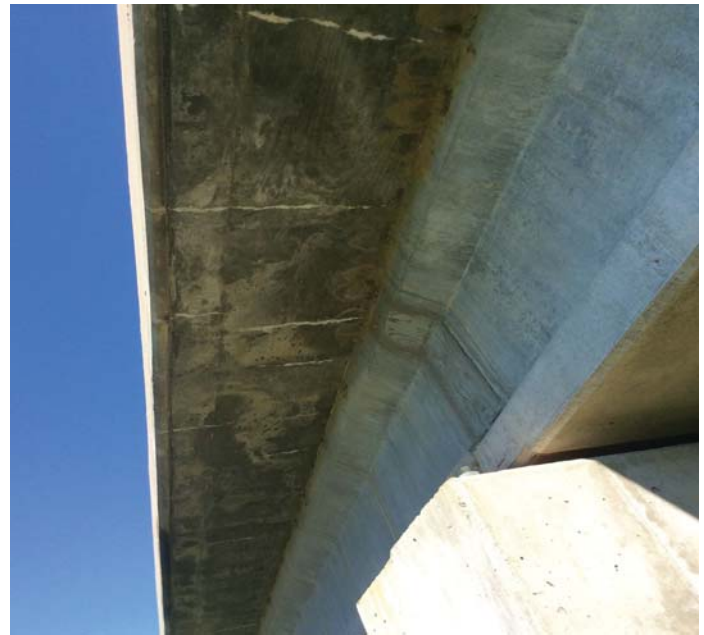
Transverse efflorescent cracks in the Lt. and Rt. overhangs.

PHOTO 2 Description Overhang above bent 2: transverse cracks with efflorescence staining. Typical condition of the overhangs in the prestressed concrete girder units.
