# Bridge Inspection Report

06902

Hwy64/sec16/L14.10

St Francis River

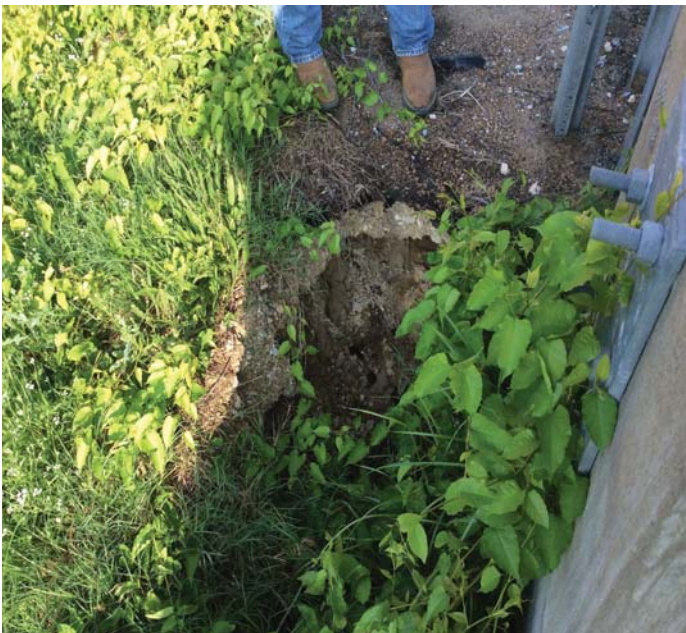
Abutment 1 right side at start of concrete bridge rail has 2' x 2' x2' deep erosion hole.

PHOTO 1      Description      Abutment 1 right side at start of concrete bridge rail has 2' x 2' x2' deep erosion hole.

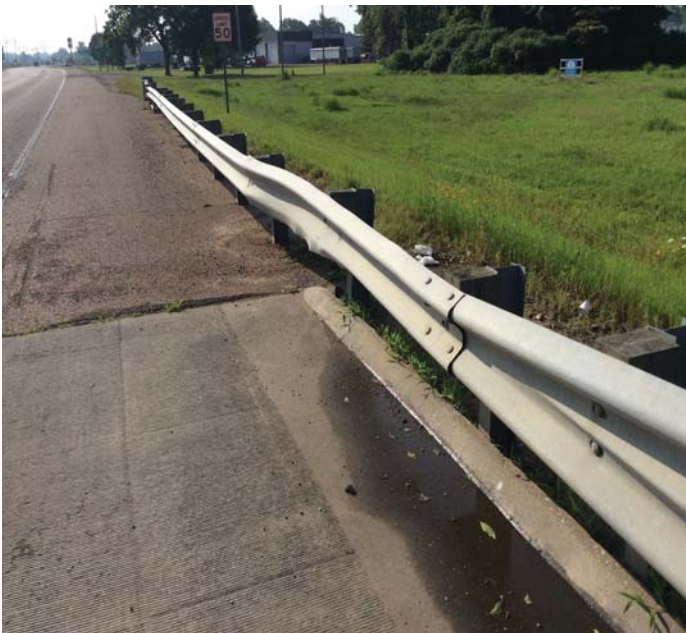
Abutment 2 right approach rail has collision damage 20' from bridge end.

PHOTO 1      Description      Abutment 2 right approach rail has collision damage 20' from bridge end.

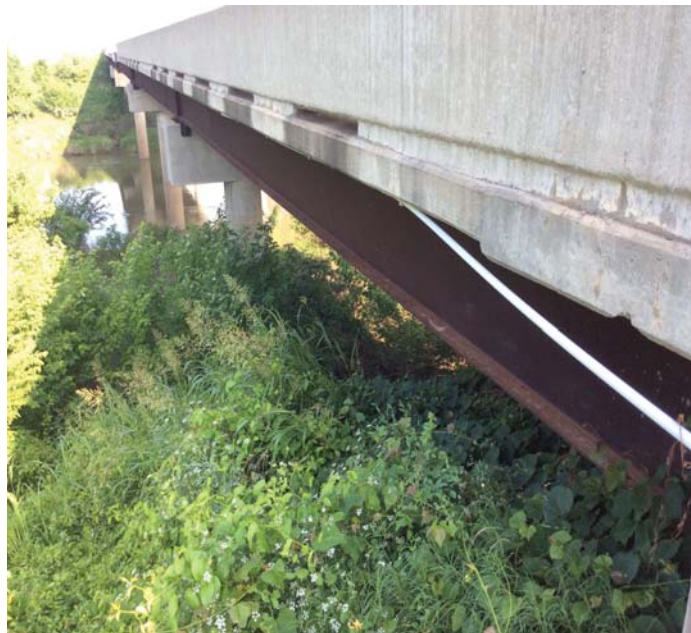
LARGE VEGETATION & TREES GROWING UNDER & BESIDE BRIDGE IN SPAN #1, 2 & 5.

PHOTO 1      Description      Typical vegetation

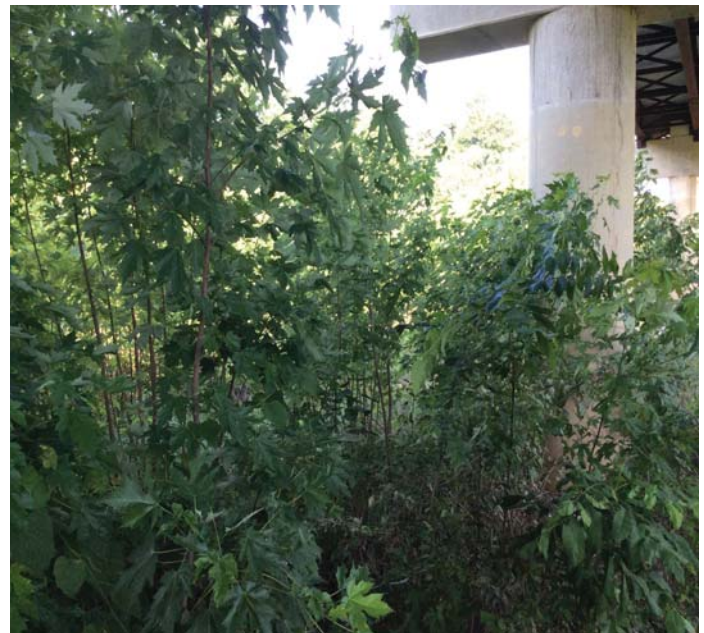
PHOTO 2      Description      Large vegetation.

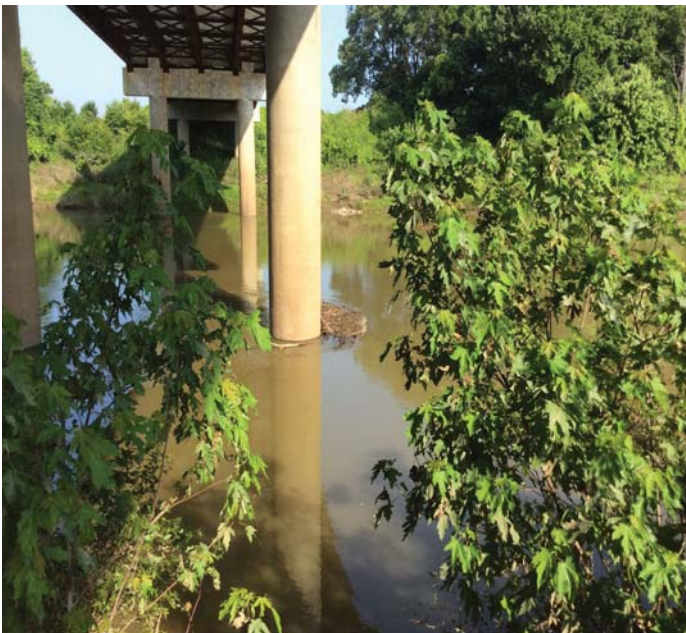
SMALL DRIFT IN CHANNEL AT BENT #4 LEFT SIDE.

PHOTO 1      Description      Small drift at bent 4 left side.
