# Bridge Inspection Report

**06960**

**US 64/sec13/L6.93**

**Cache River Relief**

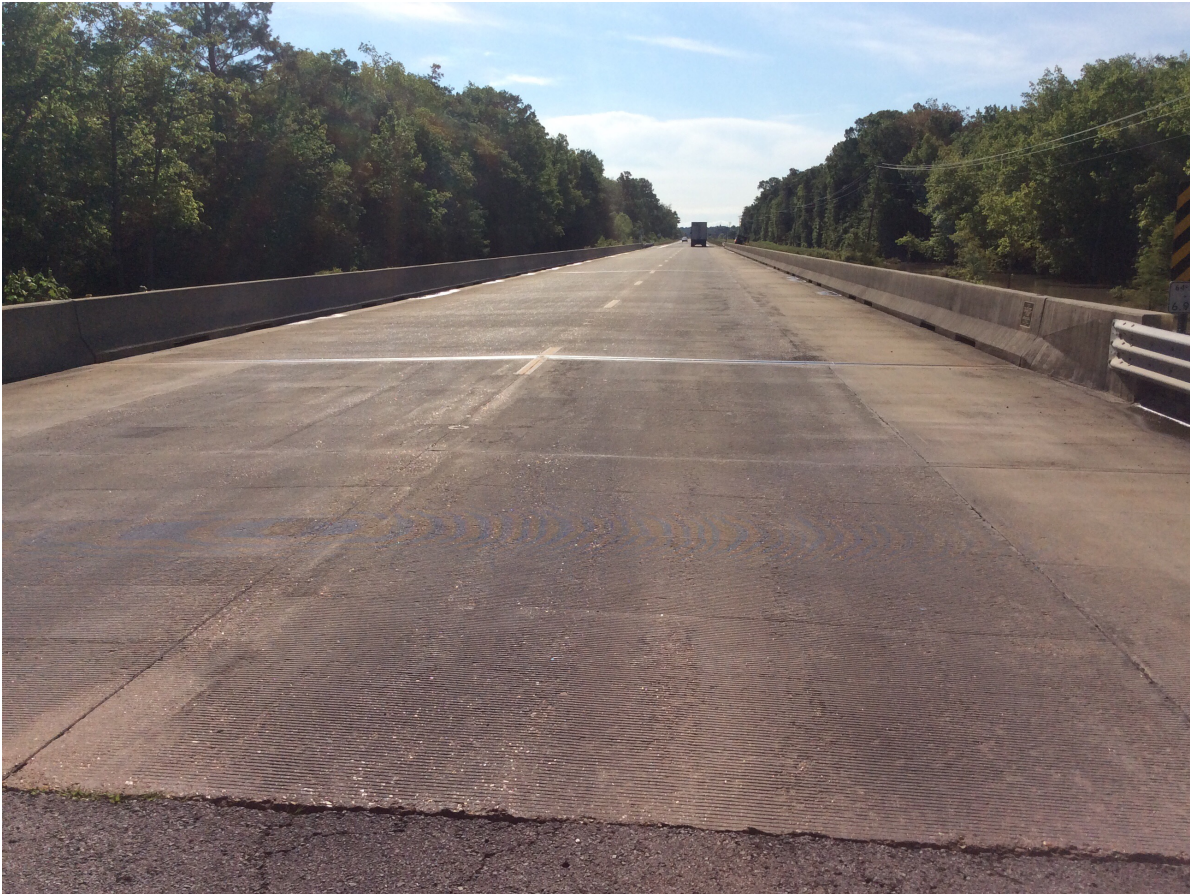
No asphalt overlay on the bridge

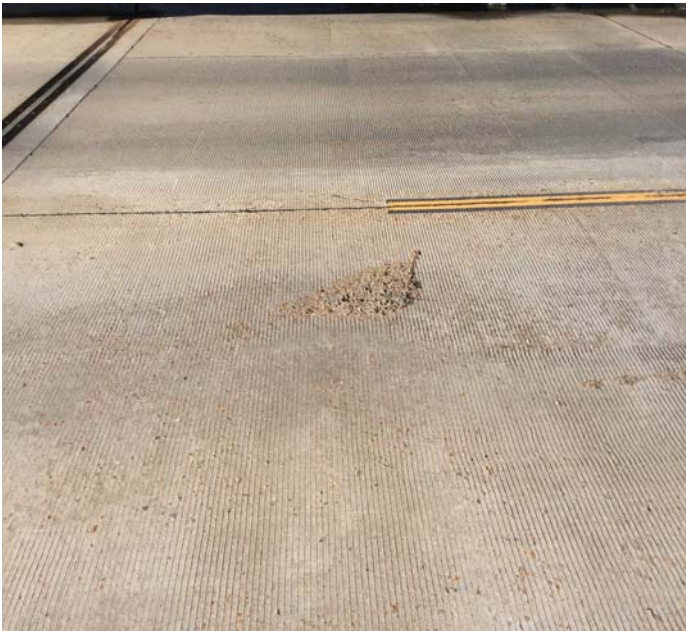
Abutment #2 approach slab right lane near chanter line has 1" spall no rebar exposed.

PHOTO 1      Description      Abutment #2 approach slab right lane near chanter line has 1' spall no rebar exposed.

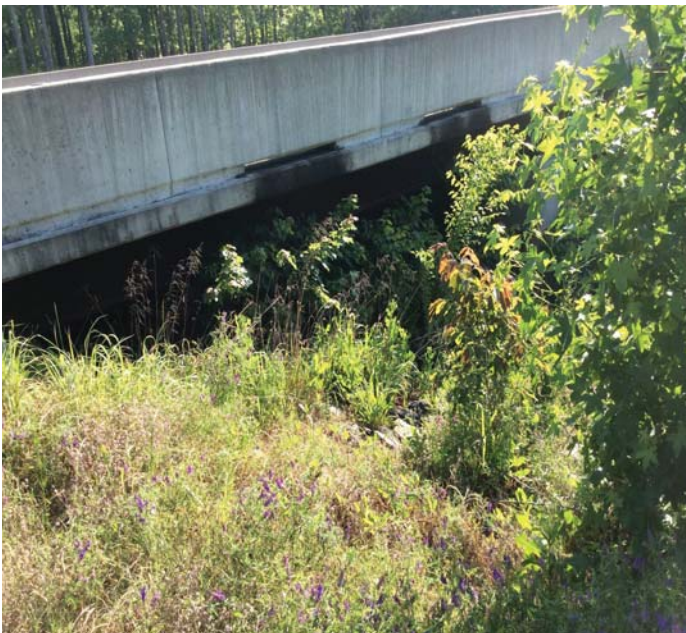
Abutments have small trees and vegetation growing beside and under bridge.

PHOTO 1      Description      Abutments have small trees and vegetation growing beside and under bridge.

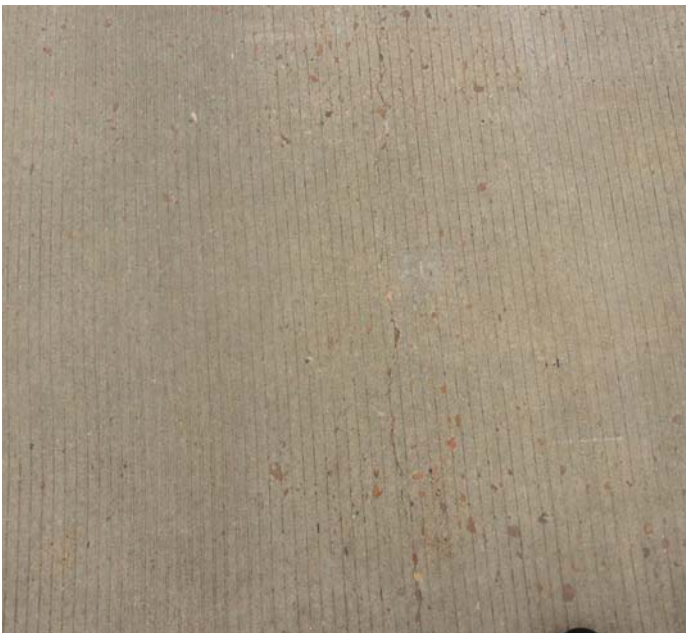
Each span has open transverse and longitudinal cracks spaced 3' apart.

PHOTO 1    Description    Typical transverse shoulder crack
