Bridge Inspection Report

06961

US 64/sec13/L7.31

Cache River

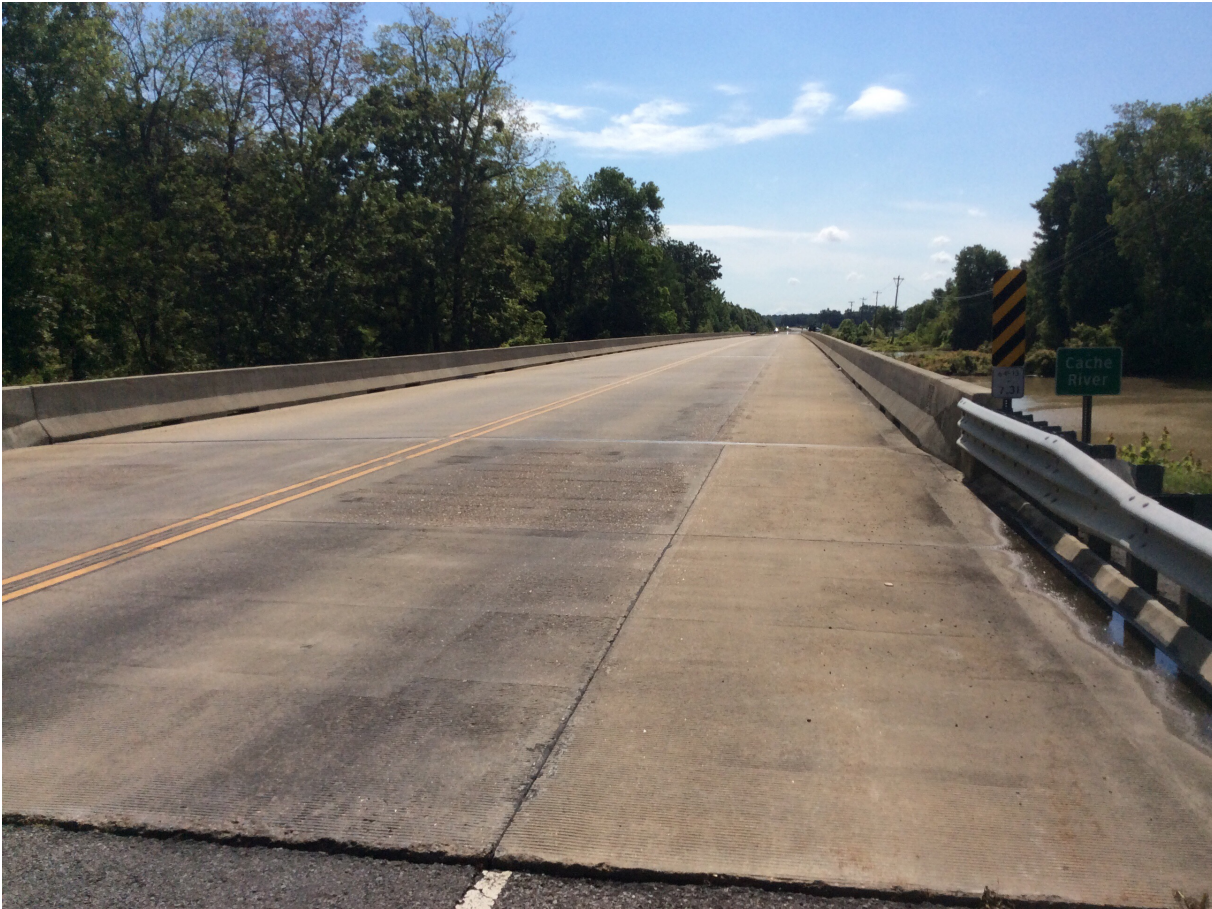
No asphalt overlay
on the deck

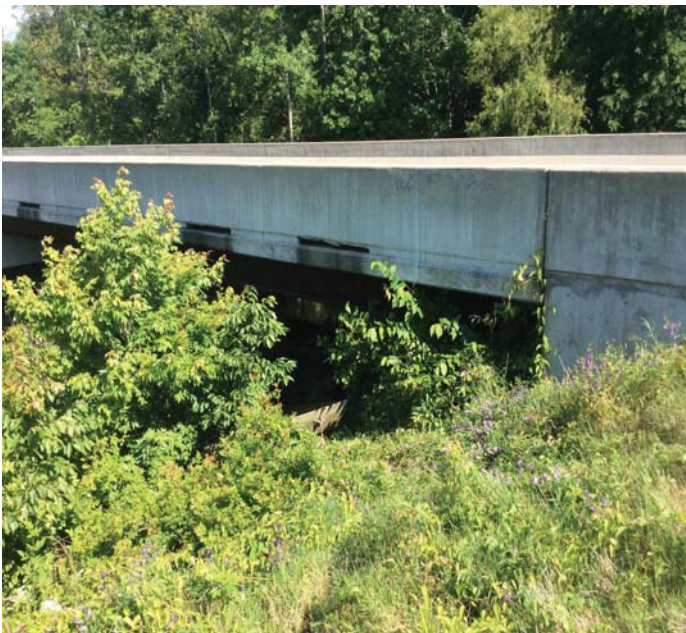
Priority: D - Routine

Small trees and vegetation are growing beside and under bridge at abutments.

PHOTO 1 Description Small trees and vegetation are growing beside and under bridge at abutments.

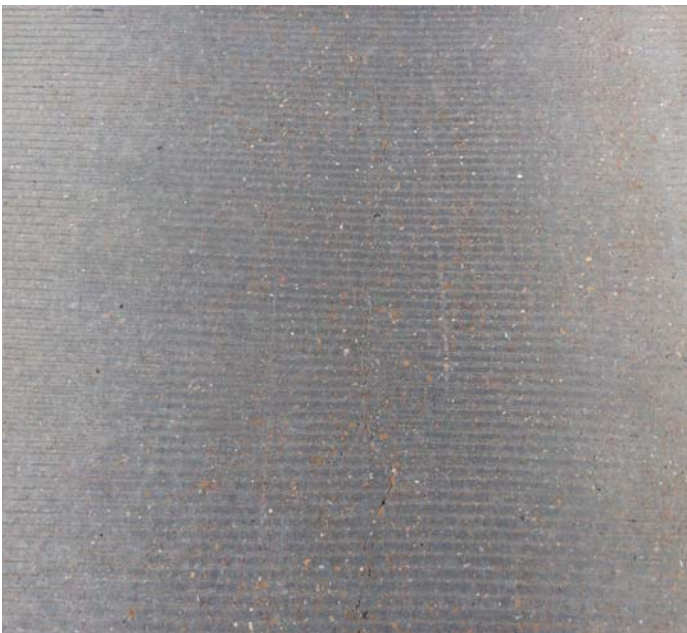
All spans have transverse and longitudinal cracks spaced at 3'.

PHOTO 1 Description Typical longitudinal deck crack
