Bridge Inspection Report

A1327
US 64 WHITE
over
BIG MINGO CREEK

Structure Number: A1327

Facility Carried: US 64 WHITE

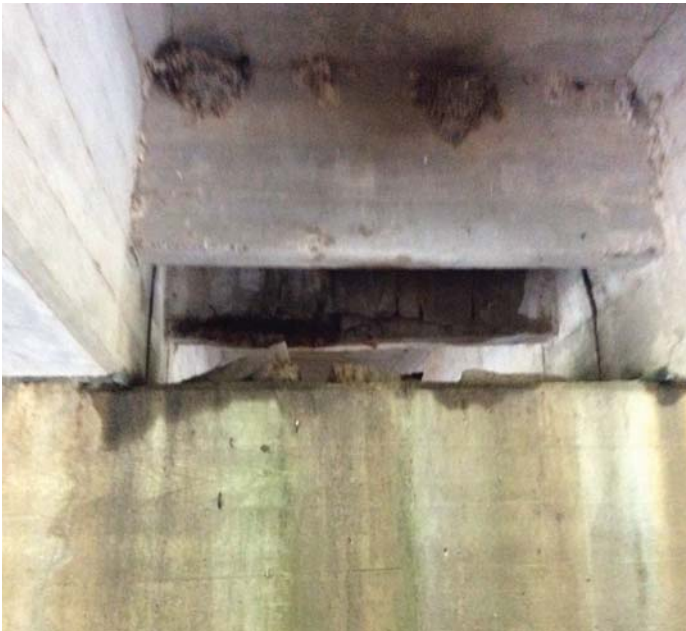
Spalls with rebar exposed to Girders & Diaphragm at Spans 1, 2, & 3.

PHOTO 1 Description Typical spalls with rebar exposed to Concrete Diaphragm.

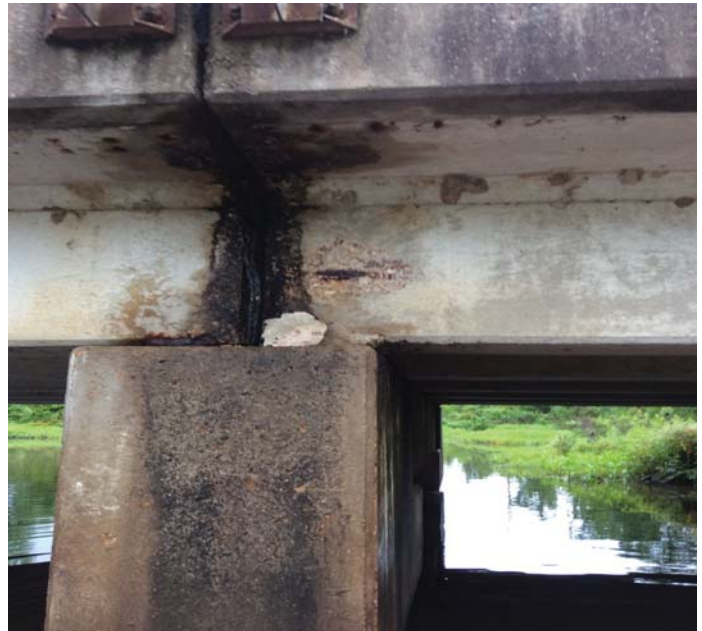
PHOTO 2 Description Span 3 Spall to Girder 6 with rebar exposed at Beginning of Span.

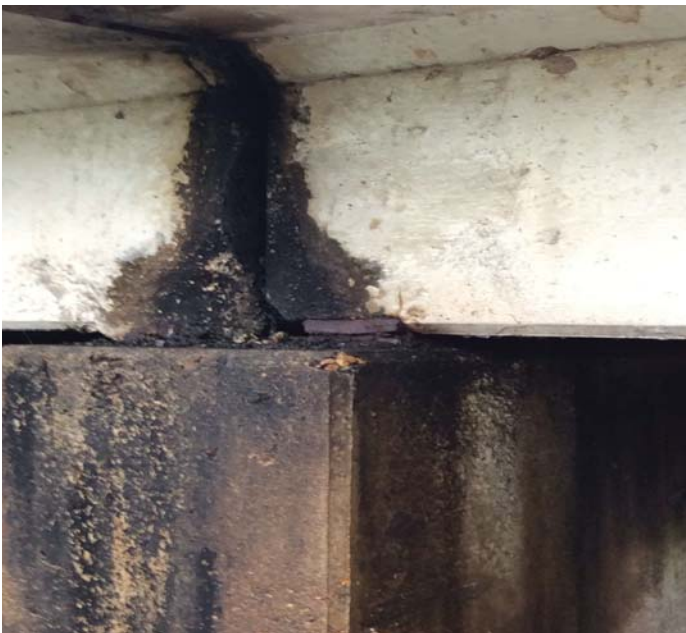
Rust & section loss to Bearings at Girders 1 & 6 at Bent 2 & 3.

PHOTO 1 Description Typical rust to Bearings.
