Bridge Inspection Report

A1328
US 64 White
over
LITTLE MINGO CREEK

Structure Number: A1328

Facility Carried: US 64 White

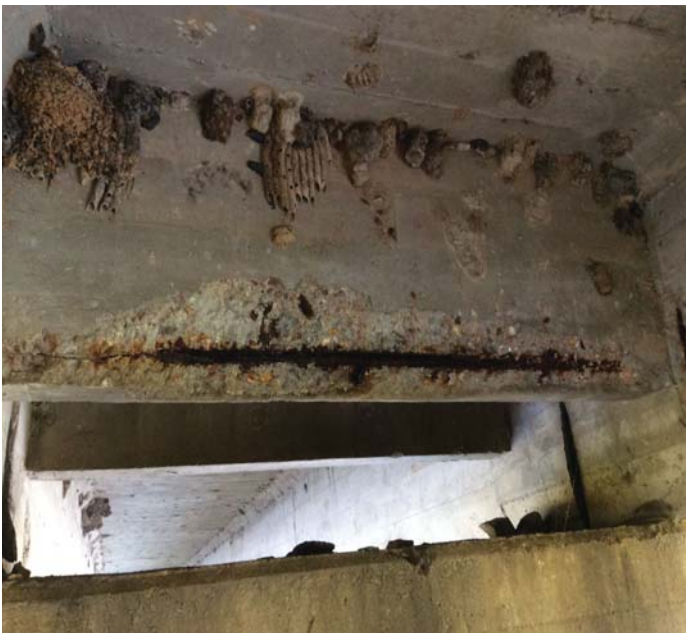
Spall to concrete diaphragm's between girders 2 & 3 @ beginning of span 3.

PHOTO 1 Description Spall to concrete Diaphragm's between Girders 2 & 3 @ beginning of Span 3.

Work Code: Repair

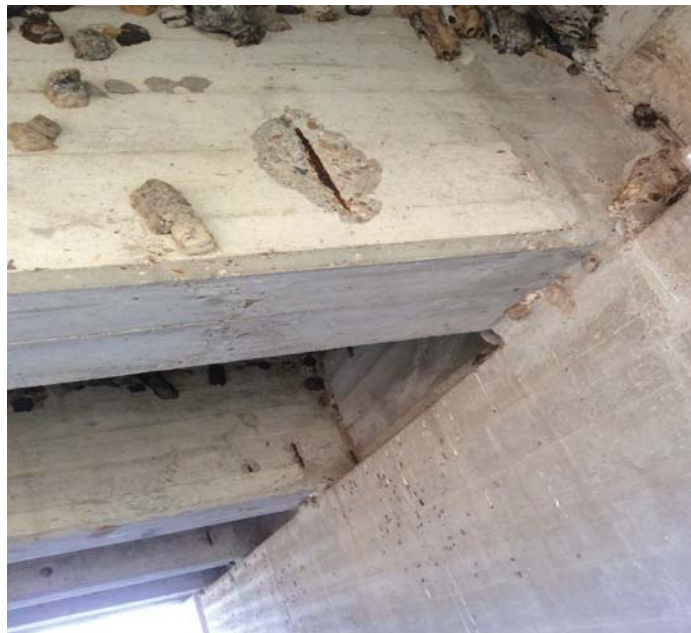
Girders at Spans 1 - 3 have spalls with rebar exposed at several locations.

PHOTO 1 Description Girders at Spans 1 thru 3 have random spalls with rebar exposed at several locations. (Span 1)

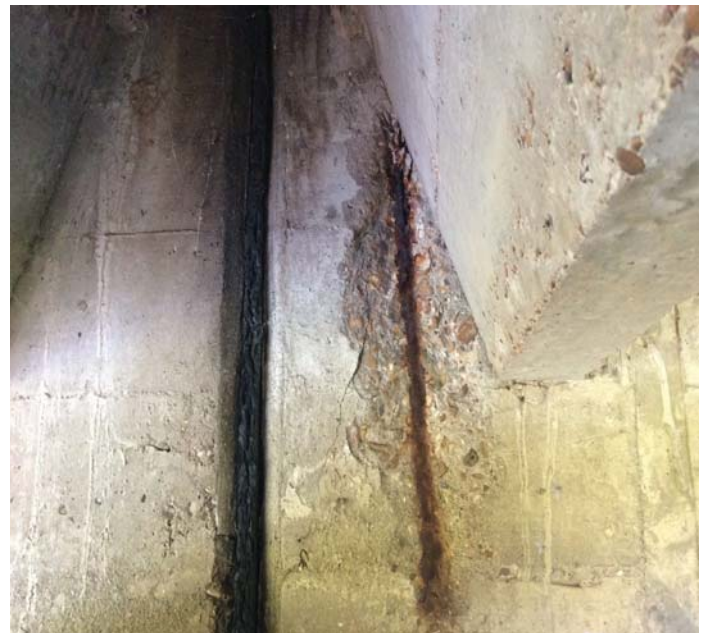
PHOTO 2 Description Girders at Spans 1 thru 3 have spalls with rebar exposed at several locations. (Span 3 girder 2 @ beginning of span)

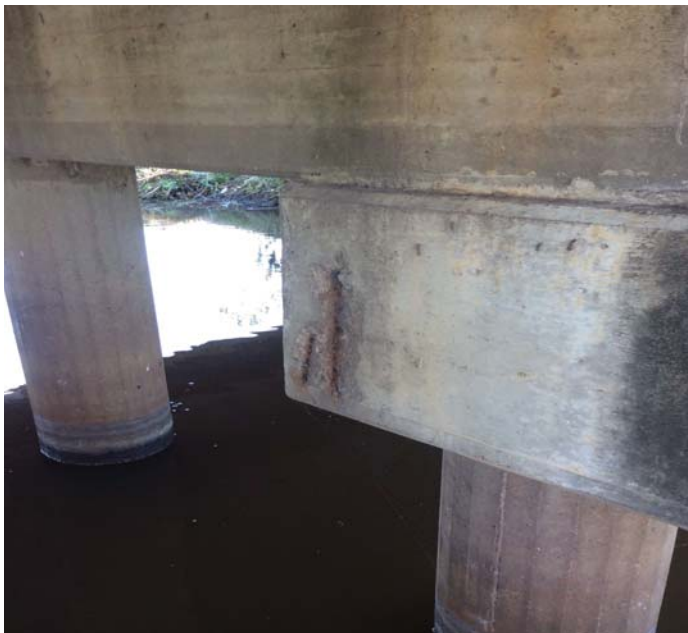
Spall with rebar exposed to cap @ Bent 2 back & ahead side.

PHOTO 1 Description Spall with rebar exposed to cap @ Bent 2. (Back side)

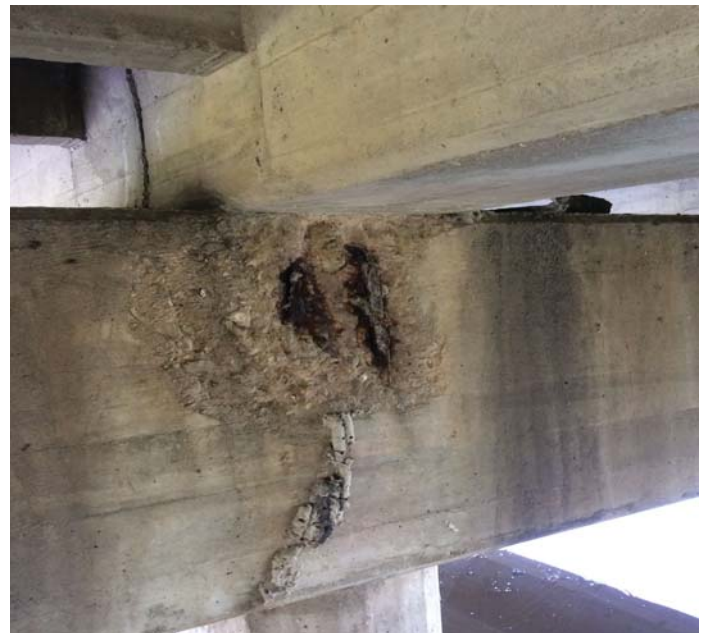
PHOTO 2 Description Spall with rebar exposed to cap @ Bent 2 back & ahead side. (Ahead side)

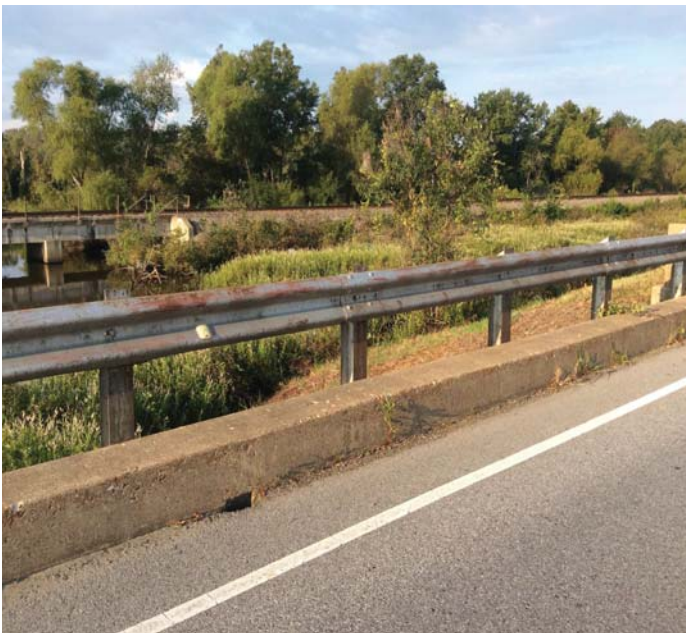
330 - Metal Bridge Railing	1- Ben.	204	ft.	204			
	Paint peeling/ rust forming						
515 - Steel Protective Coating		612	sq. ft.	612

Paint peeling and rust forming to all post and guard rail.

PHOTO 1 Description Paint peeling and rust forming to all post and guard rail.

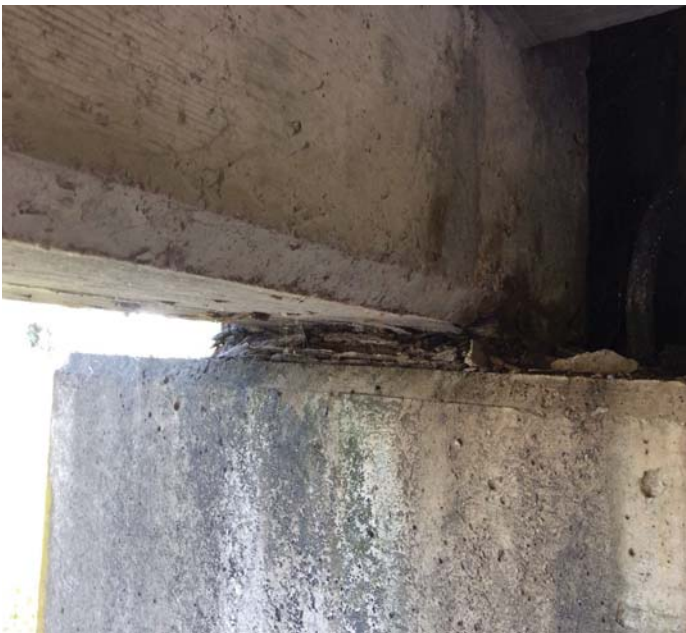
Bearings 1 & 6 @ Bent 2 have rust and section loss.

PHOTO 1 Description Bearings 1 & 6 @ Bent 2 have rust and section loss.

Work Code: Replace
