Bridge Inspection Report

A1329
US 64 WHITE
over
GLAISE CREEK

Structure Number: A1329

Facility Carried: US 64 WHITE

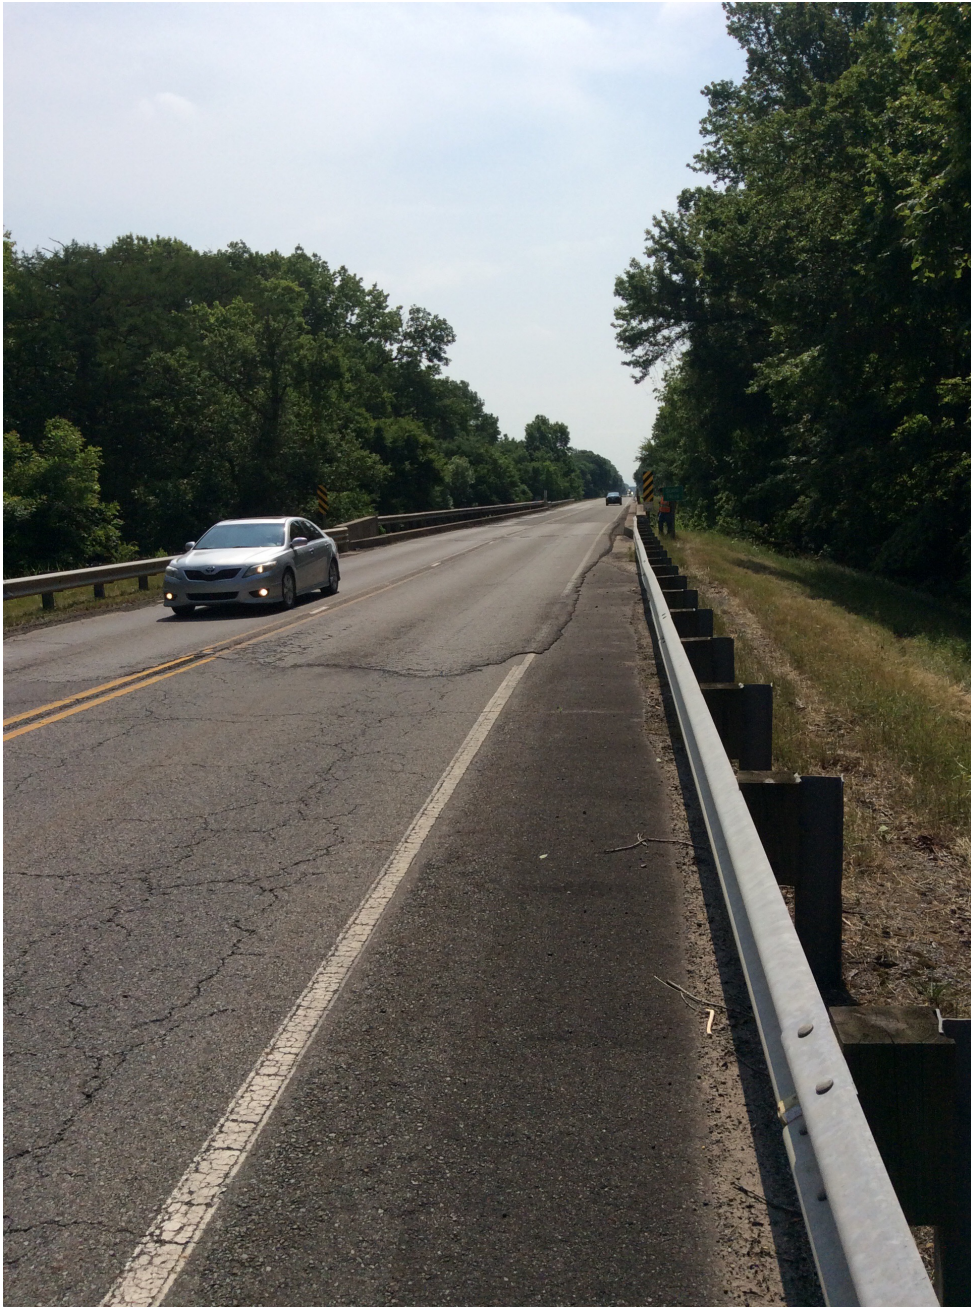
6 inches of asphalt on the deck

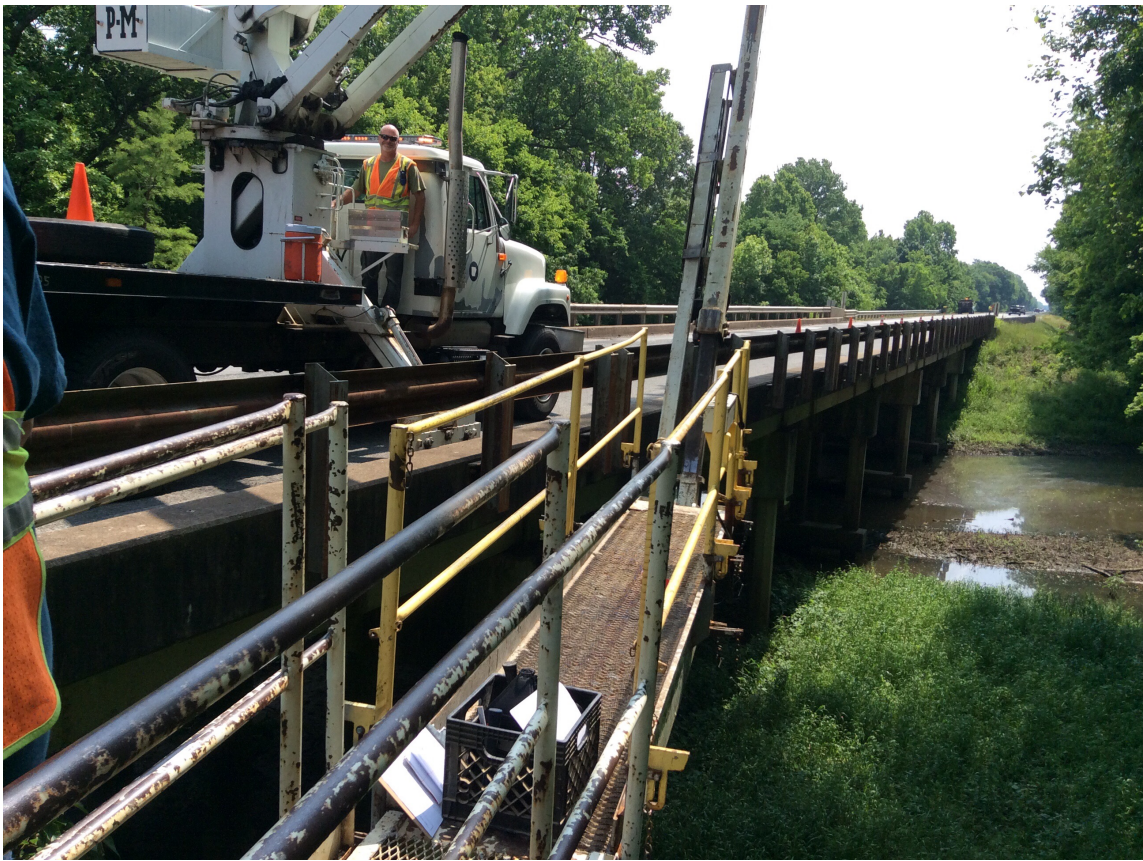
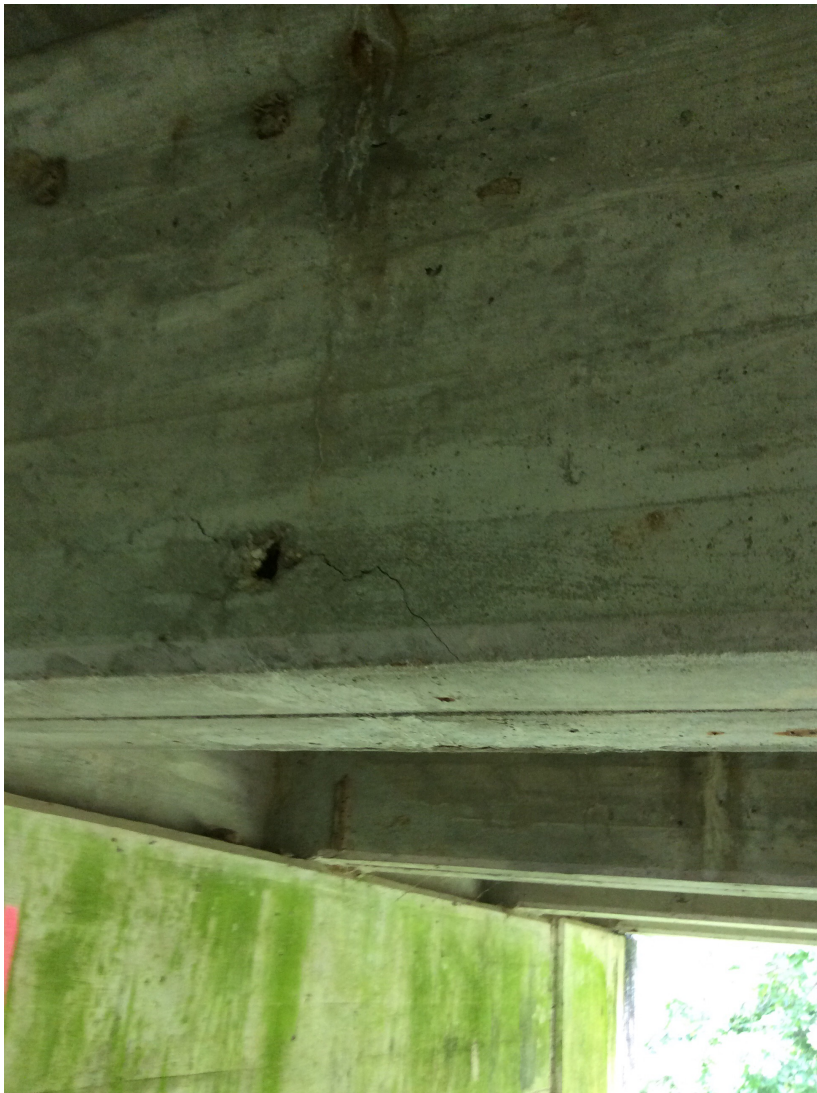
Span 2, Girder 4 - typical cracking to girder

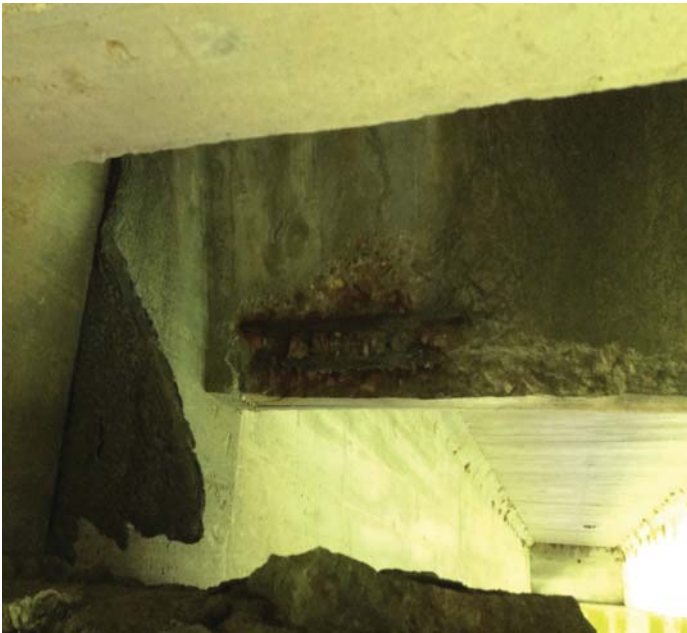
Spalls with rebar exposed to girders &/or diaphragms at Spans 2 - 8.

PHOTO 1 Description Typical spalls with rebar exposed to concrete haunches.

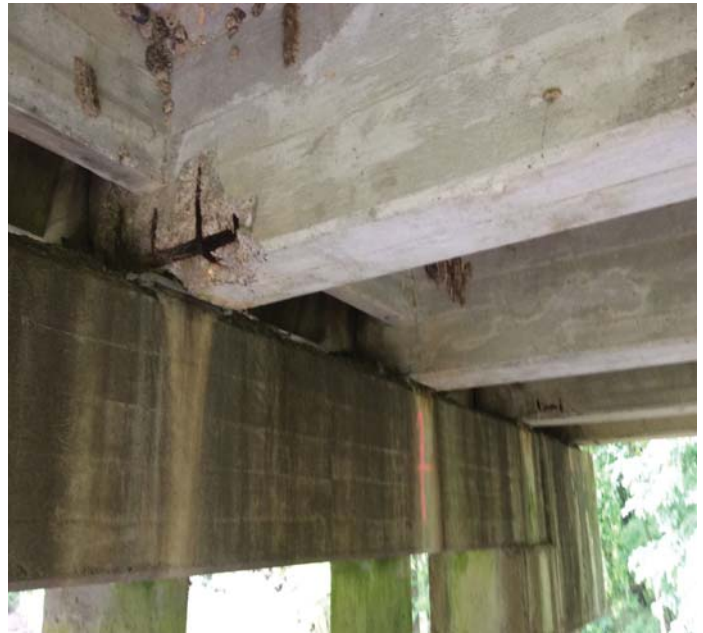
PHOTO 2 Description Span 4. Spall to Girder 3 with 3' rebar exposed & Girder 5 with 1' rebar exposed.

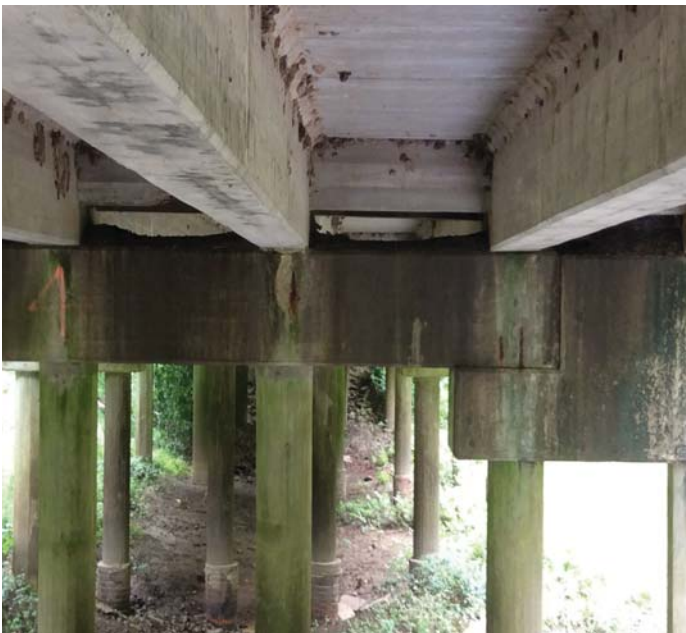
Spalls with rebar exposed to caps at Bents 1 - 4

PHOTO 1 Description Bent 4. Spall with 2' rebar exposed.

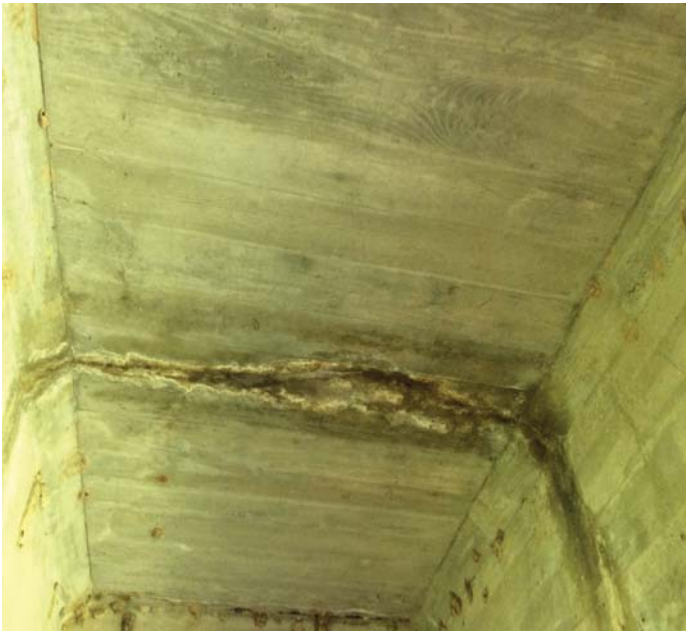
Spalls with rebar exposed &/or transverse efflorescent cracks, some with rust, to deck below at all spans.

PHOTO 1 Description Typical efflorescent cracking & spall to soffit.

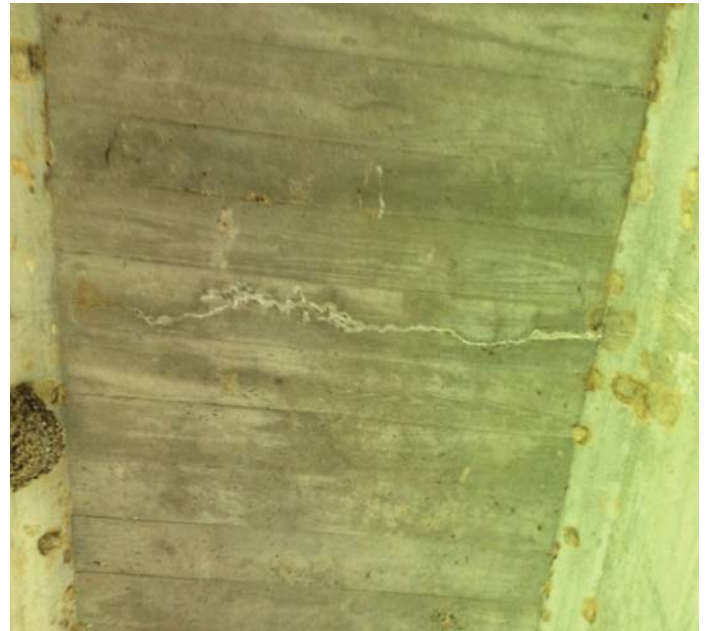
PHOTO 2 Description Typical efflorescent cracks to soffit.
