Bridge Inspection Report

A1330
US 64 WHITE
over
CUT OFF CREEK

Structure Number: A1330

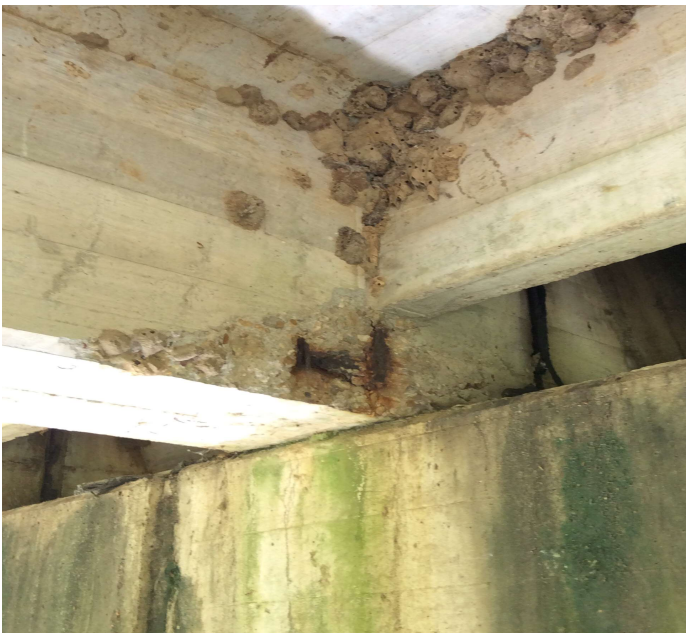
Spalls with rebar exposed to girders &/or diaphragm at Spans 2, 3, & 4

PHOTO 1 Description Span 3 Girder 5 Spall with 1' rebar exposed at beginning of span.

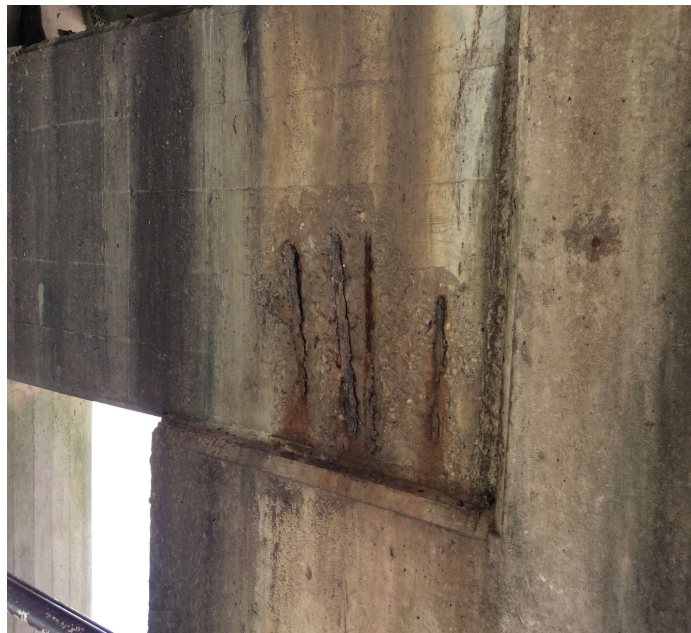
Spalls with rebar exposed &/or delaminating areas to caps at Bents 1, 2, 3, & 4.

PHOTO 1 Description Spall with 5' rebar exposed to back side of cap at Bent 2.

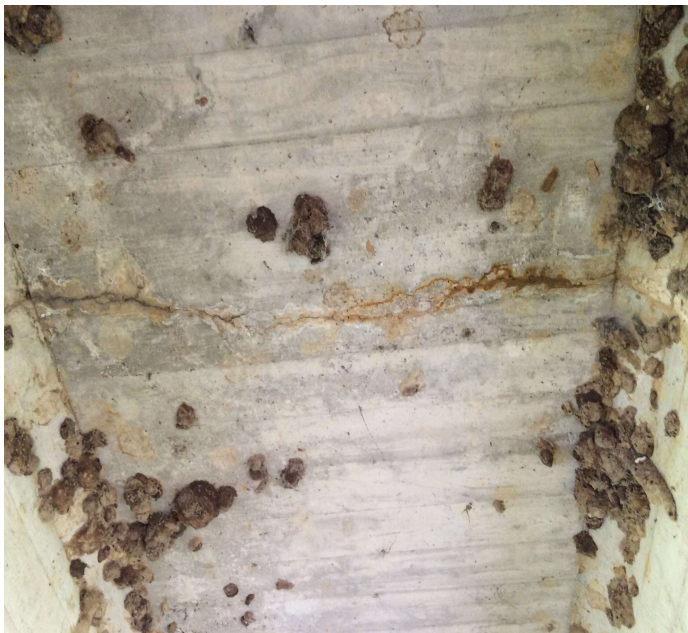
Spalls with rebar exposed & transverse cracks, some with rust, to deck below at all Spans.

PHOTO 1 Description Span 1. Typical transverse efflorescent cracks to soffit. Some with rust.

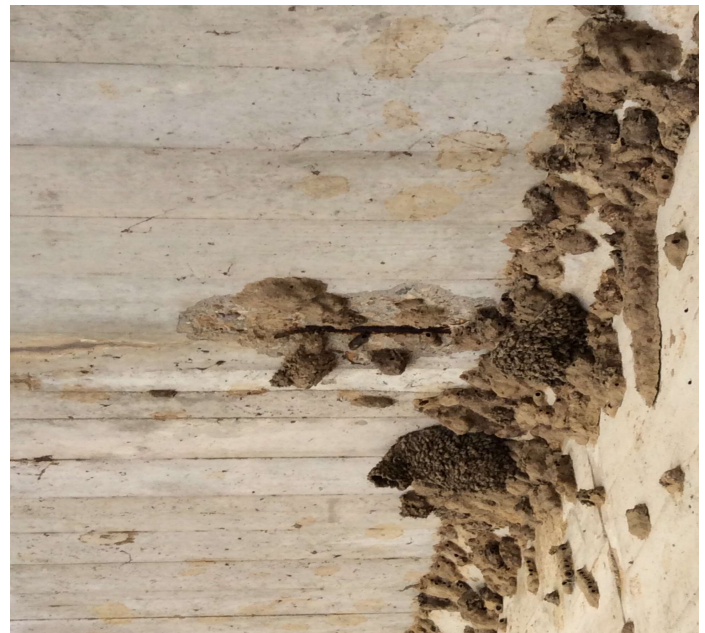
PHOTO 2 Description Spalls with rebar exposed & transverse cracks, some with rust, to deck below at all Spans.

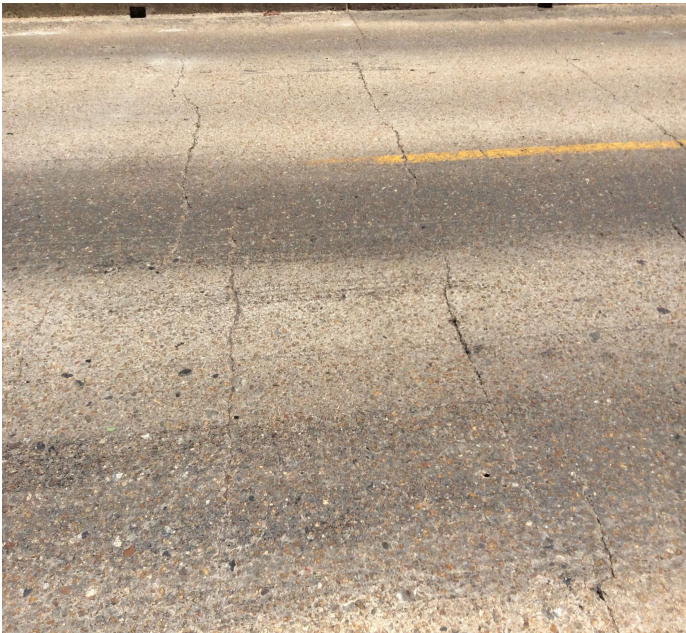
Unsealed cracks to deck & areas of heavy scaling & spalling in gutters at all Spans.

PHOTO 1 Description Typical deck cracking.

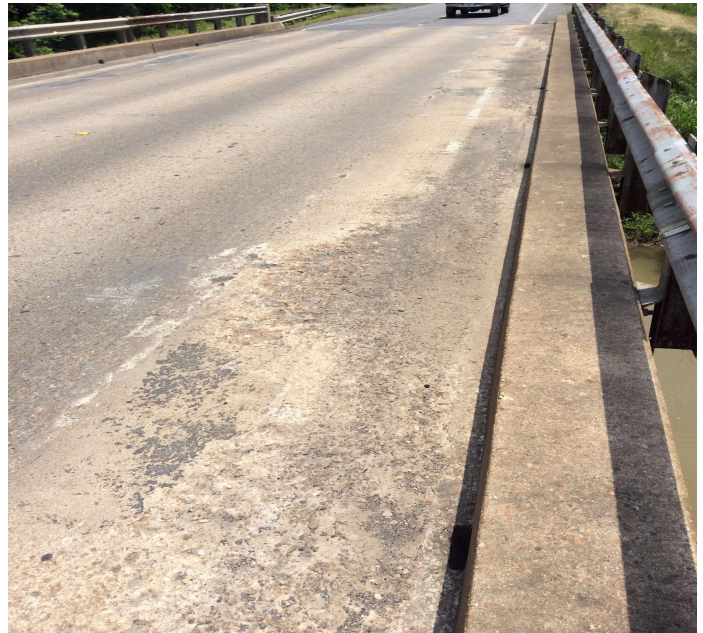
PHOTO 2 Description Areas of scaling to Left & Right gutters at all spans.

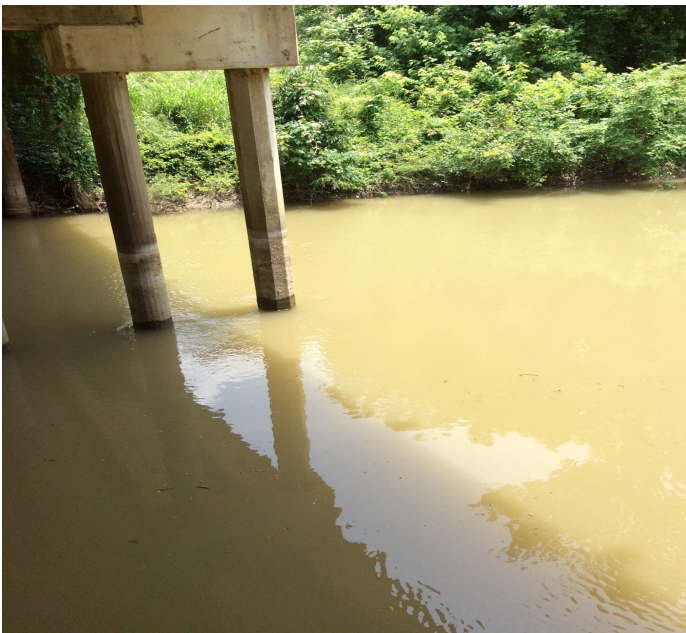
Scour present to right side at Bent 2 & 3.

PHOTO 1 Description Scour to right side of Bent 2 & 3.
