Bridge Inspection Report

**A1331
US 64 WHITE
over
WHITE RIVER RELIEF**

Structure Number: A1331

Facility Carried: US 64 WHITE

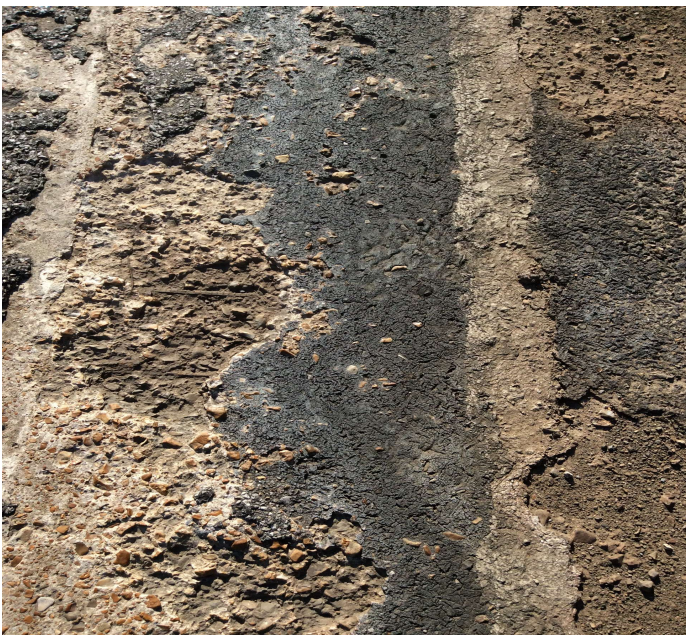
Deterioration & scaling to left & right gutters at all Spans.
Spans 8, 12, & 13 have rebar exposed.

PHOTO 1 Description Area of deterioration & scaling w/t rebar exposed in right gutter line at Span 8.

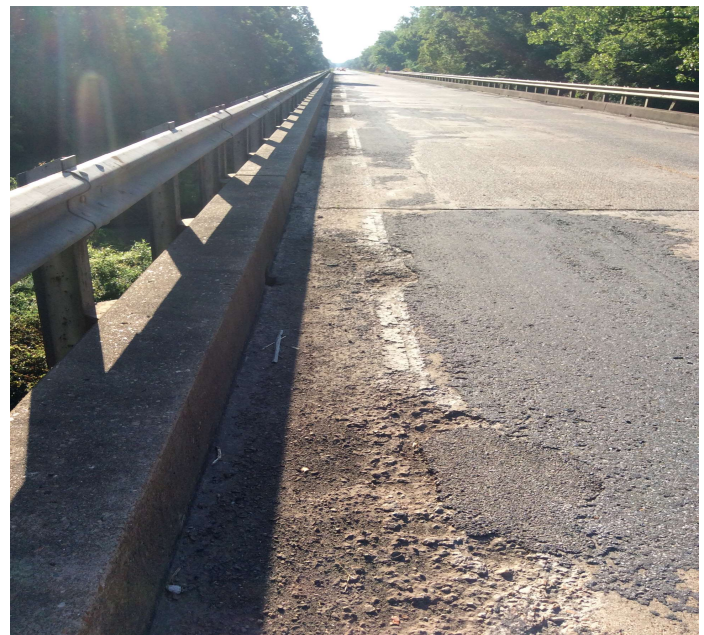
PHOTO 2 Description Deterioration & Scaling of gutter on left side, typical of Left & Right.

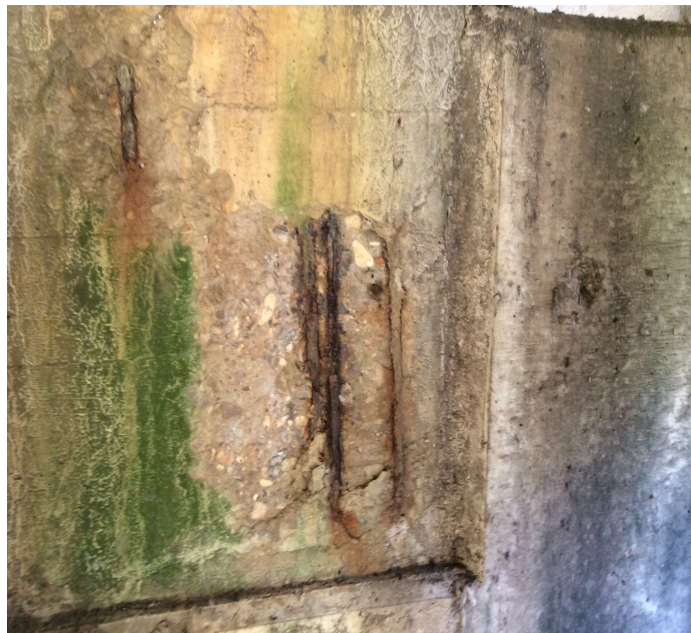
Cracks & spalls with rebar exposed to cap at Spans 1-10 & 11-16.

PHOTO 1 Description Cracks & Spalls with rebar exposed to cap at Spans 2 - 6 & 8 - 16.

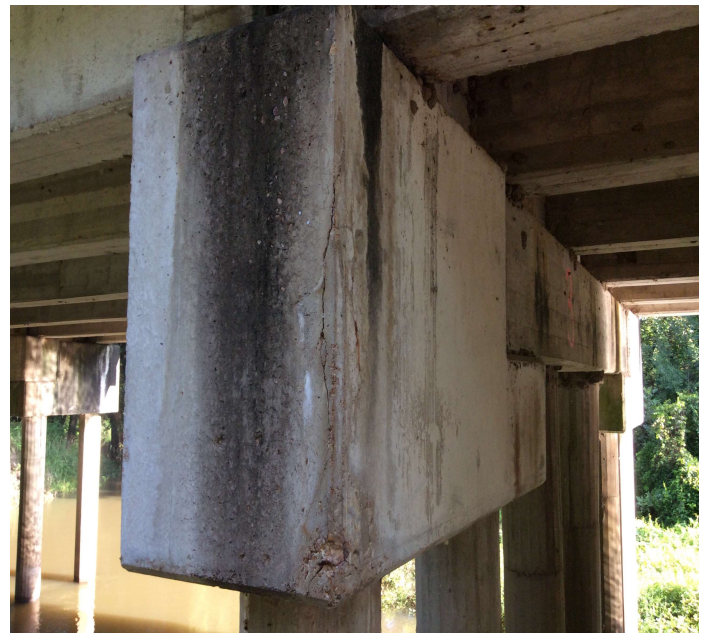
PHOTO 2 Description Crack on Right end of cap at Bent 3. Cracks & Spalls with rebar exposed to caps at Spans 2 - 6 & 8 - 16.

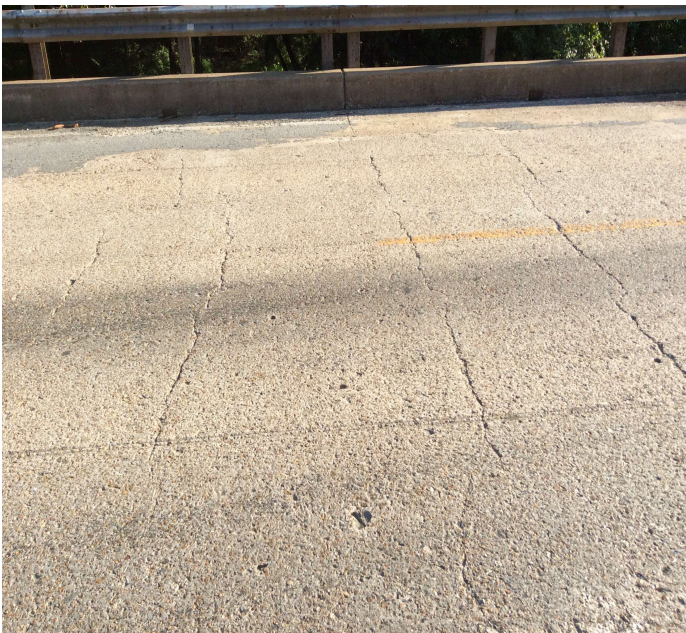
Unsealed cracks to deck at all spans.

PHOTO 1 Description Span 1. Typical of unsealed cracks to deck at all spans.

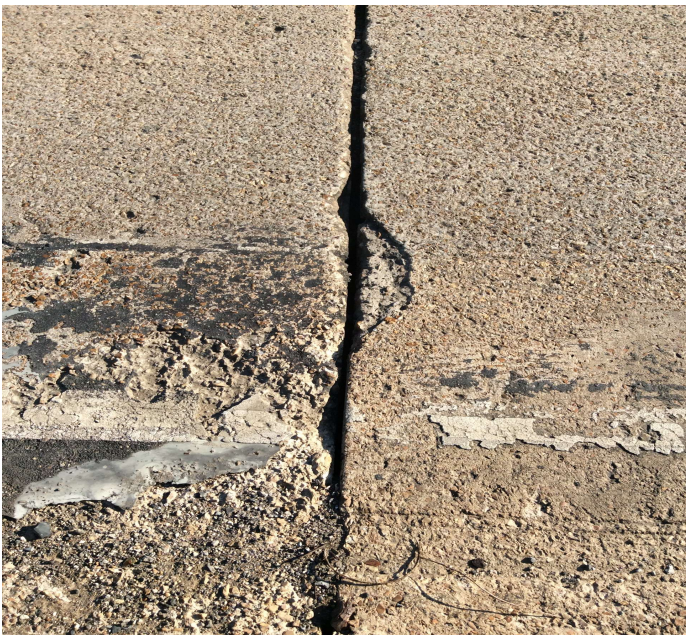
Joints are cracked, deteriorated & filled with debris at Bents 2, 4, 6, 8, 10, 12, 14, and 16.

PHOTO 1 Description Joints are cracked, deteriorated & filled with debris at Bents 2, 4, 6, 8, 10, 12, 14, and 16.

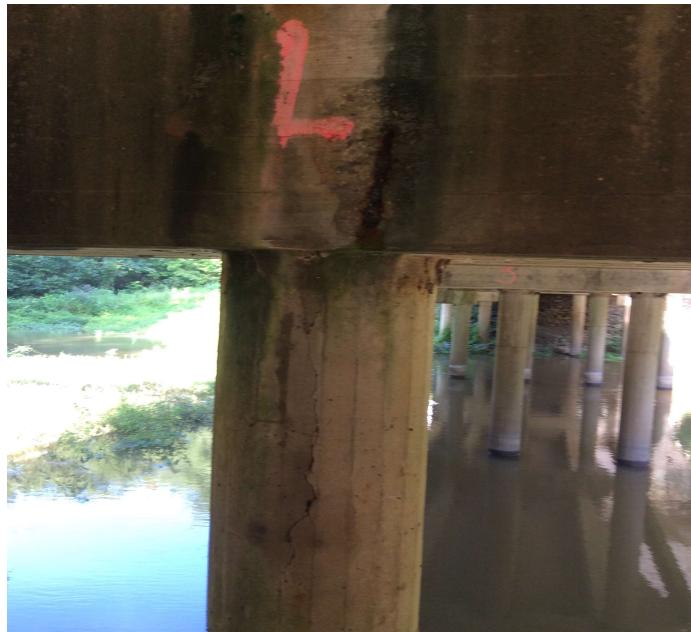
Spalls with rebar exposed with some section loss &/or cracking to concrete piles:

PHOTO 1 Description Pile 4 at Bent 4.
Typical of spalls with rebar exposed
&/or cracking to concrete piles at Bents
2, 3, 4, 8,
10, & 11.

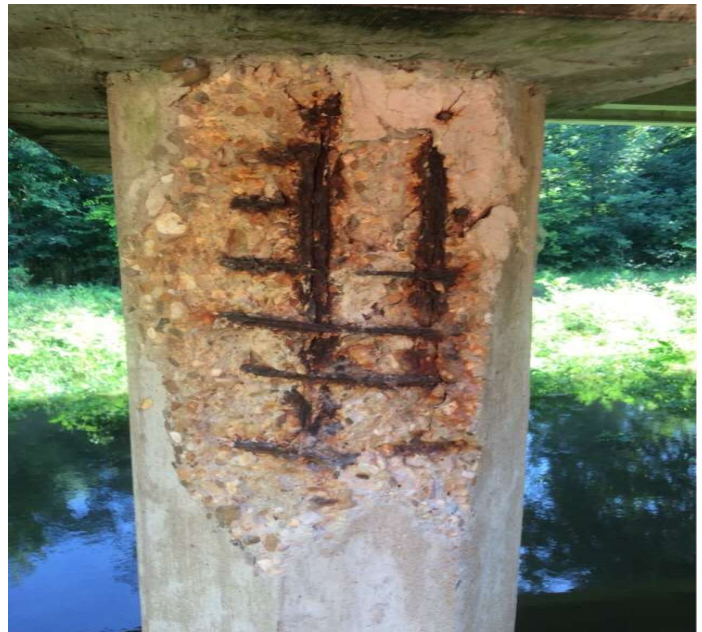
PHOTO 2 Description Pile 6 at Bent 8 with section loss to
rebar.
Spalls with rebar exposed &/or cracking
to concrete piles at Bents 2, 3, 4, 8, 10,
& 11.

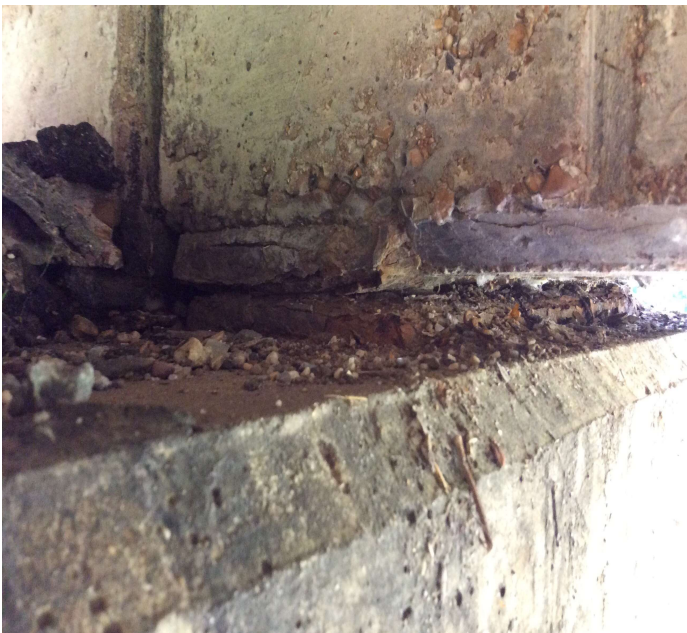
Rust to bearings 1 & 6 at Bents 2, 4, 6, 8, 10, 12, 14, and 16.

PHOTO 1 Description Bearing assembly below Girder 6.
Typical of rust to Bearings 1 & 6 at
Bents 2, 4, 6, 8, 10, 12, 14, and 16.

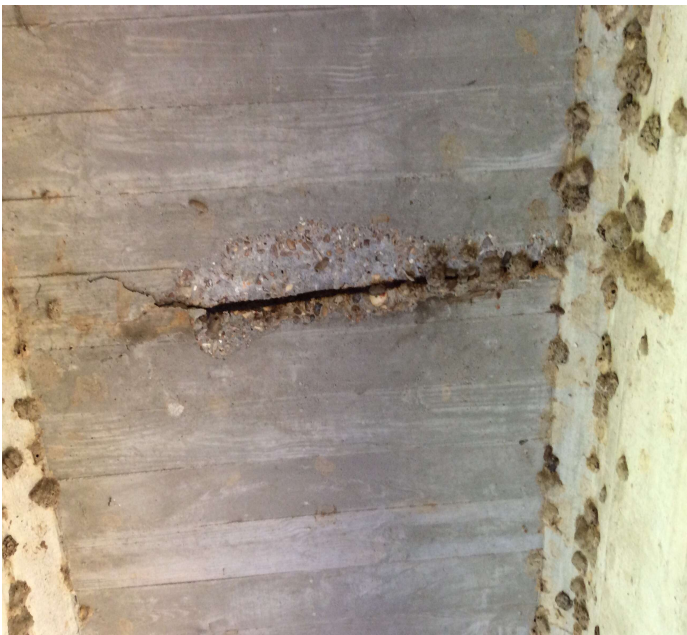
Spalls to deck below, some with rebar exposed at all spans.

PHOTO 1 Description Span 3 between G4-G5.
Typical of spalls to deck below, some
with rebar exposed at all spans.

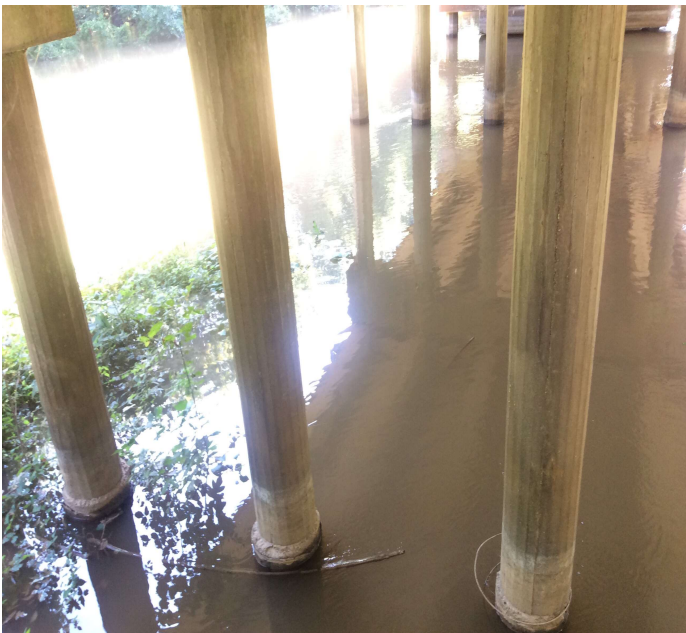
Scour at Bents 4, 9, 10, 11, 12, 13, 14, 15 & 16.

PHOTO 1 Description Typical of scour at Bents 1, 2, 4, 9, 10, 11, 12, 13, 14, 15 & 16.

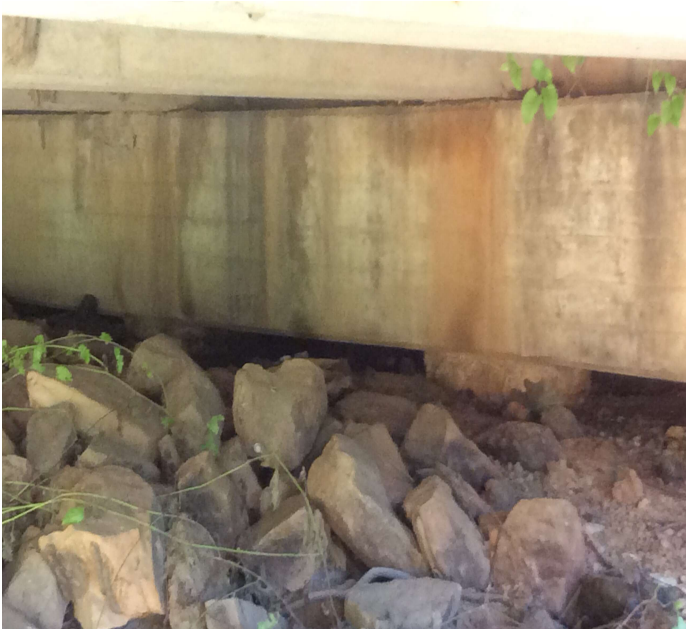
Embankment has settled at Abutment 1 & 2 with 2 piles exposed at each abutment.

PHOTO 1 Description Photo at Abutment 2.
Embankment has settled at Abutment 1
& 2 with 2 piles exposed at each
abutment.

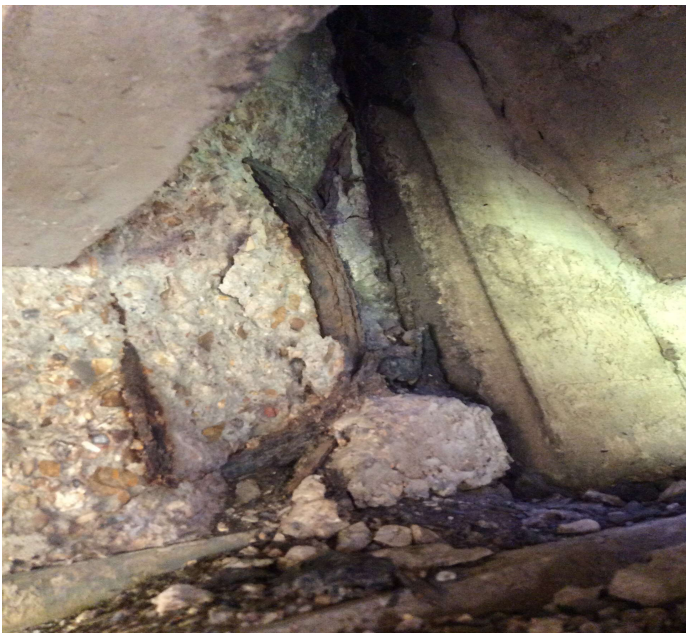
Spalls with rebar exposed to several Girders at Spans 2 - 17.

PHOTO 1 Description Girder 5 at Span 2.
Typical of spalls with rebar exposed to
girders at
Spans 2 - 17.

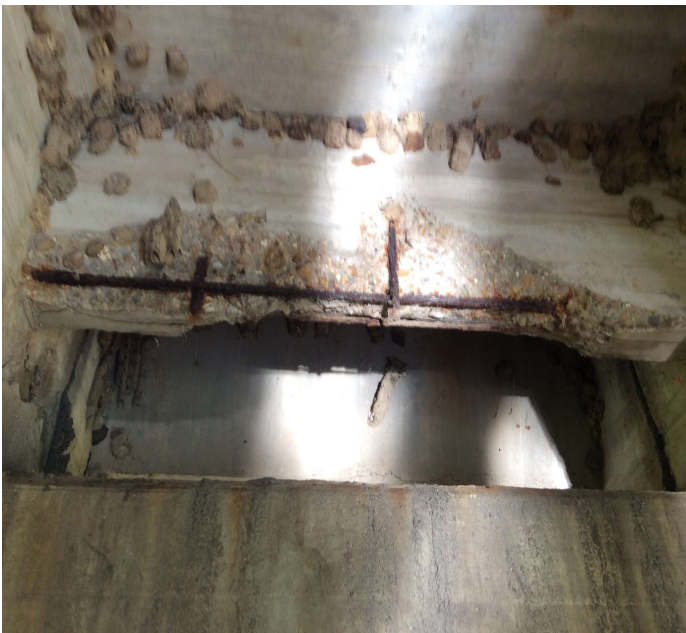
Spalls with rebar &/or cracking to concrete diaphragms at Spans 3, 5, 10, 11, 12, 13, 17.

PHOTO 1 Description Typical diaphragm at G3 - G4 at Bent 2.
Spalls with rebar &/or cracking to
concrete diaphragms at Spans 5 - 8 &
10 - 14 & 17.
