Bridge Inspection Report

A1332
US 64 WHITE
over
WHITE RIVER RELIEF

Structure Number: A1332

Facility Carried: US 64 WHITE

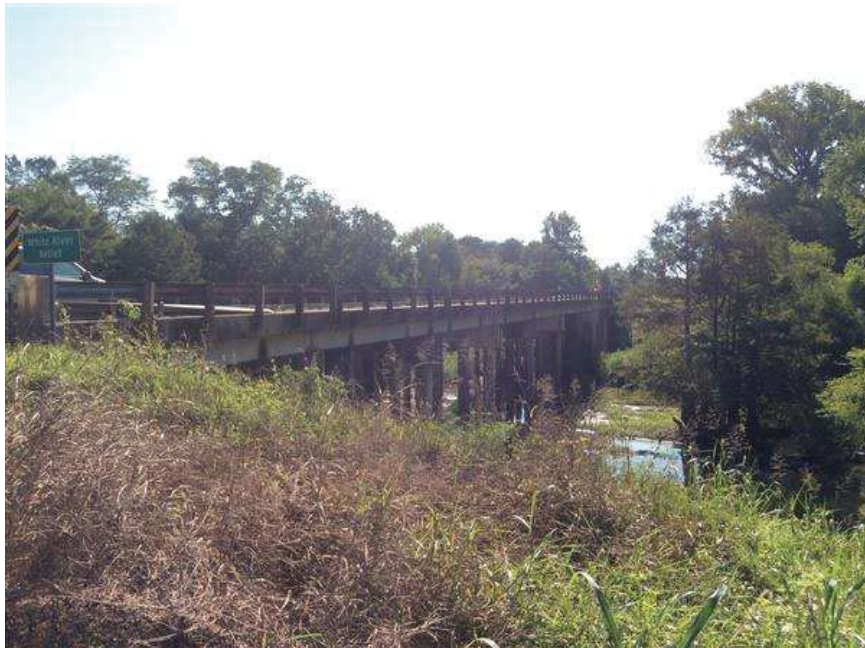
Logmile looking East.
Construction Job: 5501.

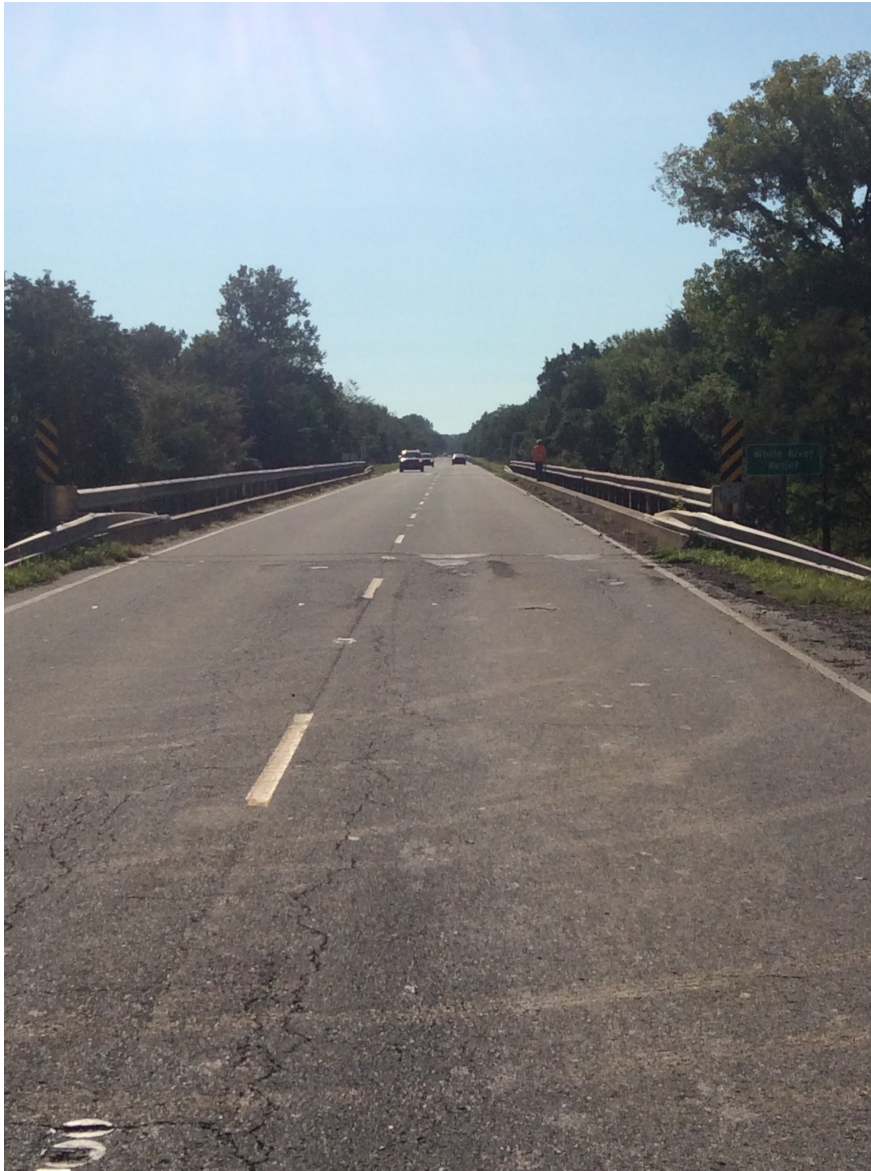
2 inches of asphalt on to p of the deck.

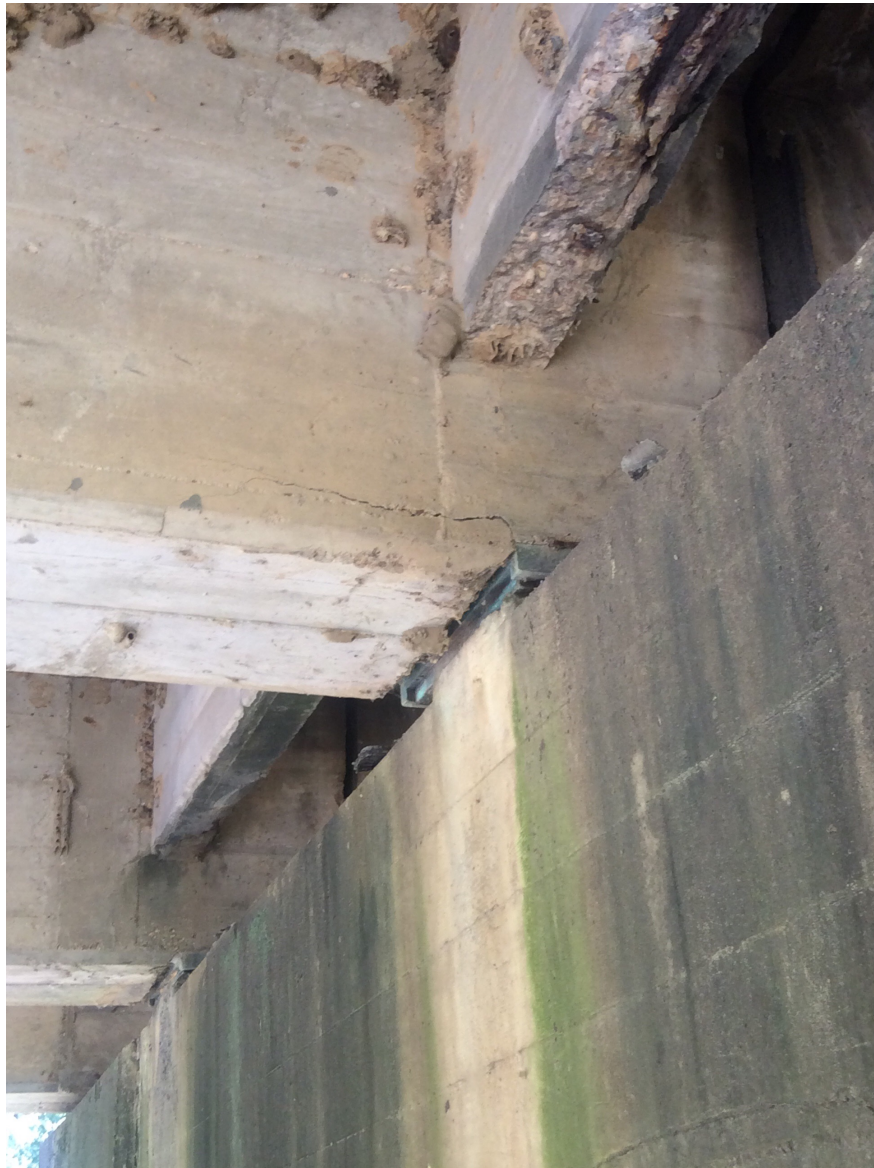
Typical cracking to bottom of girders at random areas.

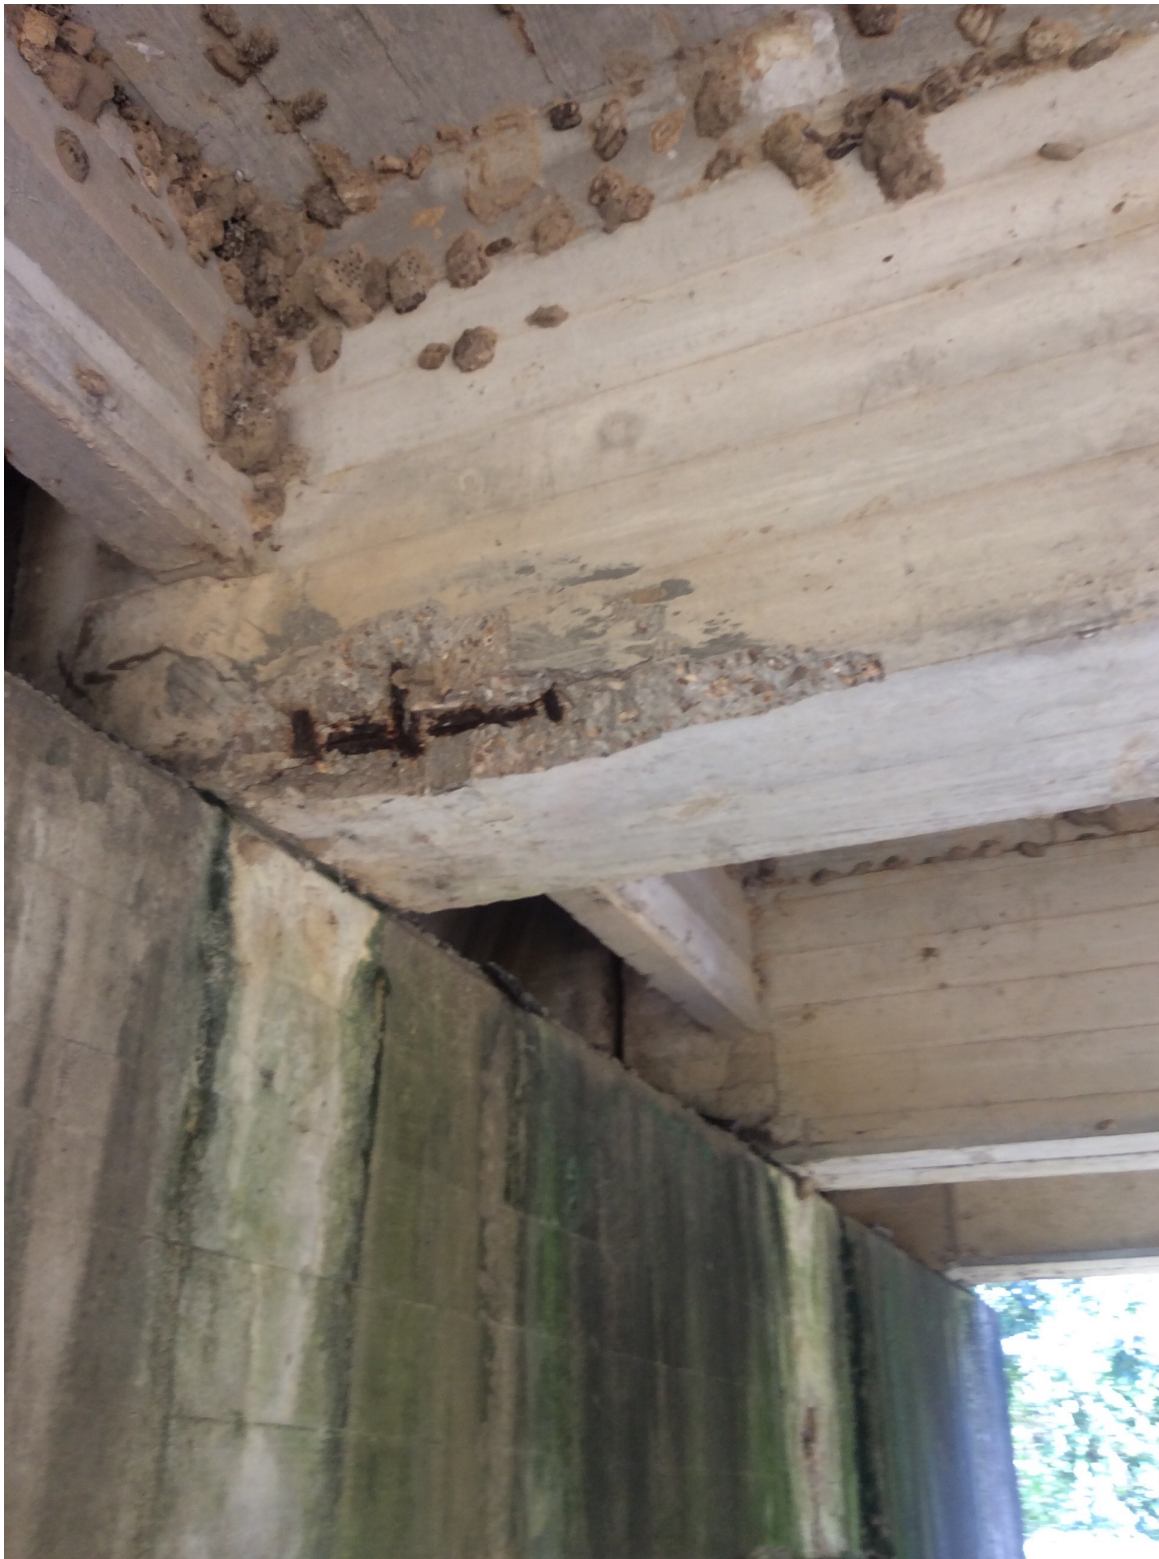
Span 6 Girder 3 - Typical cracking, delaminating, and spalling with rebar exposed to girders at all spans

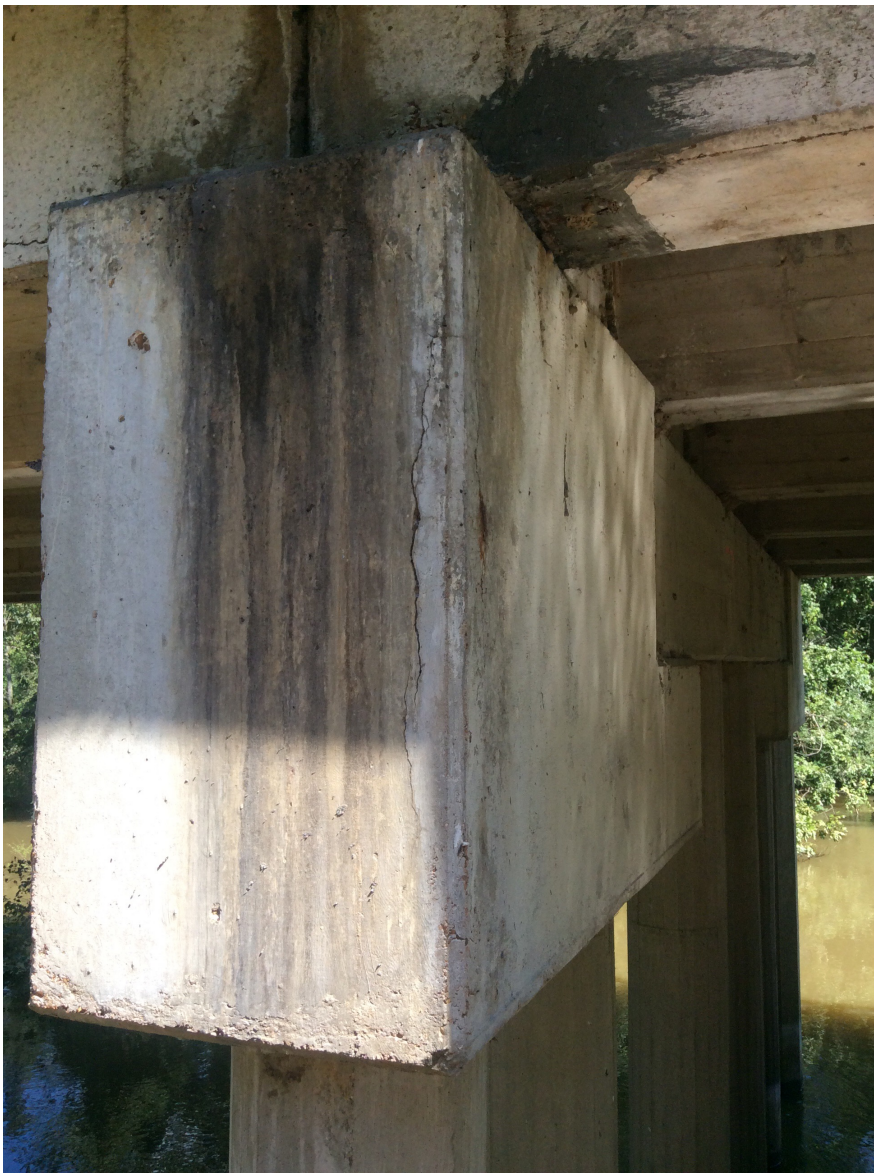
Bent 7 - typical of cracks, delamination, and spalls with rebar exposed to caps at Bents 1 through 9

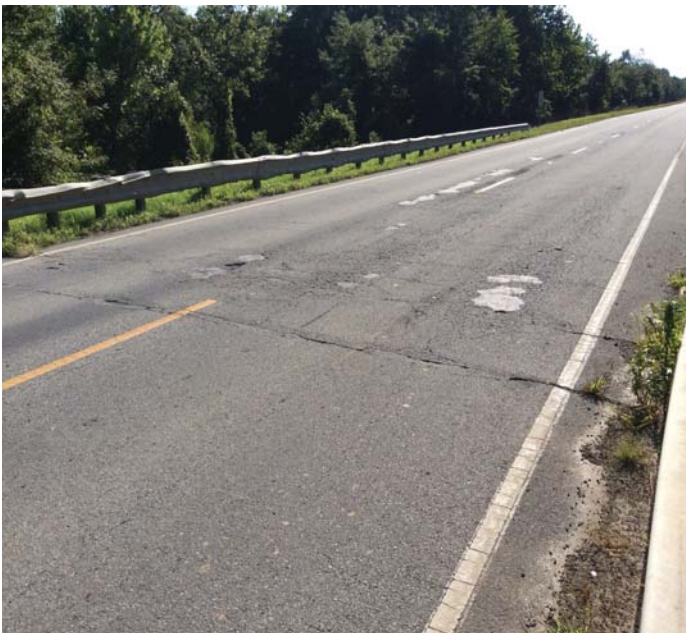
Priority: D - Routine

Visible settlement to roadway approaches at Abutments 1 & 2.

PHOTO 1 Description Visible settlement to roadway approaches at Abutments 1 & 2.

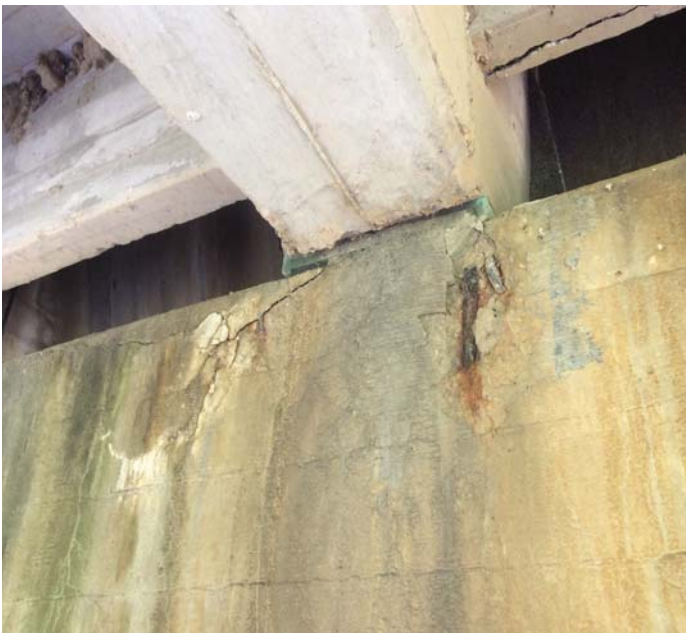
Priority: C - Important

Cracks, delaminating &/or spalls with rebar exposed to caps at Bents 1 - 9.

PHOTO 1 Description Cracks, delaminating &/or spalls with rebar exposed to caps at Bents 1 - 9.

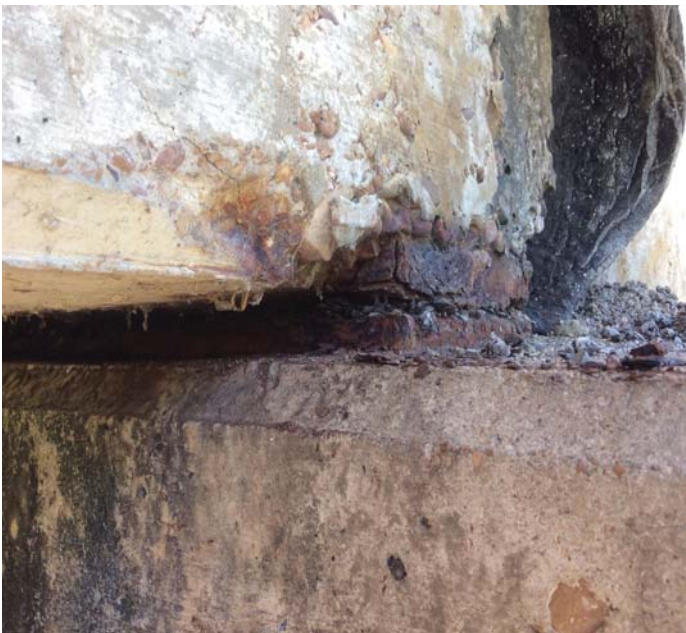
Priority: C - Important

Rust to bearings 1 & 6 at Bents 2, 4, 6, & 8

PHOTO 1 Description Span 4 Girder 6 - Typical of rust to Bearings 1 & 6 at Bents 2, 4, 6, & 8.

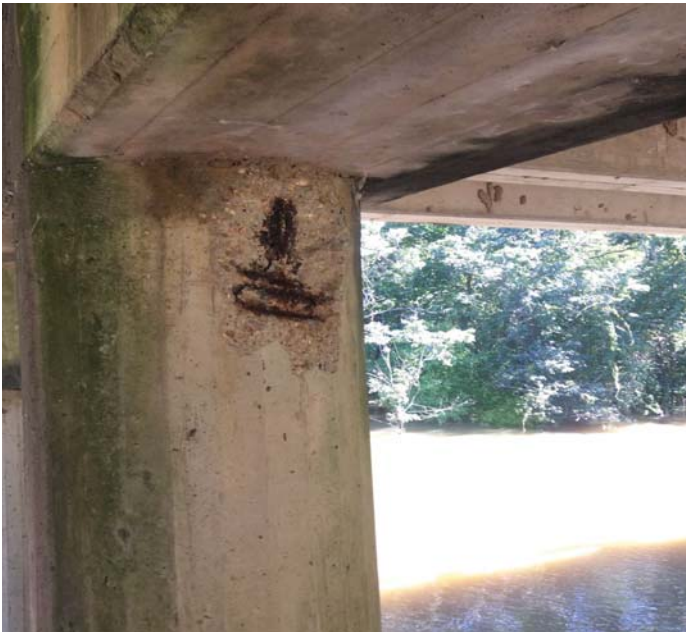
Priority: C - Important

Bent 4 Pile 3 - Cracking, delaminating & spalls with rebar exposed.
Bent 8 Piles 6 - Minor spall.

PHOTO 1	Description	Bent 4 Pile 3 - Cracking, delaminating & spalls with rebar exposed at top of piles.
---------	-------------	---

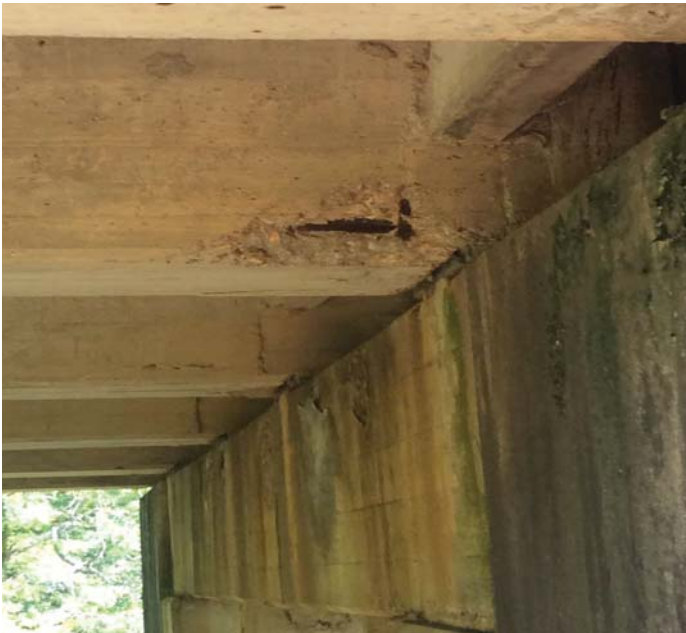
Priority: C - Important

Cracking, delaminating &/or spalls with rebar exposed to girders at all spans.

PHOTO 1 Description Bent 2 Girder 5 - Typical cracking, delaminating &/or spalls with rebar exposed to girders at all spans.

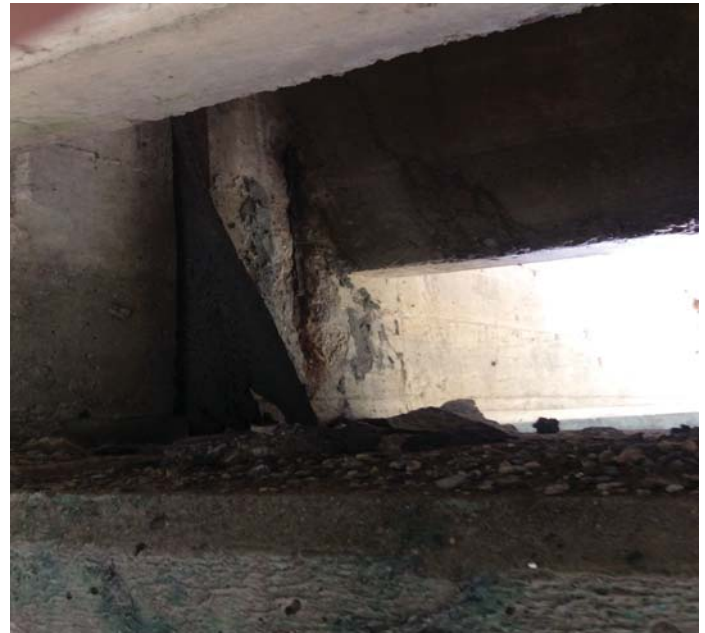
PHOTO 2 Description End of Girder 5 at Span 5. Cracking, delaminating &/or spalls with rebar exposed to girders at all spans.

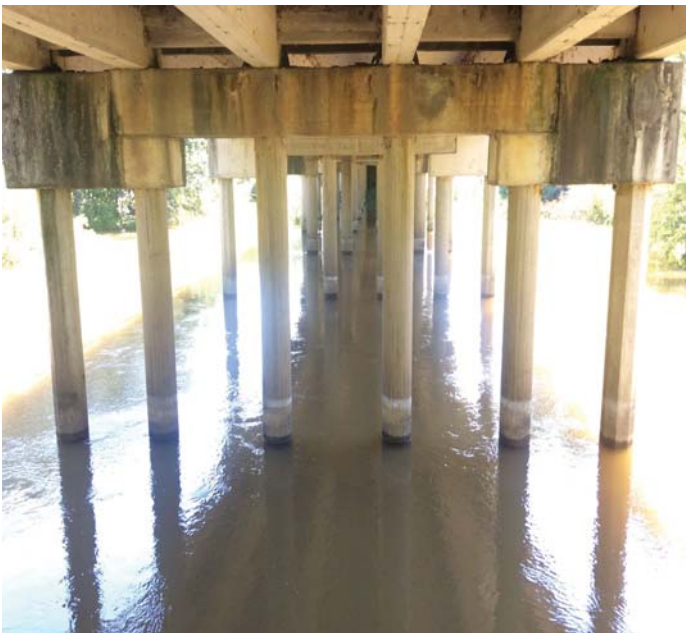
Priority: D - Routine

Minor scour to Bents 2, 3, 4, 5, and 7.

PHOTO 1 Description Minor scour to Bents 2, 3, 4, 5, and 7.
