# Bridge Inspection Report

**A1333**  
**US 64 WHITE CO.**  
**over**  
**WHITE RIVER RELIEF**

Structure Number: A1333

Facility Carried: US 64 WHITE CO.

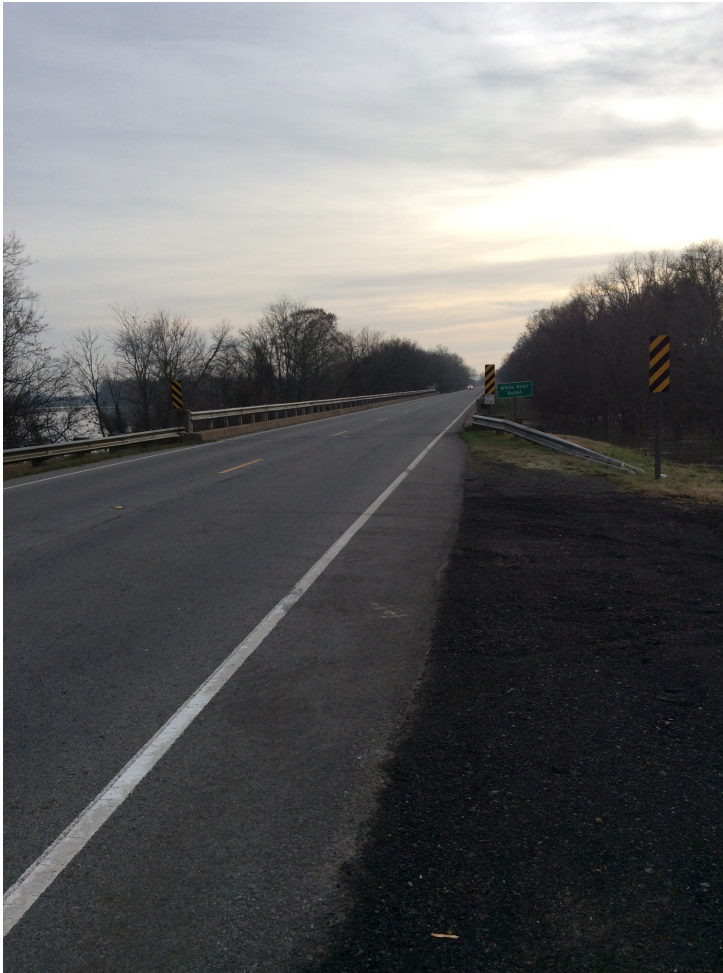
1 1/2 inches of asphalt on top of the deck

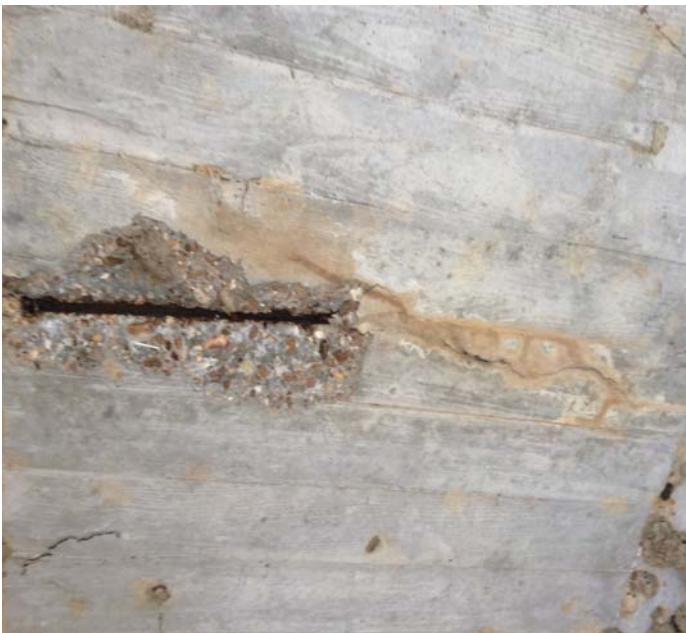
Spalls to Deck below with Rebar Exposed @ Spans 1, 2, 3, 5, 6, 7, 8, 9, 10, 11 & 12.

PHOTO 1      Description      Typical spalls with Rebar Exposed to Soffit @ Spans 2, 8, 11 & 12.

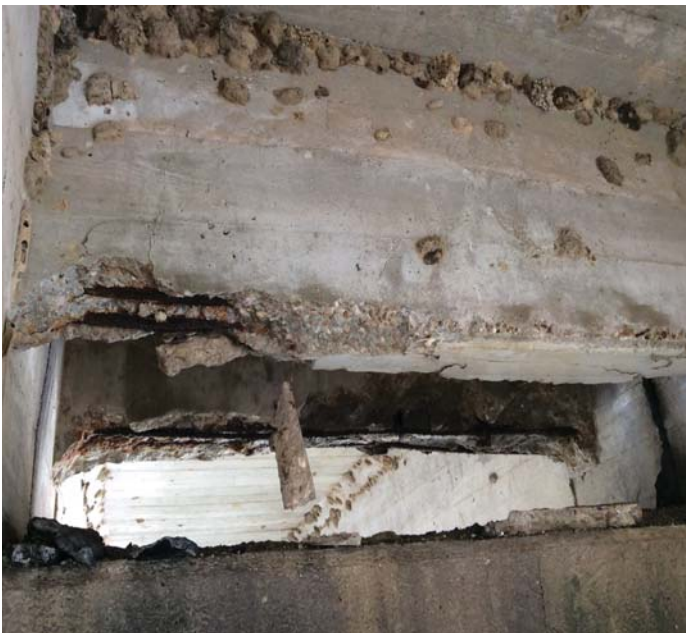
Spalls to concrete diaphragm with rebar exposed @ Spans 3, 4, 5, 6, 7, 8, 10, 11, 12 & 13.

PHOTO 1      Description      Spalls to Concrete Diaphragms with Rebar Exposed @ Spans 3, 4, 5, 8, 10 & 11.  
(Diaphragms between Girders 3 & 4 back & ahead side @ Bent 4.)

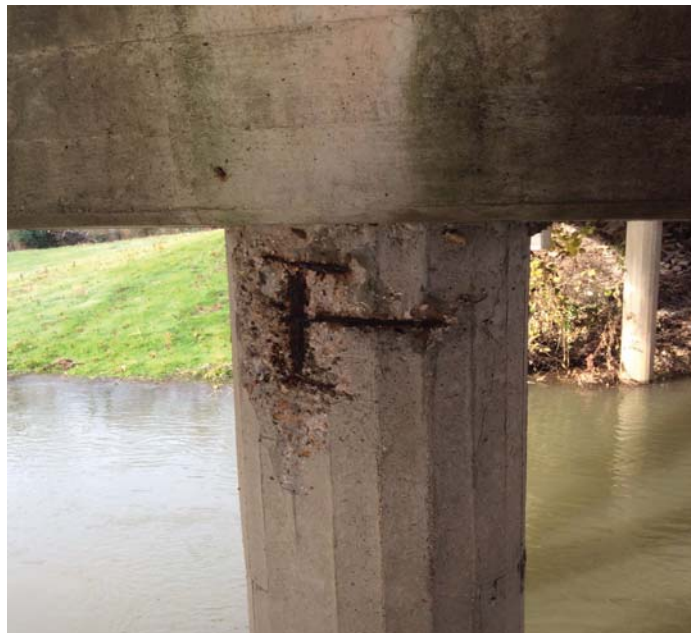
Spalls to Concrete Piles with Rebar Exposed @ Bents 2, 3, 4, 6 & 7.

PHOTO 1      Description      Typical spalls with Rebar Exposed to some Piles.  
(Bent 2 Pile 4)

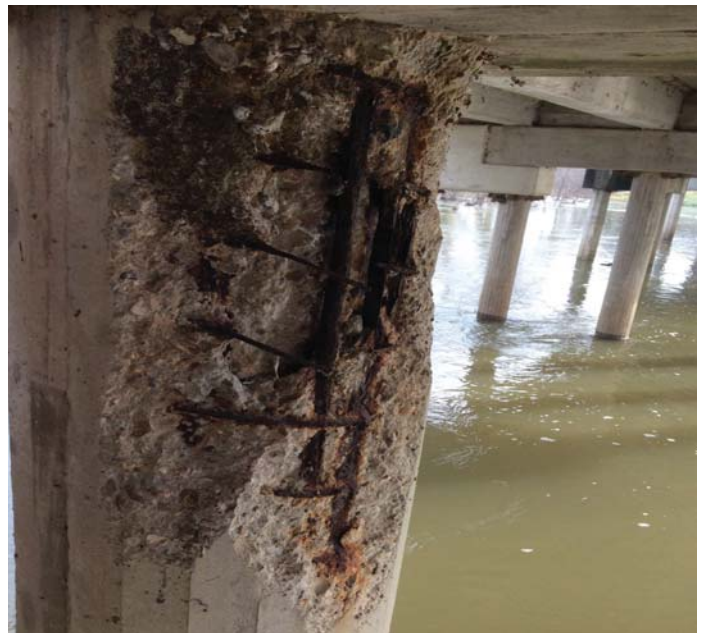
PHOTO 2      Description      Typical spalls with Rebar Exposed to some Piles.  
(Bent 4 Pile 4 has large spall with 9' Rebar Exposed.)

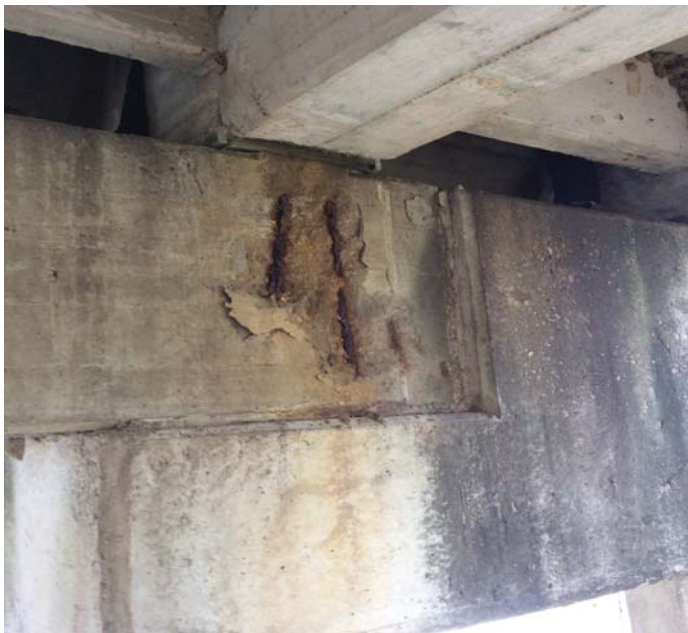
Spalls to Caps with Rebar exposed @ Bents 1, 2, 3, 4, 5, 6, 7, 8, 10, 11 & 12.

PHOTO 1      Description      Typical spalls with Rebar Exposed or areas of delamination to some Caps @ Bents 1, 2, 4, 8, 10, 11 & 12. (Bent 2 back side)

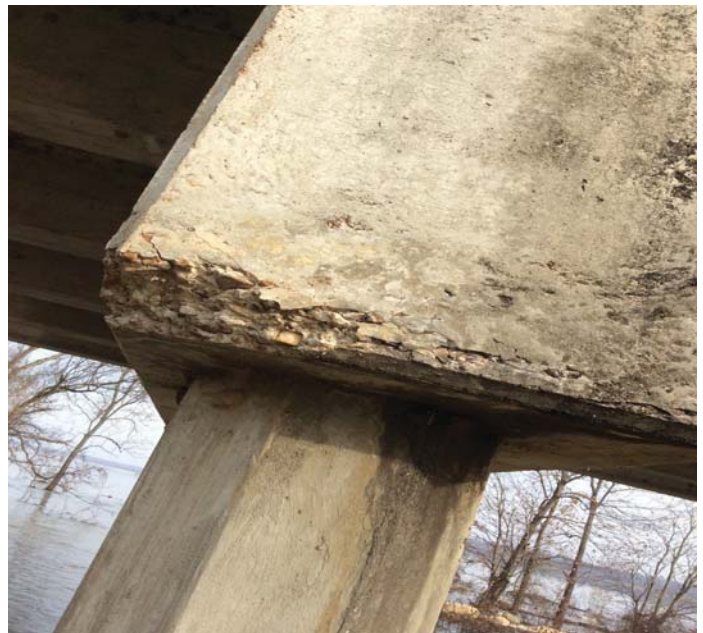
PHOTO 2      Description      Typical spalls with Rebar Exposed or areas of delamination to some Caps @ Bents 1, 2, 4, 8, 10, 11 & 12. (Bent 3 @ Right end.)

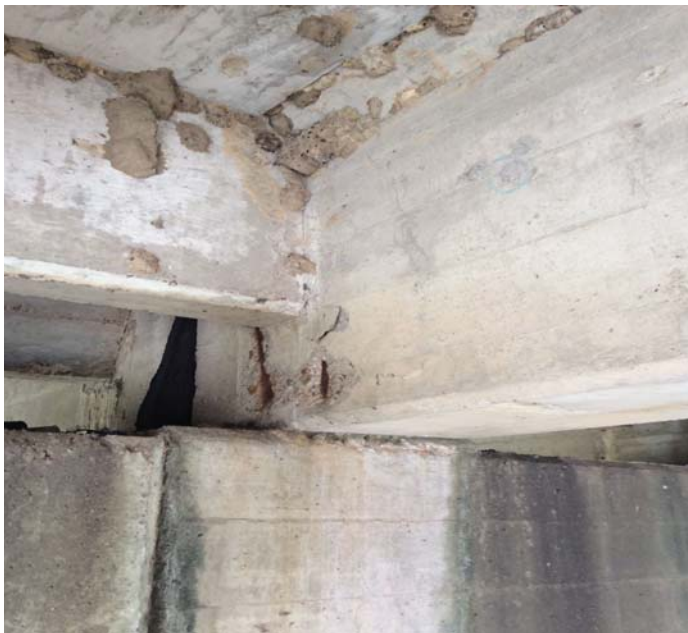
Spalls to Girders with Rebar Exposed v@ Spans 1 - 12.

PHOTO 1      Description      Spalls to Girders with Rebar Exposed  
@ Spans 1, 3, 4, 5, 6, 9, 10, 11 & 12.  
(Span 3 Girder 5 @ Beginning of Span)

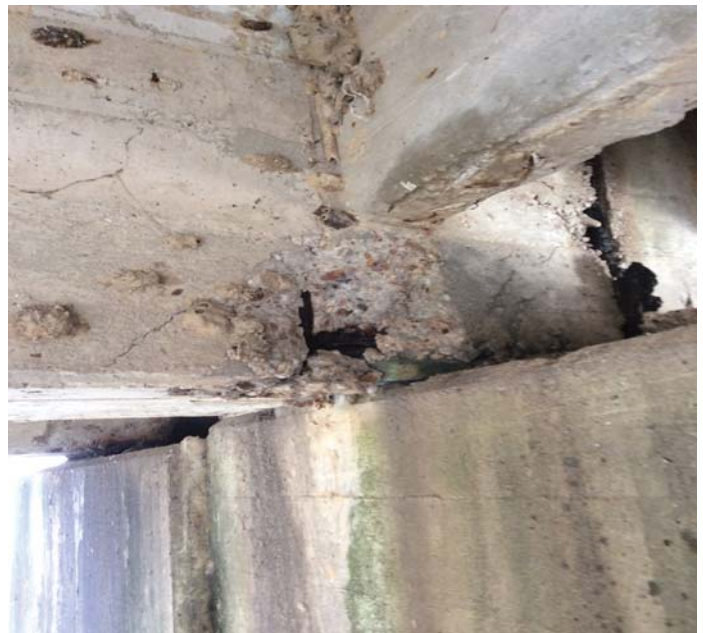
PHOTO 2      Description      Spalls to Girders with Rebar Exposed  
@ Spans 1, 3, 4, 5, 6, 9, 10, 11 & 12.  
(Span 4 Girder 2 @ End of Span)
