Bridge Inspection Report

A1334
US 64 WHITE
over
WHITE RIVER RELIEF

Structure Number: A1334

Facility Carried: US 64 WHITE

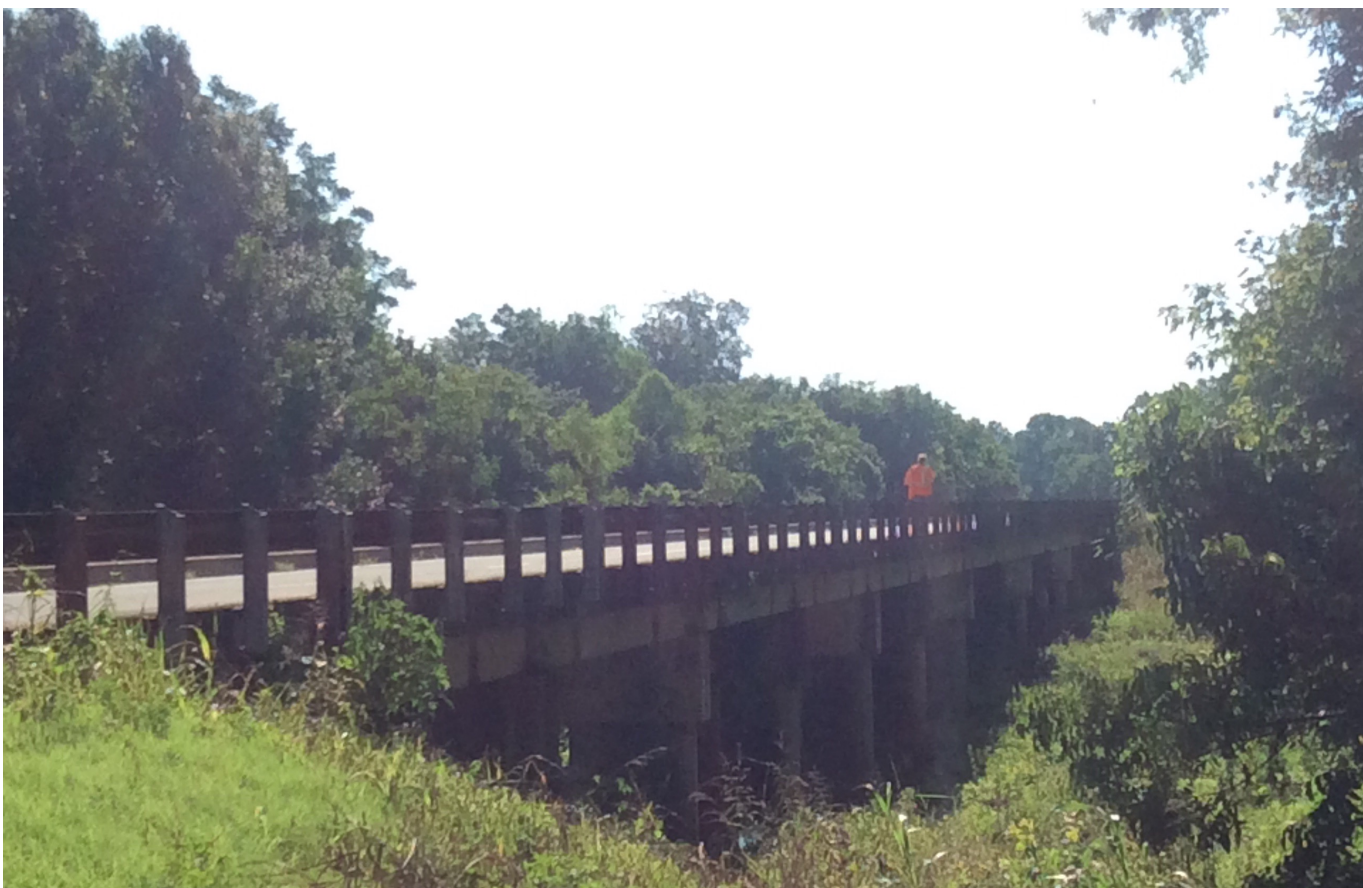
1 1/2 inches of asphalt on top of the deck

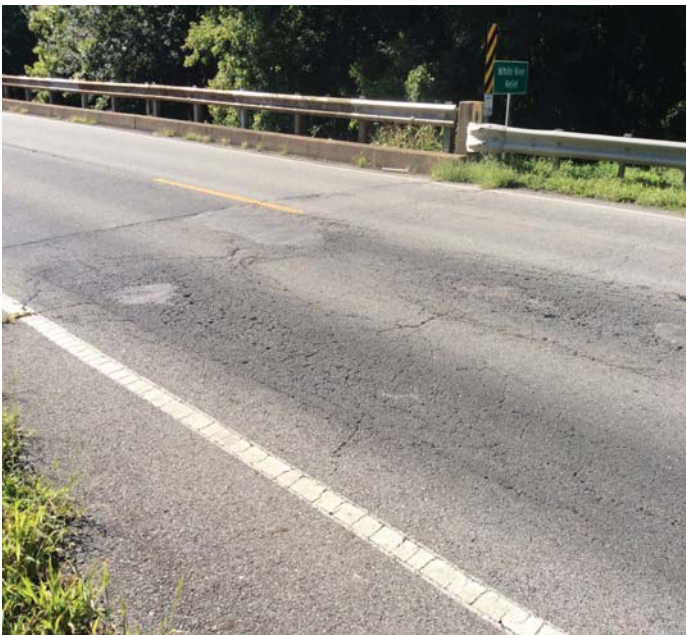
Visual settlement to approach roadway at Abutments 1 & 2.

PHOTO 1 Description Visual settlement to approach roadway at Abutments 1 & 2.

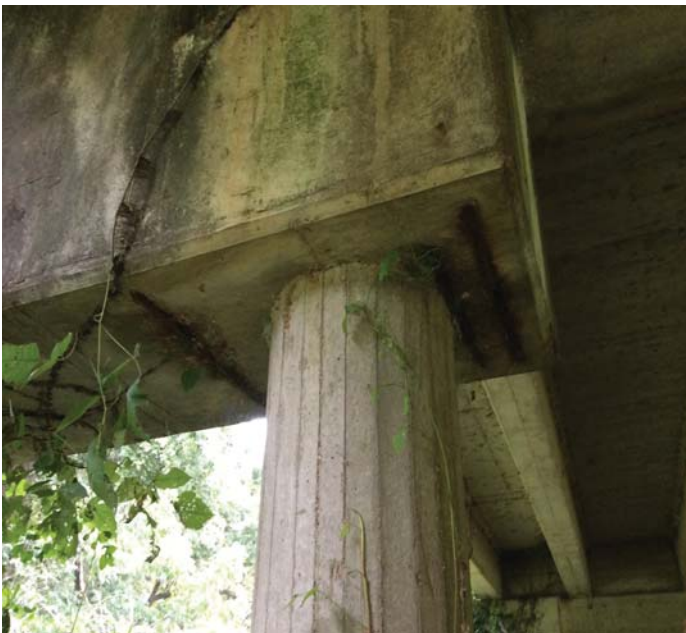
Spalls with rebar exposed to caps Bents 2, 3, 6, 7, 8, 9, 10, 11, & 12.

PHOTO 1 Description Spalls with rebar exposed to caps at Bents 2, 3, 6, 7, 8, 9, 10, 11, & 12.

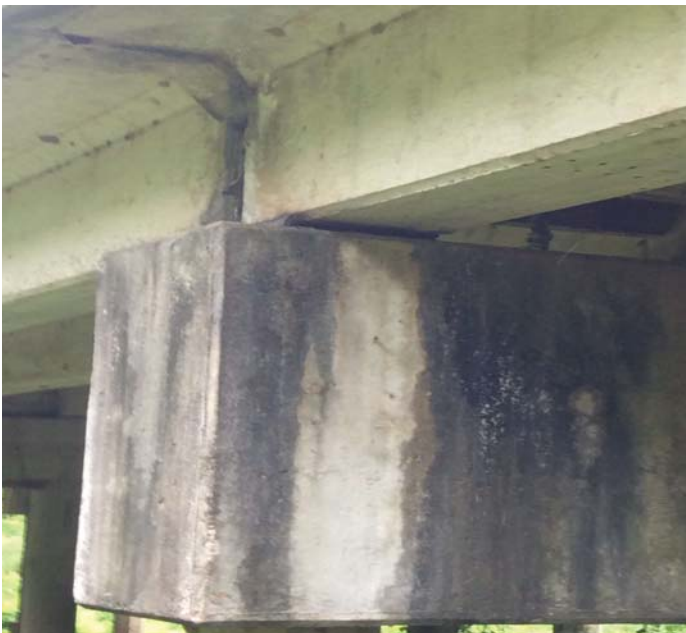
Rust & corrosion to Bearings 1 & 6 at Bents 2, 4, 6, 8, 10 & 12

PHOTO 1 Description Rust & corrosion to Bearings 1 & 6 at
Bents 2, 4, 6, 8, 10, & 12

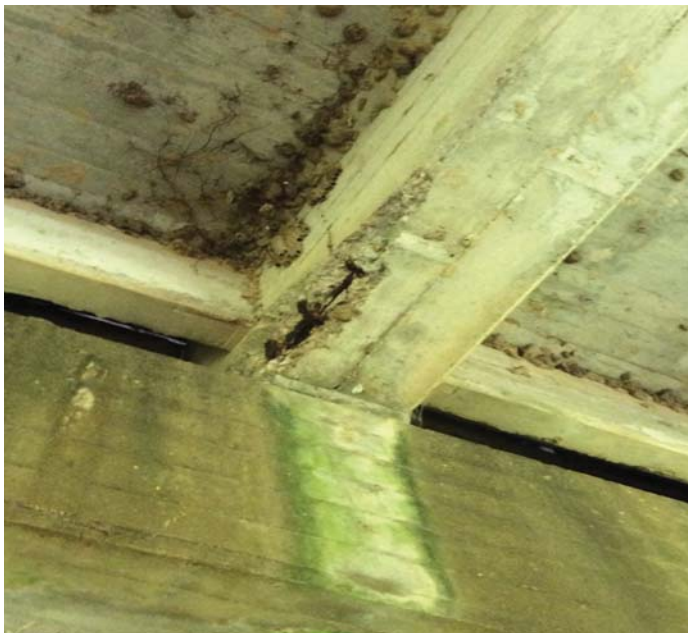
Cracking, delaminating &/or spalls with rebar exposed to end of girders & concrete diaphragms at all Spans.

PHOTO 1 Description Cracking, delaminating &/or spalls with rebar exposed to end of girders & concrete diaphragms at all Spans.

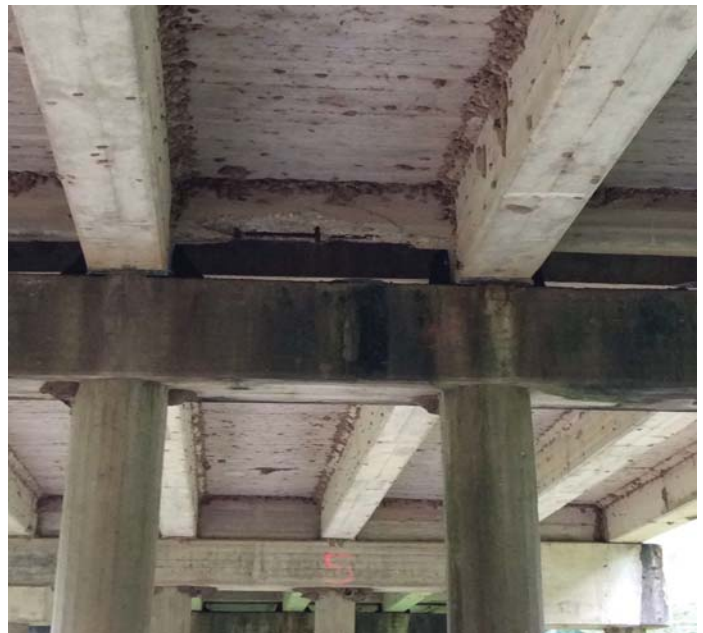
PHOTO 2 Description Cracking, delaminating &/or spalls with rebar exposed to ends of girders & concrete diaphragms.

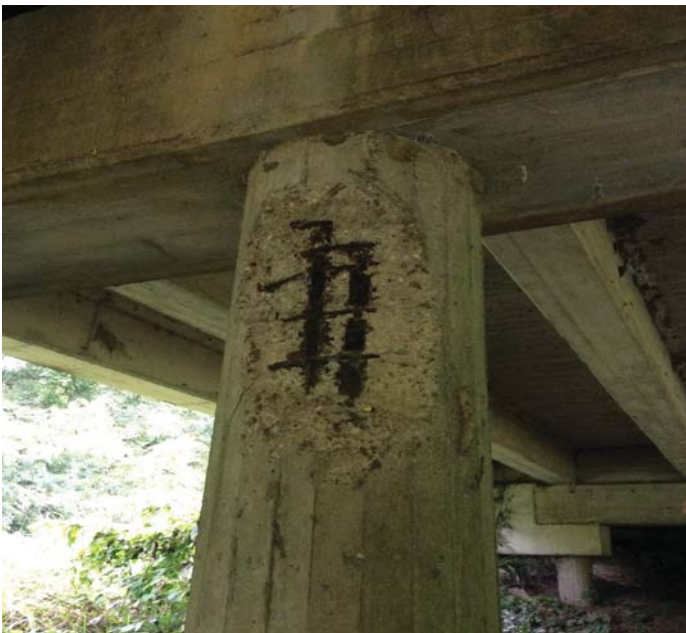
Large spall with 3.5' rebar exposed to Pile 4 at Bent 2.

PHOTO 1 Description Large spall with 3.5' rebar exposed to Pile 4 at Bent 2.

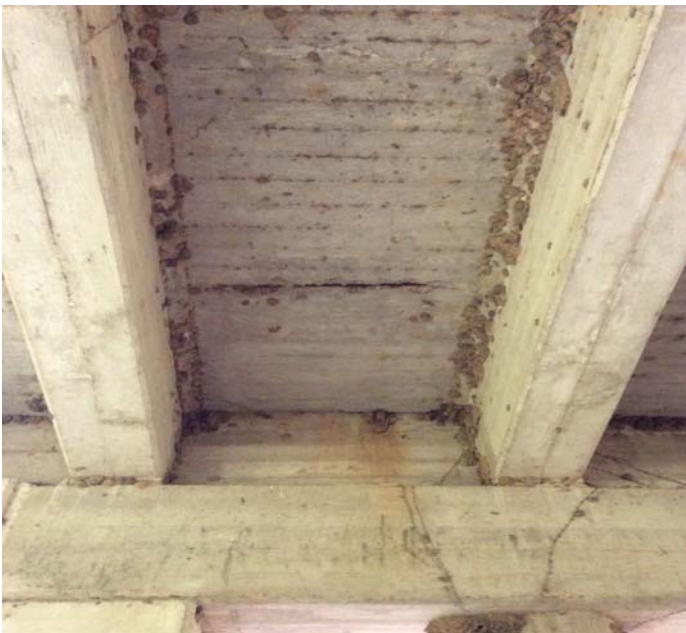
Spalls with rebar exposed to deck below at Spans 2, 3, 4, 5, 6, 8, 9, 12, 13, & 14.

PHOTO 1	Description	Spalls with rebar exposed to deck below at Spans 2, 3, 5, 6, 8, 9, 13, & 14.
---------	-------------	--
