Bridge Inspection Report

**A1335
US 64 WHITE
over
BIG GREEN TOM LAKE**

Structure Number: A1335

Facility Carried: US 64 WHITE

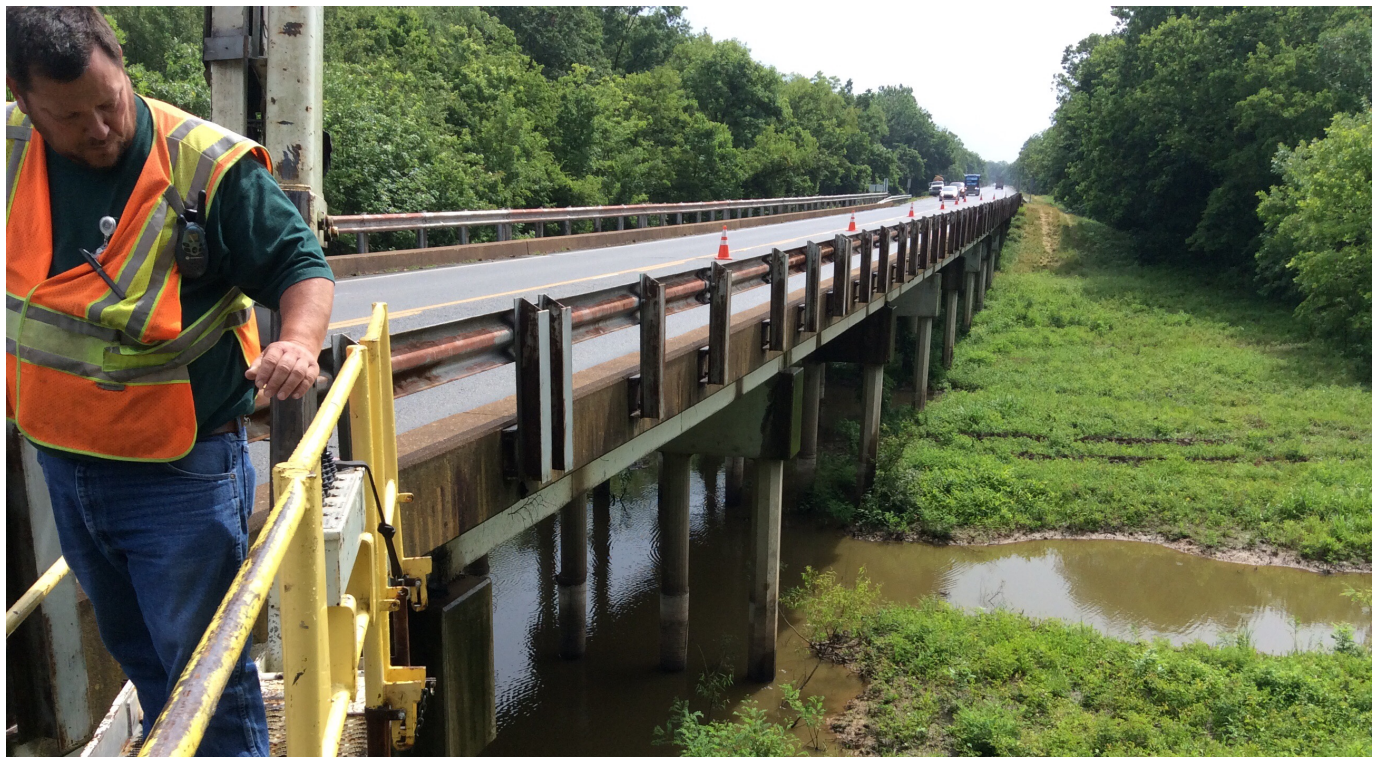
6 inches of asphalt on the deck

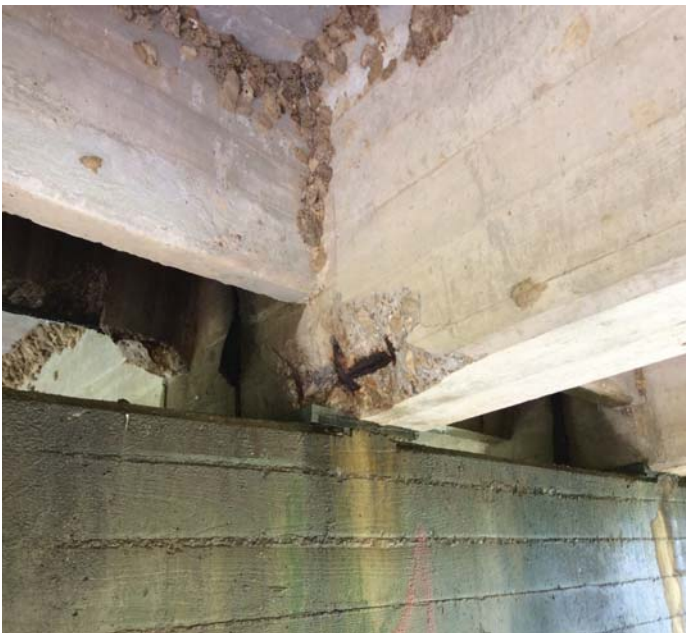
Spalls with rebar exposed to Girders at Spans 2, 3, 4, 5, 6, 7, 8, 9 & 11.

PHOTO 1 Description Spalls with rebar exposed to Girders at Spans 2, 3, 4, 5, 6, 7, 8, 9 & 11.

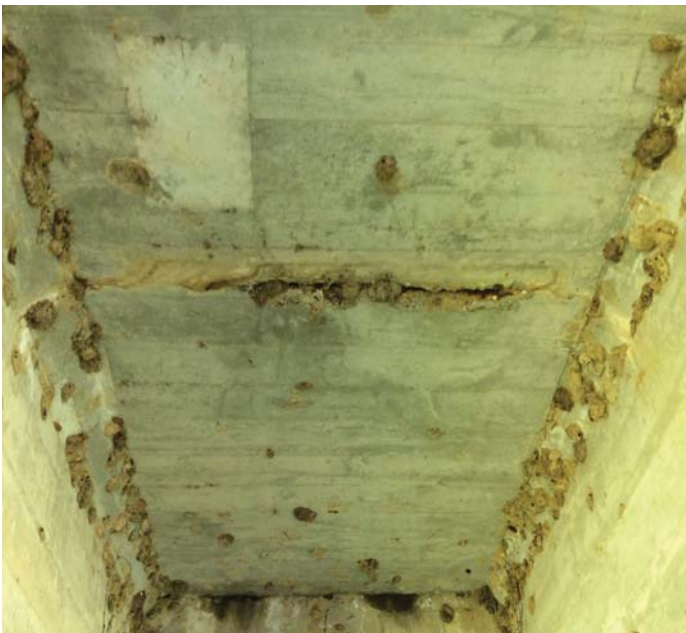
Spalls with rebar exposed to deck below at Spans 2, 6, & 10.

PHOTO 1 Description Spalls with rebar exposed to deck below at Spans 2, 6 & 10.

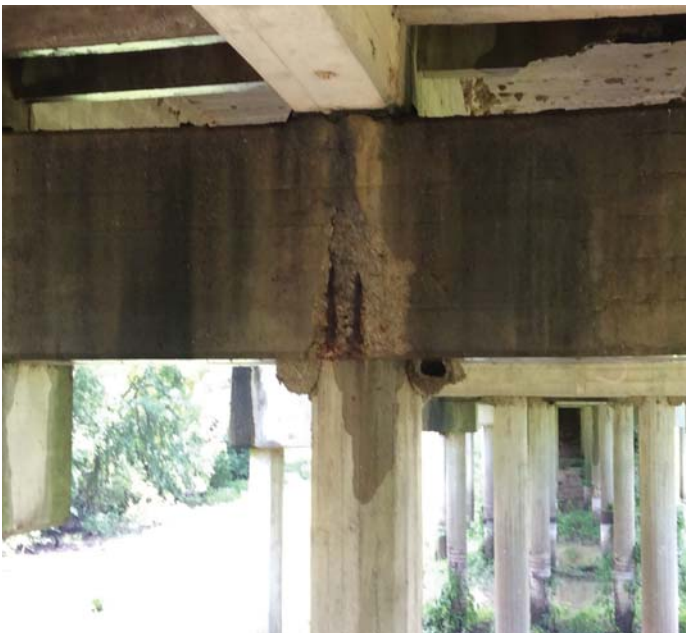
Spalls with rebar exposed to cap at Bents 4, 5, 6, 8, 9 & 10.

PHOTO 1 Description Spalls with rebar exposed to cap at Bents 4, 5, 6, 8, 9 & 10.

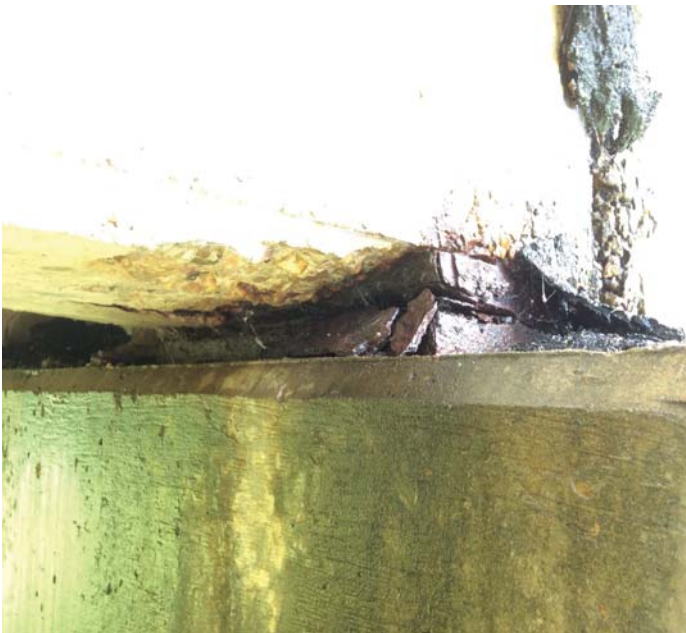
Rust & pitting with section loss to moveable Bearings 1 & 6 at Bents 2, 4, 6, 8, & 10.

PHOTO 1 Description Rust & pitting with section loss to moveable Bearings 1 & 6 at Bents 2, 4, 6, 8, & 10.

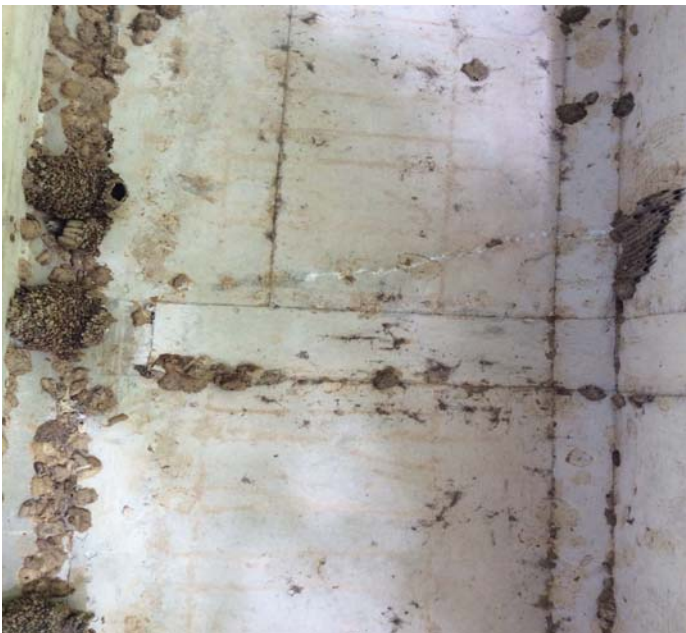
Transverse cracks, some with rust stains, to deck below & to girders at all Spans.

PHOTO 1 Description Transverse cracks, some with rust stains, to deck below & to girders at all Spans
