Bridge Inspection Report

A1337
US 64 White Co.
over
WHITE RIVER RELIEF

Structure Number: A1337

Facility Carried: US 64 White Co.

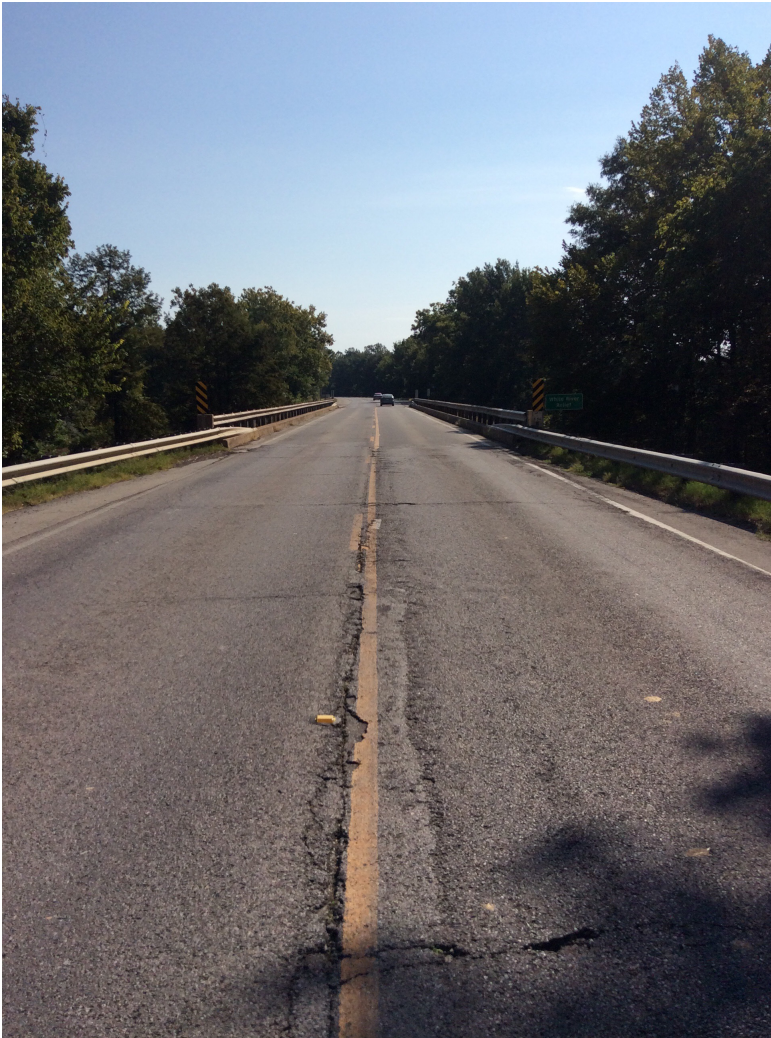
4 inches of asphalt on the deck

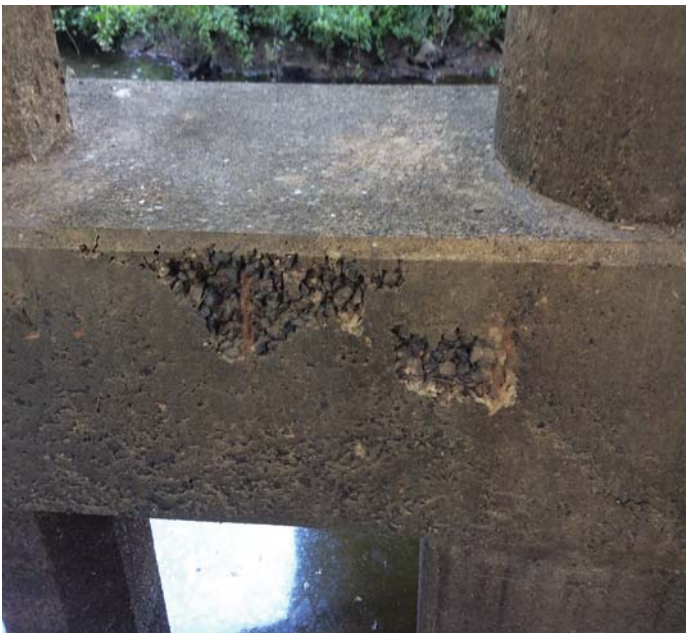
Bent 4 has Large honeycomb area with 6" rebar exposed to back side of Sub Cap between Pile 1 & 2.

PHOTO 1 Description Bent 4 has Large honeycomb area with 6" rebar exposed to back side of Sub Cap between Pile 1 & 2.

Work Code: Repair

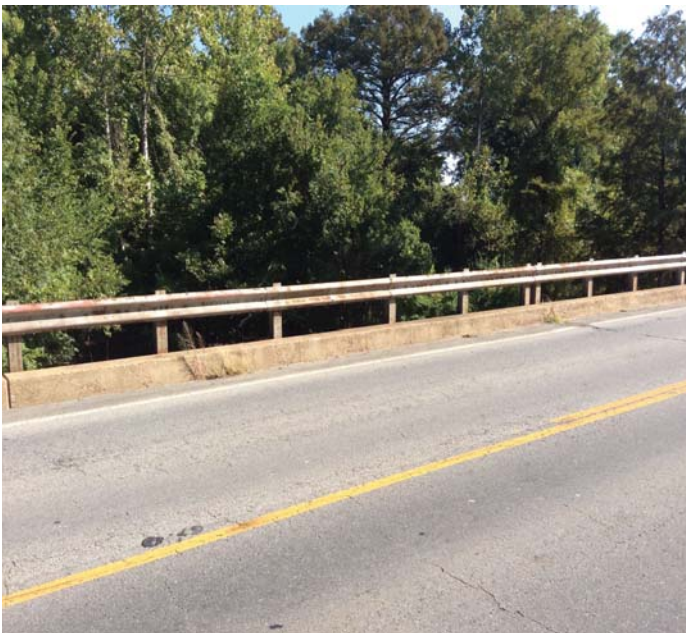
All Guard rail is rusting & peeling.

PHOTO 1 Description All Guard Rail is rusting & areas of peeling paint.

Work Code: Replace

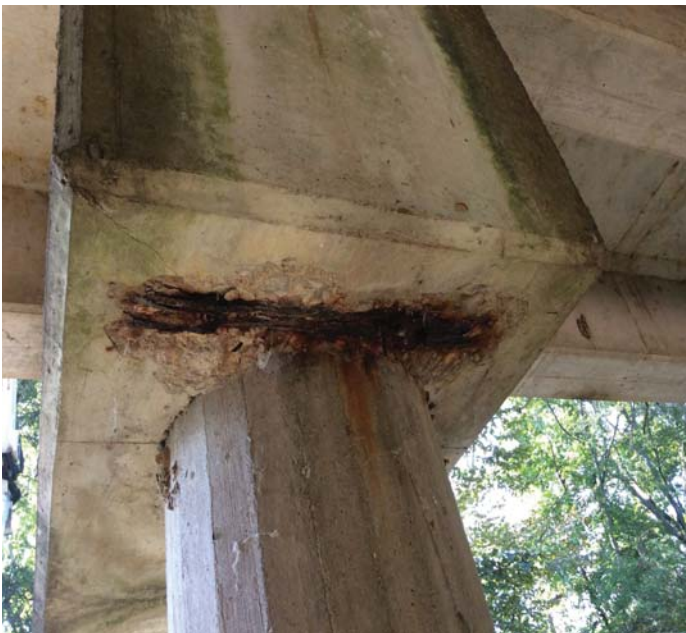
Environment	Total Quantity	Units	Condition State 1	Condition State 2	Condition State 3	Condition State 4
12 - Reinforced Concrete Deck	1- Ben.	8405	sq. ft.	8405			
	Asphalt is raveling @ open joints						
510 - Wearing Surfaces		7616	sq. ft.	7616			
110 - Reinforced Concrete Open Girder/Beam	1- Ben.	1632	ft.	1576	56		0
	Random cracking & spalls with rebar exposed to girders. See Form III						
1090 - Exposed Rebar		6			6		
1130 - Cracking (RC and Other)		50			50		
215 - Reinforced Concrete Abutment	1- Ben.	70	ft.	70			
220 - Reinforced Concrete Pile Cap/Footing	1- Ben.	57	ft.	0	57		
	Honeycomb area with rebar exposed. SEE FORM III						
227 - Reinforced Concrete Pile	1- Ben.	42	each	0	42		
	Random cracks or spalls to Piles. SEE FORM III						
234 - Reinforced Concrete Pier Cap	1- Ben.	199	ft.	188	11		0
	Spalls with rebar exposed to cap @ Bents 1, 2, 3 & 6 SEE FORM III						
1090 - Exposed Rebar		11			11

Spalls with rebar exposed to caps @ Bents 1, 2, 3 & 6

PHOTO 1 Description Spalls with rebar exposed to Caps @
Bents 1, 2, 3 & 6.

Work Code: Repair

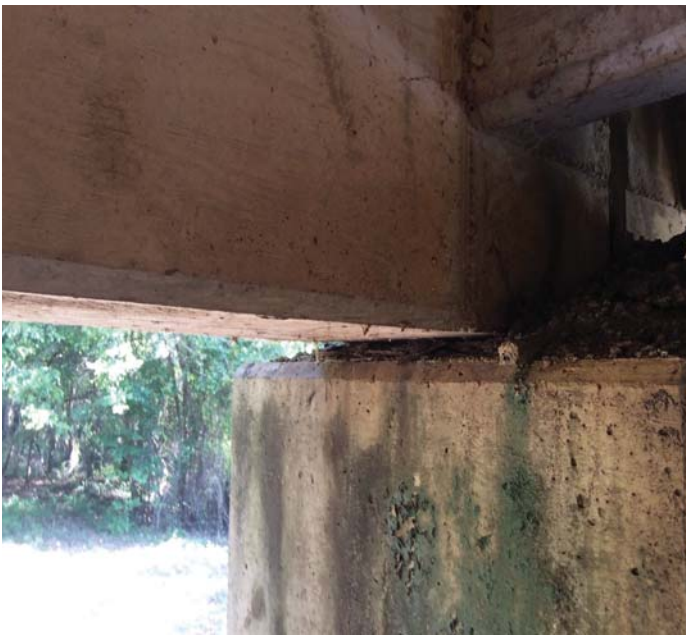
311 - Movable Bearing	1- Ben.	23	each	17		6	0
	Rust & section loss to Bearings 1 & 6 @ Bents 2, 4 & 6.						
1000 - Corrosion		6				6	
330 - Metal Bridge Railing	1- Ben.	544	ft.	544			
	All metal bridge rails peeling & rusting.						
515 - Steel Protective Coating		1632	sq. ft.	0		1632

Rust & section loss to bearings 1 & 6 @ Bents 2, 4 & 6

PHOTO 1 Description Rust & section loss to Bearings 1 & 6
@ Bents 2, 4 & 6

Work Code: Replace

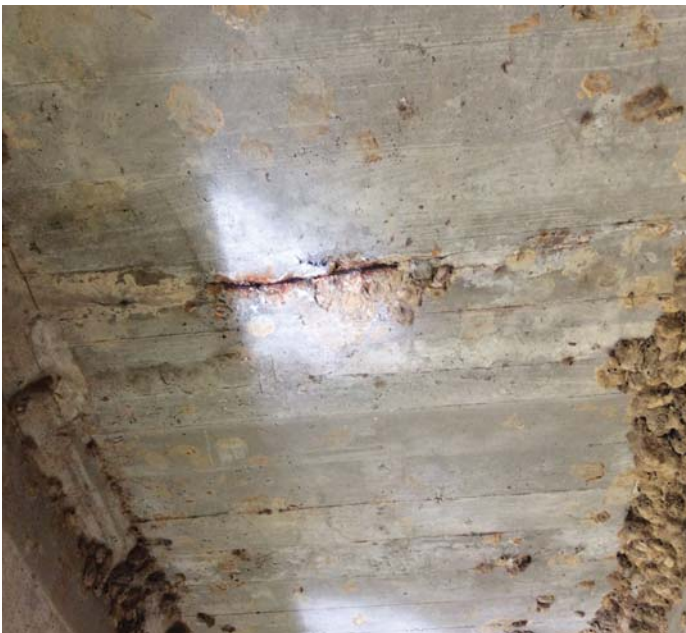
Spalls with rebar exposed to Deck below @ Spans 1, 2, 3, 4, 6, 7 & 8

PHOTO 1 Description Spalls with rebar exposed to Deck below @ Spans 1, 2, 3, 4, 6, 7 & 8.

Work Code: Repair

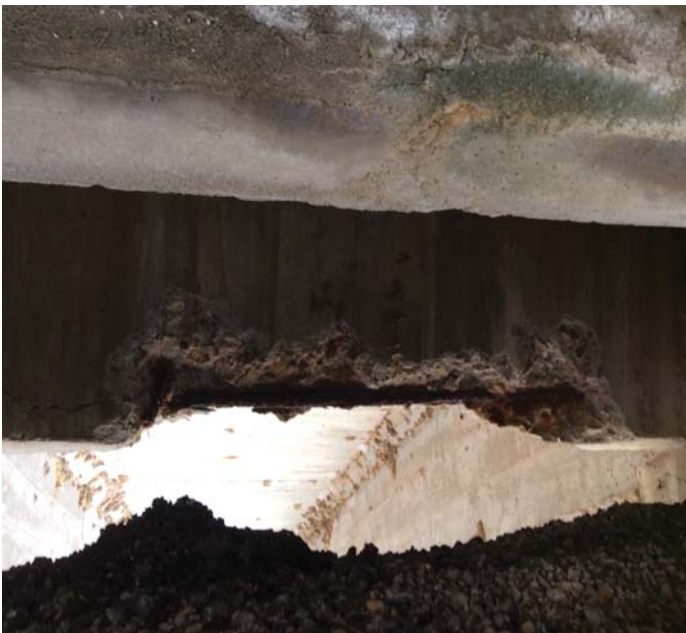
Spalls with rebar exposed to Concrete Diaphragms @ Spans 2, 4, 5, 6, 7 & 8.

PHOTO 1 Description Spalls with rebar exposed to Concrete Diaphragms @ Spans 2, 4, 5, 6, 7 & 8.

Work Code: Repair
